MFC Auction House  
M57 Pretoria Rd, Glenmarais, KEMPTON PARK  
Gauteng

Vehicle Type	PASSENGER VEHICLE	Registered Owner	MFC AUCTION HOUSE
Manufacturer	KIA	Registration Number	FJ16RFGP
Model	RIO	Register Number	
VIN	KNADN511LG6763118	Date Of First Licensing	
Engine Number		Last COR	
Doors	5	License Expiry Date	31/10/2024
Color	RED	Power / Displacement	
Year Model		Paint Finish	M - METALLIC
Km Reading	121,880 KM	Fuel	PETROL
Cab / Body Type	HATCHBACK	Transmission	MANUAL

## CONDITION REPORT

Report No: 2016256681

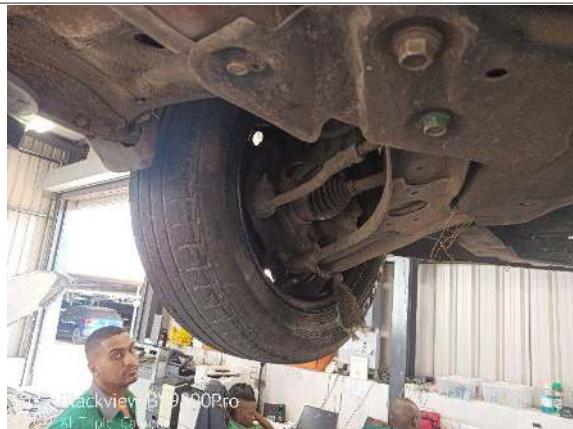
LF TYRE TREAD

Size	Load/Speed Index	Manufacture	Model	Type*	Production Date	Tread Depth (mm)
Front Left	185/65R15	88H	Invovic	EI601	V	2518	2 mm
Front Right	185/65R15	88H	Goodride	Radial	V	1622	3 mm
Rear Left	185/65R15	88H	Firestone	Touring	V	5021	3 mm
Rear Right	185/65R15	88H	Kumho	Solus	V	4115	3 mm

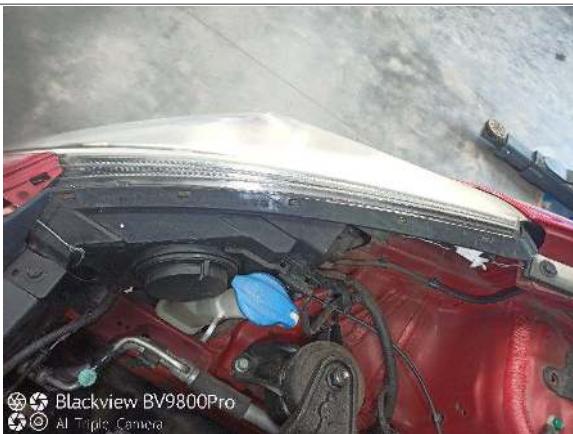
Damage	Repair Way
Headlight Right Damaged	Replace
Seat Front Left Torn / Cut	Repair
Side Mirror Left Paintwork • Scratched	Repair
Side Mirror Right Paintwork • Scratched	Repair
Front Bumper Damaged	Repair
A • Pillar Right Paintwork • Discoloured	Repair
Front Fender Left Dented	Repair
Front Fender Right Paintwork • Scratched	Repair
Rear Fender Left Paintwork • Scratched	Repair
Rear Fender Right Dented	Repair
Door Front Left Paintwork • Scratched	Repair
Door Front Right Dented	Repair
Door Rear Left Dented	Repair
Door Rear Right Paintwork • Scratched	Repair
Boot Lid / Hatch door Paintwork • Scratched	Repair
Rear bumper Damaged	Repair
Service Brake Performance Front Axle Left / Right Difference out of legal range	Repair
Bolt(s) / Nut(s) Front Wheel Left Damaged	Repair
Bolt(s) / Nut(s) Front Wheel Right Missing	Replace
CV Joint(s) Boot(s) Front Left (inner/outer) Defective	Repair
CV Joint(s) Boot(s) Front Right (inner/outer) Defective	Repair
