CONDITION REPORT

Report No: 2016847401

MFC Auction House  
M57 Pretoria Rd, Glenmarais, KEMPTON PARK  
Gauteng

| Manufacturer | KIA | Registration Number | CH08PVGP |

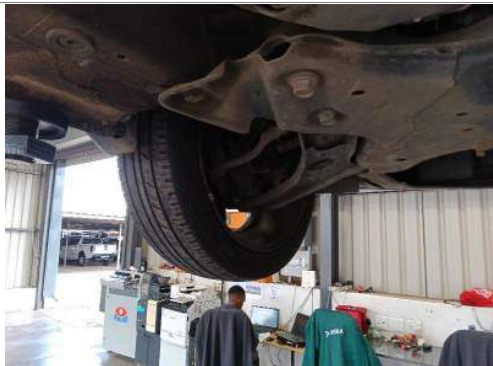
LF TYRE TREAD

| | Size | Load/Speed Index | Manufacture | Model | Type* | Production Date | Tread Depth (mm) |
|---|---|---|---|---|---|---|---|
| Front Left | 205/45R17 | 88W | Royal black | Royal perfor | V | 4722 | 3 mm |

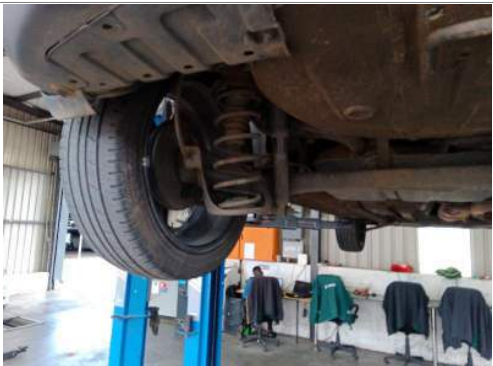
LR TYRE TREAD

| | Size | Load/Speed Index | Manufacture | Model | Type* | Production Date | Tread Depth (mm) |
|---|---|---|---|---|---|---|---|
| Rear Left | 205/45R17 | 88W | Royal black | Royal perfor | V | 3418 | 3 mm |

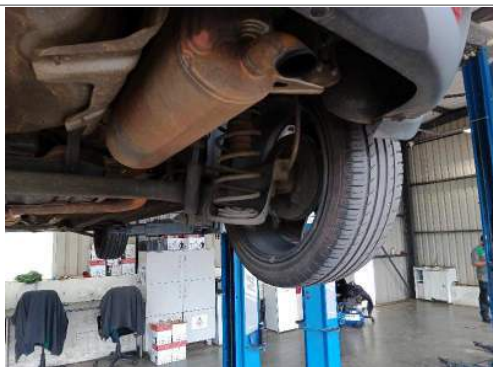
RR TYRE TREAD

| | Size | Load/Speed Index | Manufacture | Model | Type* | Production Date | Tread Depth (mm) |
|---|---|---|---|---|---|---|---|
| Rear Right | 205/45R17 | 88W | Good ride | Sport sa-37 | V | 4519 | 4 mm |

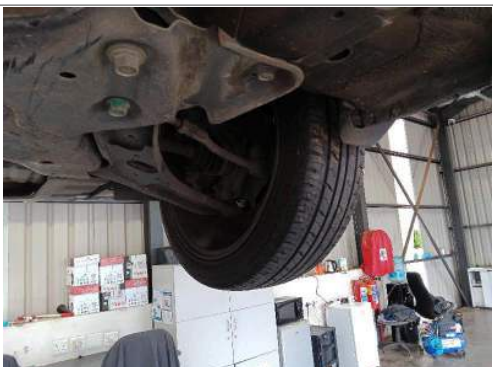
RF TYRE TREAD

| | Size | Load/Speed Index | Manufacture | Model | Type* | Production Date | Tread Depth (mm) |
|---|---|---|---|---|---|---|---|
| Front Right | 205/45R17 | 88W | Royal black | Royal perfor | V | 4822 | 3 mm |

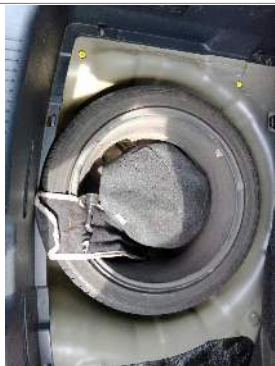
Spare wheel

| | Size | Load/Speed Index | Manufacture | Model | Type* | Production Date | Tread Depth (mm) |
|---|---|---|---|---|---|---|---|
| Spare | 205/45R17 | 88W | Good ride | Sport sa37 | V | 0000 | 4 mm |

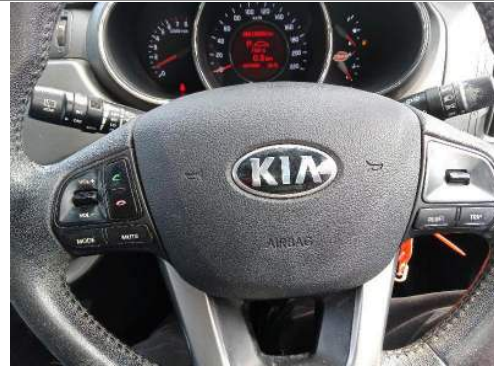
| Damage | Repair Way |
|---|---|
| Hooter Defective | Repair |

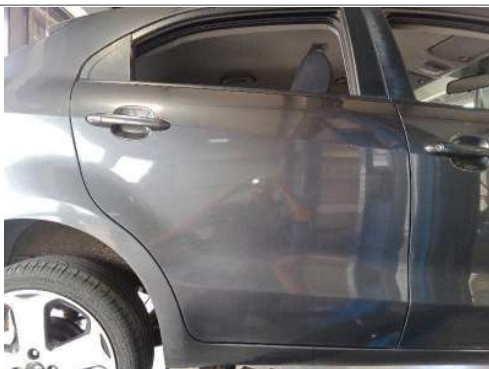
| Damage | Repair Way |
|---|---|
| Door Rear Right Paintwork • Scratched | Repair |

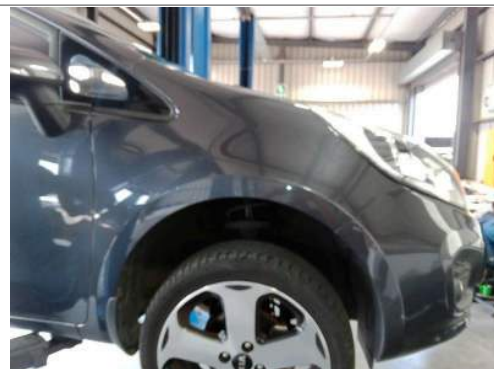
| Damage | Repair Way |
|---|---|
| Front Fender Right Paintwork • Scratched | Repair |

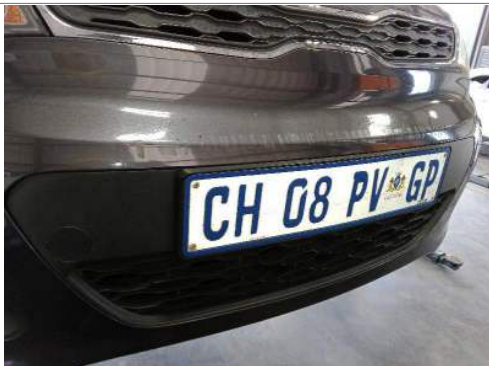
| Damage | Repair Way |
|---|---|
| Front Bumper Paintwork • Scratched | Repair |

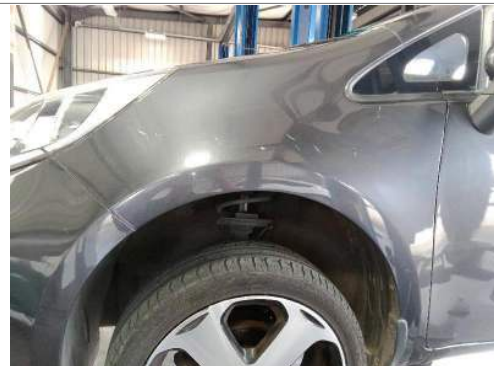
| Damage | Repair Way |
|---|---|
| Front Fender Left Paintwork • Scratched | Repair |

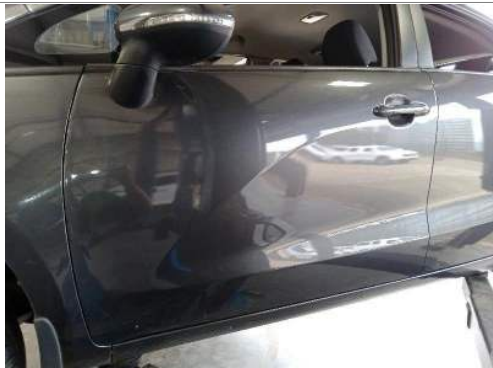
| Damage | Repair Way |
|---|---|
| Door Front Left Paintwork • Scratched | Repair |

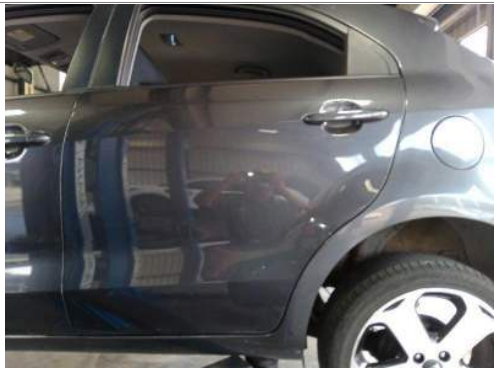
| Damage | Repair Way |
|---|---|
| Door Rear Left Paintwork • Scratched | Repair |

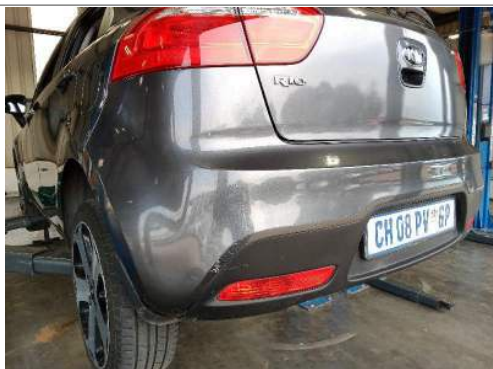
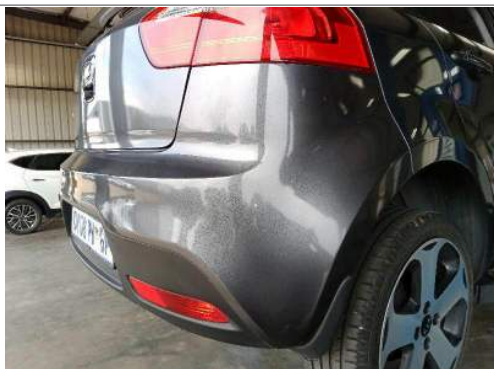
| Damage | Repair Way |
|---|---|
| Rear bumper Paintwork • Scratched | Repair |
