CONDITION REPORT

Report No: 2016825494

| Manufacturer | KIA | Registration Number | DX25XNGP |
| Model | RIO 1.4 5-DR [2015-2018] | Register Number | |

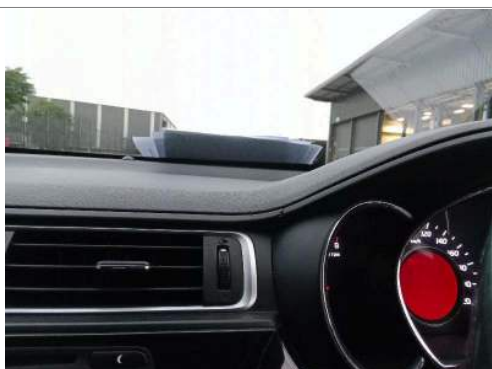
| Damage | Repair Way |
|---|---|
| Dash Padding Defective | Repair |

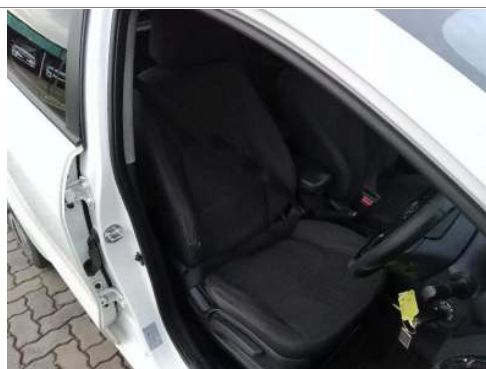
| Damage | Repair Way |
|---|---|
| Seat Front Right Damaged | Repair |

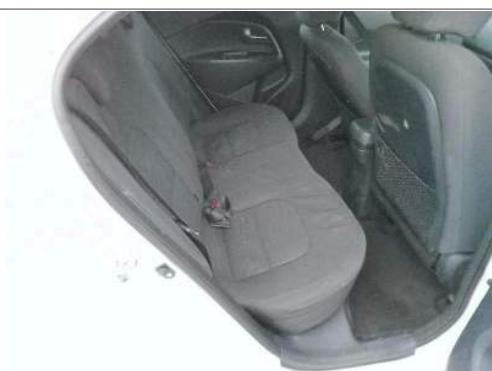
| Damage | Repair Way |
|---|---|
| Seat Rear Defective | Repair |

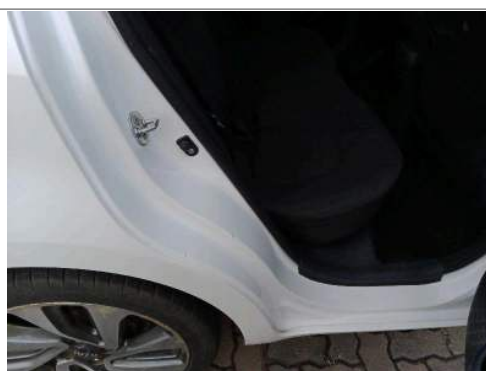
| Damage | Repair Way |
|---|---|
| C • Pillar Right Dented | Repair |

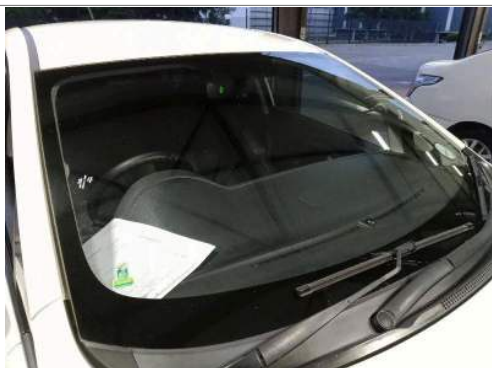
| Damage | Repair Way |
|---|---|
| Windscreen Chipped | Repair |

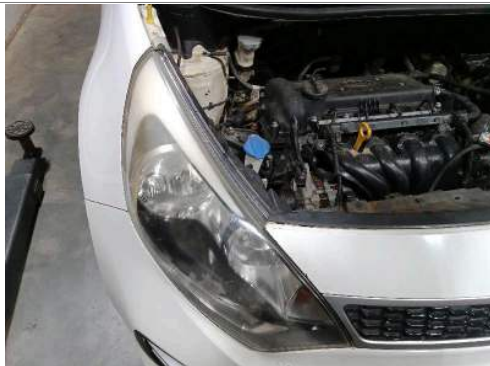
| Damage | Repair Way |
|---|---|
| Headlight Right Damaged | Replace |

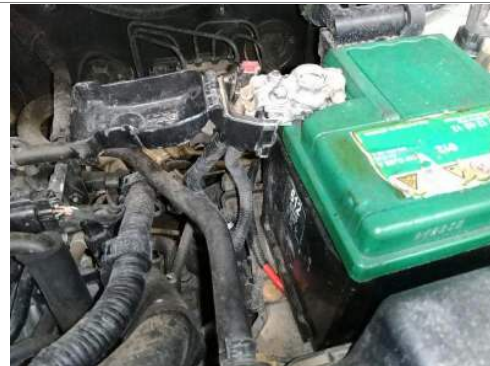
| Damage | Repair Way |
|---|---|
| Engine Wiring Defective | Repair |

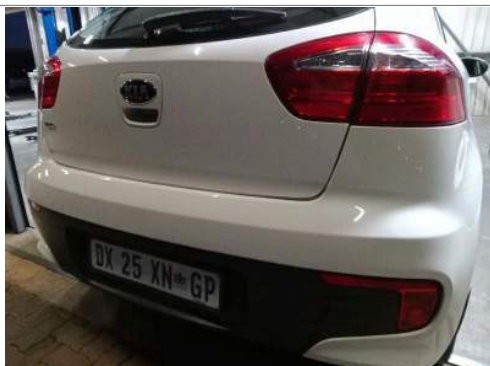
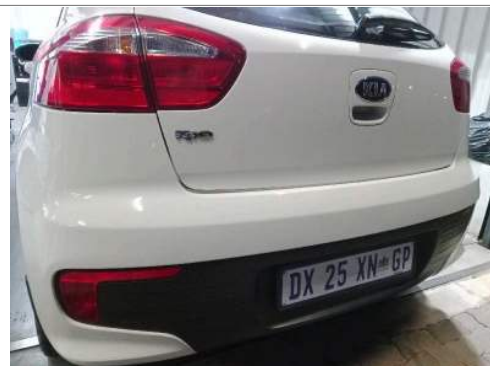
| Damage | Repair Way |
|---|---|
| Rear bumper Paintwork • Scratched | Repair |

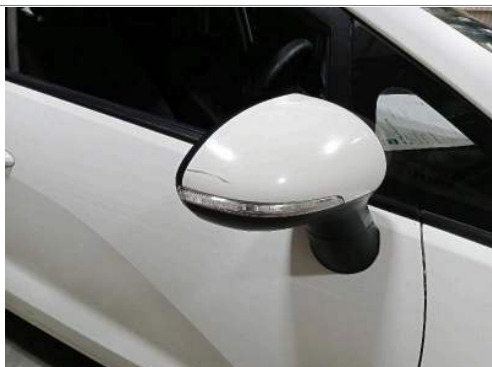
| Damage | Repair Way |
|---|---|
| Indicator Light Front Right Cracked | Replace |

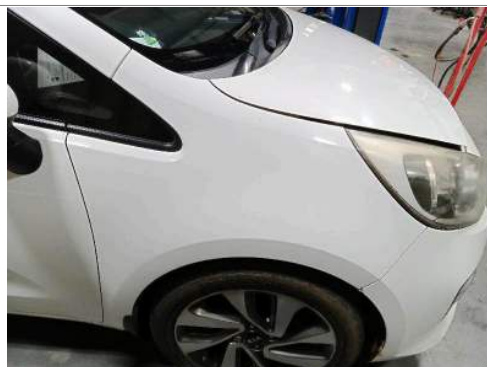
| Damage | Repair Way |
|---|---|
| Front Fender Right Paintwork • Scratched | Repair |

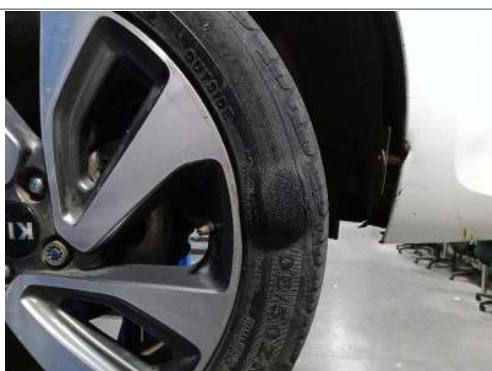
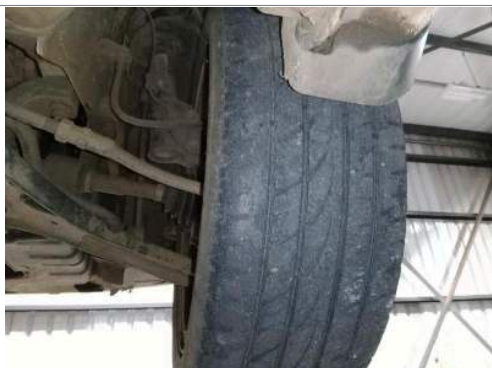
| Damage | Repair Way |
|---|---|
| Tyre Front Right Damaged | Replace |

| | Size | Load/Speed Index | Manufacture | Model | Type* | Production Date | Tread Depth (mm) |
|---|---|---|---|---|---|---|---|
| Front Right | 205/50Z R17 | 93W | Wideway | Sport | V | 2015 | 0 mm |

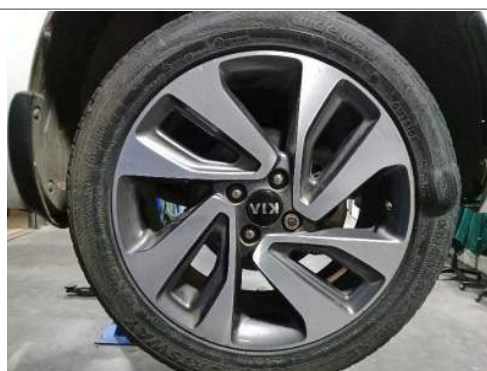
| Damage | Repair Way |
|---|---|
| Rim Front Right Scratched | Repair |

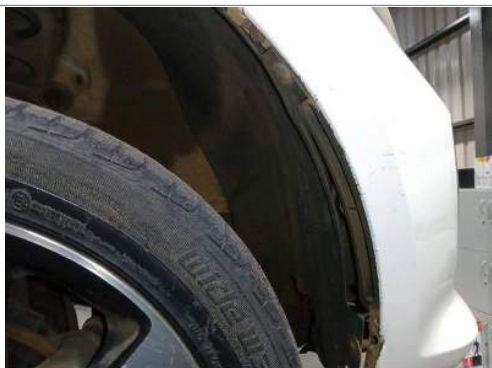
| Damage | Repair Way |
|---|---|
| Front Fender Right / Inner Tray Damaged | Repair |

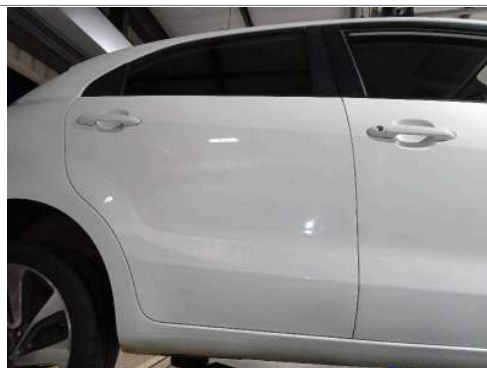
| Damage | Repair Way |
|---|---|
| Door Rear Right Residual Traces of Repair | Repair |

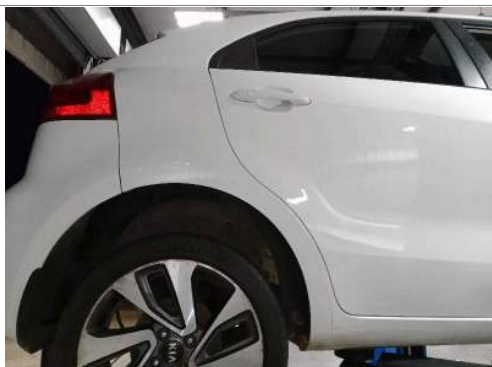
| Damage | Repair Way |
|---|---|
| Rear Fender Right Residual Traces of Repair | Repair |

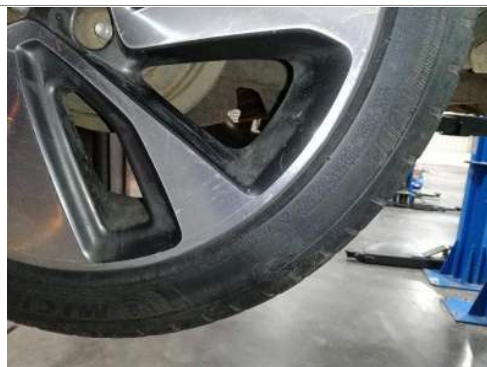
| Damage | Repair Way |
|---|---|
| Tyre Rear Right Damaged | Replace |

| | Size | Load/Speed Index | Manufacture | Model | Type* | Production Date | Tread Depth (mm) |
|---|---|---|---|---|---|---|---|
| Rear Right | 205/45Z R17 | 88W | Michelin | Pilot Sport | V | 2318 | 1 mm |

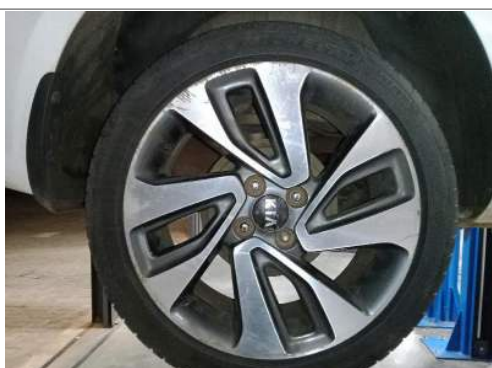
| Damage | Repair Way |
|---|---|
| Rim Rear Right Scratched | Repair |

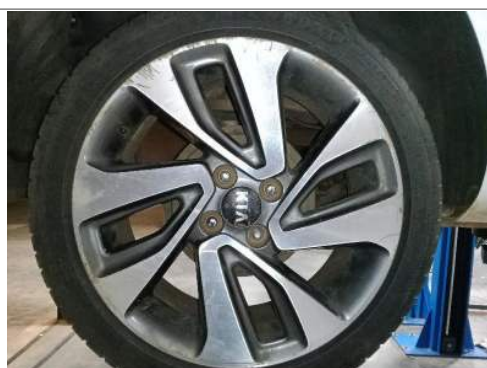
| Damage | Repair Way |
|---|---|
| Bolt(s) / Nut(s) Rear Wheel Right Missing | Replace |

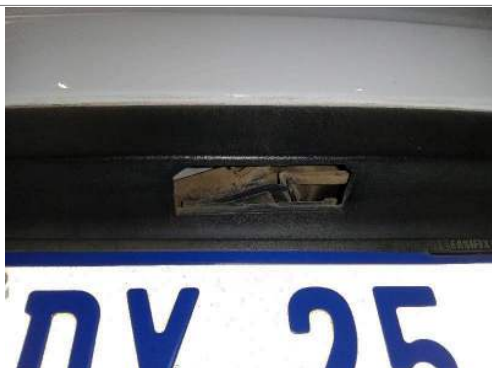
| Damage | Repair Way |
|---|---|
| Number Plate Light Left Damaged | Replace |

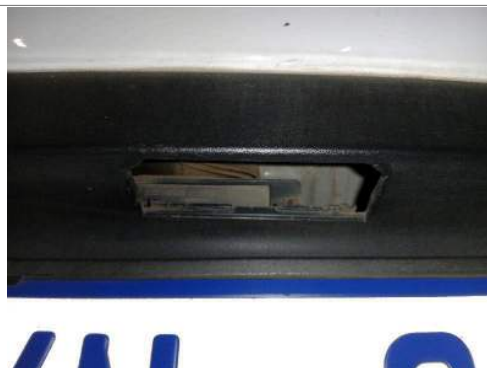
| Damage | Repair Way |
|---|---|
| Number Plate Light Right Damaged | Replace |

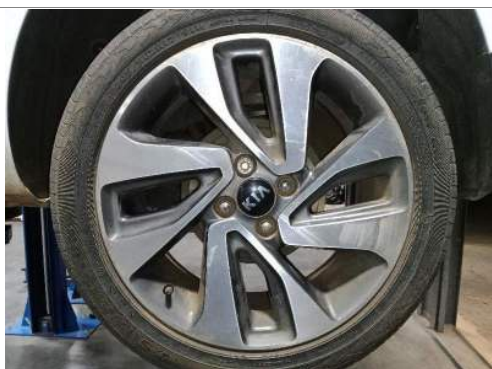
| Damage | Repair Way |
|---|---|
| Rim Rear Left Scratched | Repair |

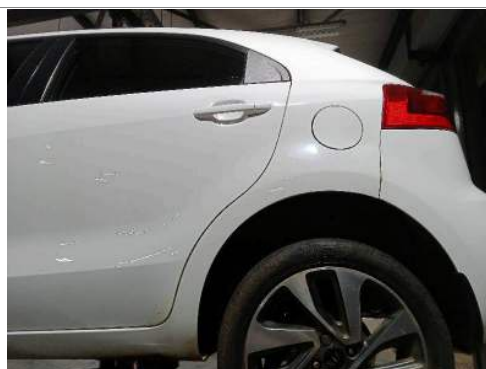
| Damage | Repair Way |
|---|---|
| Rear Fender Left Damaged | Repair |

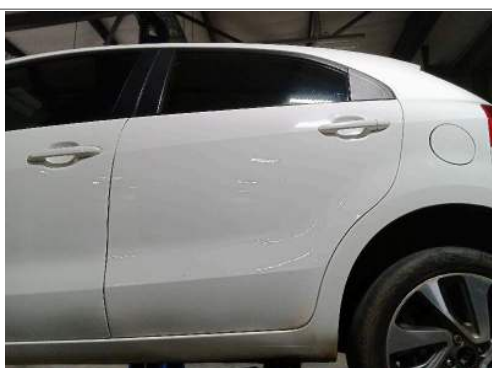
| Damage | Repair Way |
|---|---|
| Door Rear Left Dented | Repair |

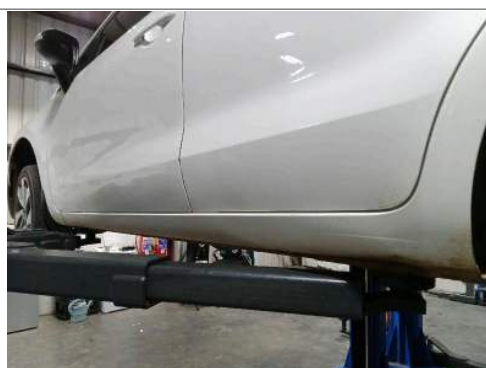
| Damage | Repair Way |
|---|---|
| Sill Panel Left Dented | Repair |

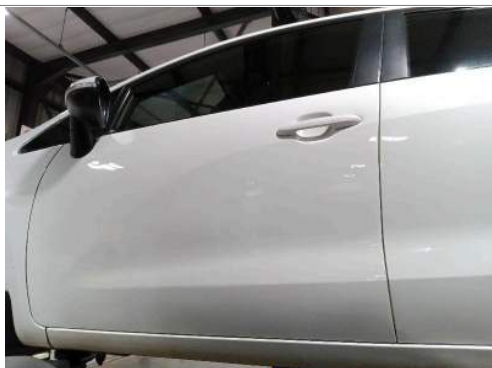
| Damage | Repair Way |
|---|---|
| Door Front Left Damaged | Repair |

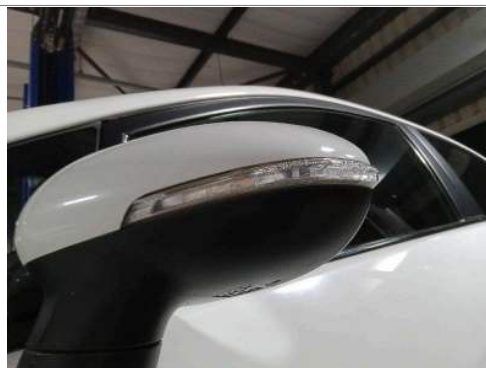
| Damage | Repair Way |
|---|---|
| Indicator Light Front Left Damaged | Replace |

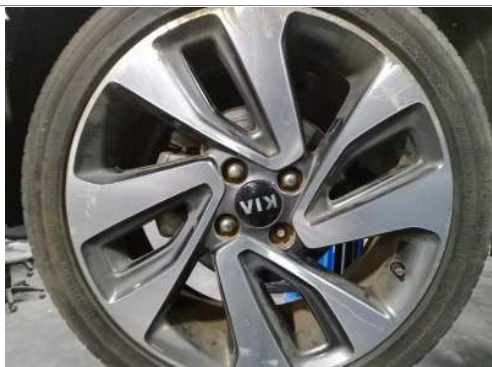
| Damage | Repair Way |
|---|---|
| Bolt(s) / Nut(s) Front Wheel Left Missing | Replace |

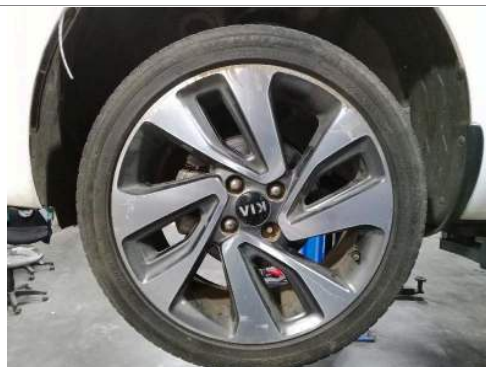
| Damage | Repair Way |
|---|---|
| Rim Front Left Dented | Repair |

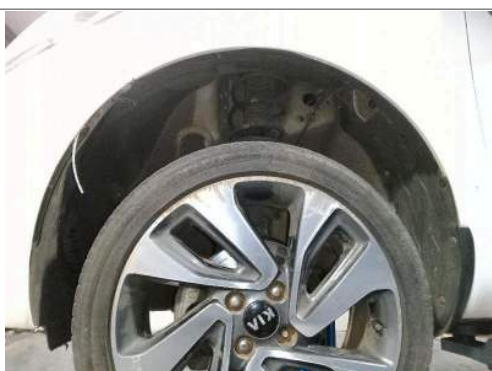
| Damage | Repair Way |
|---|---|
| Front Fender Left / Inner Tray Damaged | Repair |

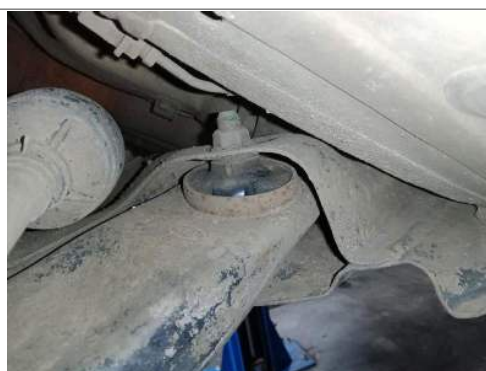
| Damage | Repair Way |
|---|---|
| Control Arm Bush(es) Front Axle Left Cracked | Replace |

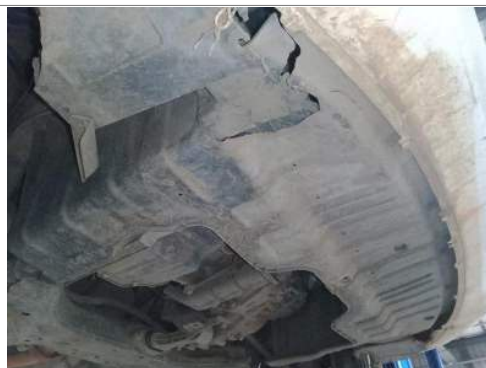
| Damage | Repair Way |
|---|---|
| Belly plates Damaged | Replace |

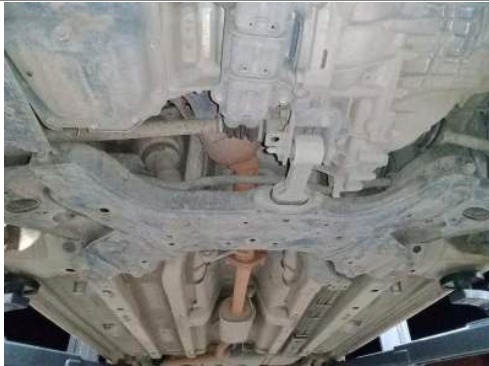
| Damage | Repair Way |
|---|---|
| Sub Frame Dented | Repair |

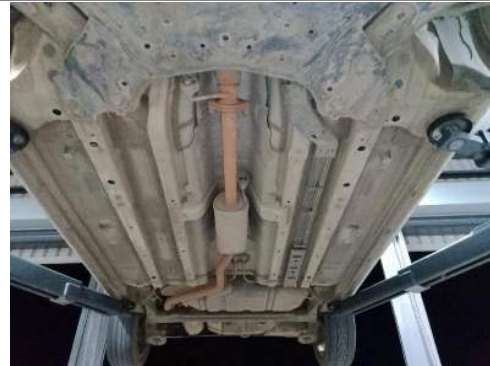
| Damage | Repair Way |
|---|---|
| Chassis Dented | Repair |

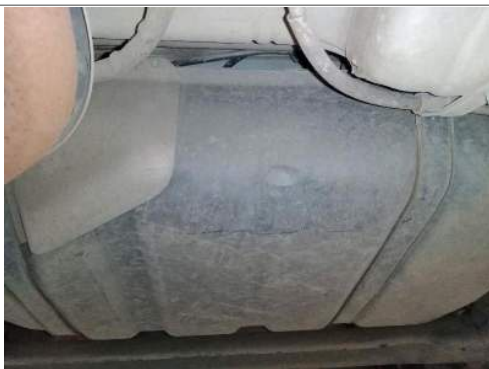
| Damage | Repair Way |
|---|---|
| Fuel Tank Dented | Repair |

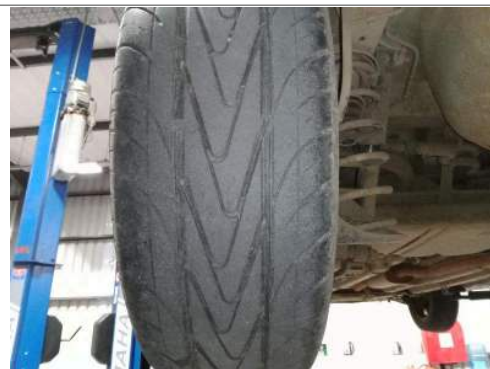
| Damage | Repair Way |
|---|---|
| Tyre Rear Left Damaged | Replace |

| | Size | Load/Speed Index | Manufacture | Model | Type* | Production Date | Tread Depth (mm) |
|---|---|---|---|---|---|---|---|
| Rear Left | 205/50Z R17 | 91W | Silverstone | Sport | V | 3918 | 0 mm |

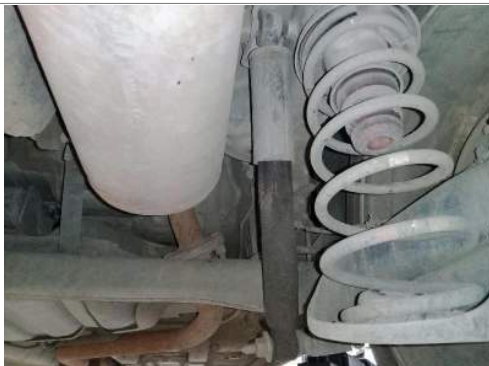
| Damage | Repair Way |
|---|---|
| Shock Absorber Rear Right Leak | Replace |
| Rear right shock absorber weak | Replace |

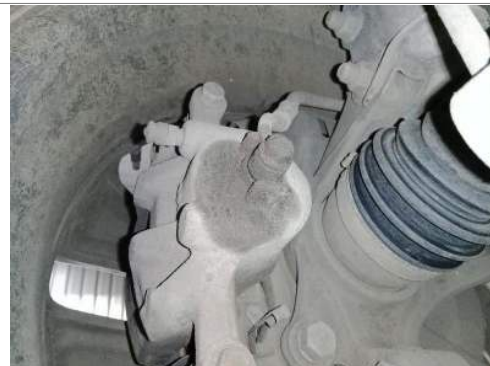
| Damage | Repair Way |
|---|---|
| Caliper 1. Axle right Sweat | Repair |

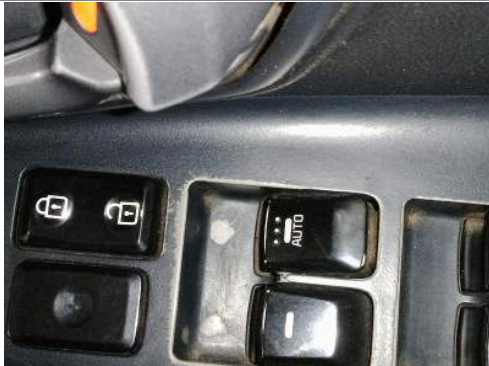
| Damage | Repair Way |
|---|---|
| Switch Electrical Window Winder front right Damaged | Replace |
