CONDITION REPORT

Report No:
2016963143
DATE
30/07/2025

Vehicle Type	PASSENGER VEHICLE	Registered Owner	MFC
Manufacturer	KIA	Registration Number	JJX551MP
Model	RIO 1.4 TEC 5-DR [2015-2018]	Register Number	
VIN	KNADN512LG6767023	Date Of First Licensing	
Engine Number		Last COR	
Doors	5	License Expiry Date	31/10/2020
Color	SILVER	Power / Displacement	
Year Model	2017	Paint Finish	M - METALLIC
Km Reading	59,208 KM	Fuel	PETROL
Cab / Body Type	HATCHBACK	Transmission	MANUAL

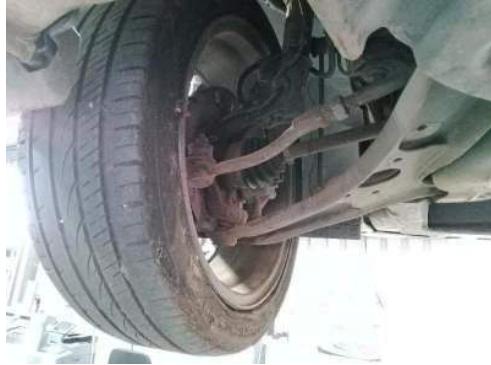
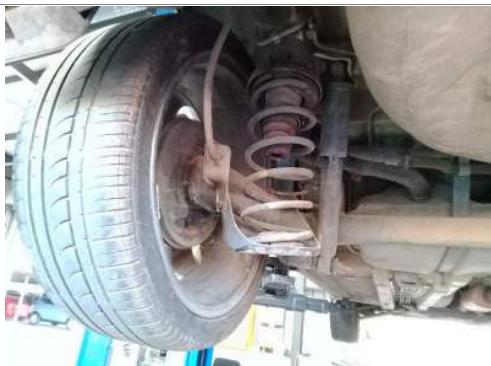
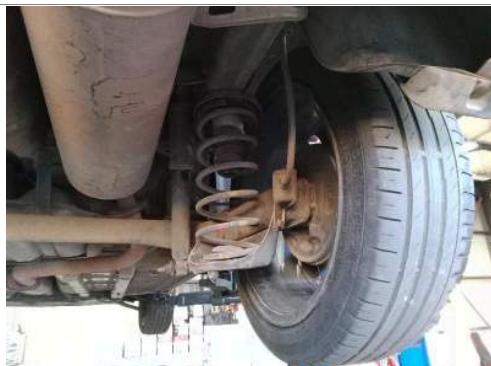
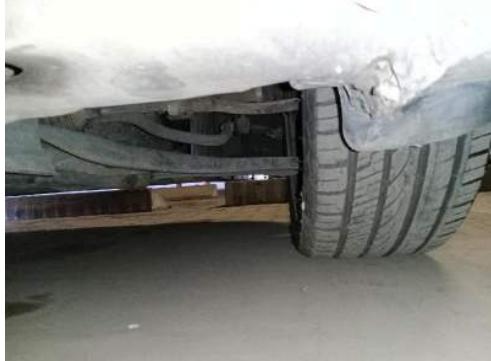
Size	Load/Speed Index	Manufacture	Model	Type*	Production Date	Tread Depth (mm)
Front Left	205/45ZR17	88W	Autogrip	Grip200	V	3618	1 mm
Front Right	205/45ZR17	88W	Autogrip	Grip200	V	3618	0 mm
Rear Left	205/45ZR17	88W	Continental	ContiSport	V	3215	0 mm
Rear Right	205/45ZR17	84W	Dunlop	SP Sport	V	1117	0 mm
Spare	205/45R17	88W	Continental	ContiSport	V	0000	0 mm

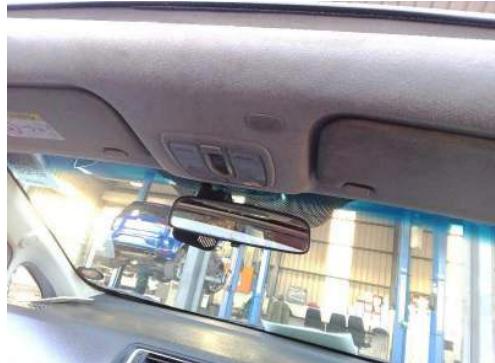
Damage	Repair Way
Seat Belt Rear Left Defective	Repair
Hood Lining Dirty	Repair
Side Mirror Left Broken	Replace
Side Mirror Right Broken	Replace
Front Bumper Damaged	Repair
Bonnet Dented	Repair
Front Fender Left Paintwork • Scratched	Repair
Front Fender Right Paintwork • Scratched	Repair
Rear Fender Right Paintwork • Scratched	Repair
Front Fender Right / Inner Tray Broken	Replace
Door Front Left Paintwork • Scratched	Repair
Door Rear Left Paintwork • Scratched	Repair
Door Rear Right Paintwork • Scratched	Repair
Roof Dented	Repair
Sealing Sun Roof Worn	Repair
Windscreen Chipped	Repair
Tyre Front Right Torn / Cut	Replace
Tyre Rear Left Damaged	Replace
Tyre Rear Right Damaged	Replace
Spare Tyre Worn	Replace
Rim Front Left Dented	Repair
Rim Rear Right Scratched	Repair
Sub Frame Scratched	Repair
Fuel Tank Deformed	Repair

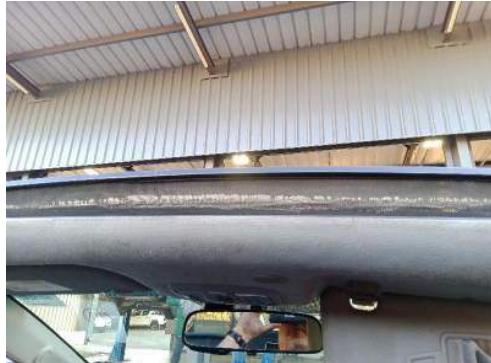
Sealing Sun Roof

General Comments: ACCORDING TO THE AGE AND MILEAGE OF THE VEHICLE, NORMAL WEAR AND TEAR MARKS ARE VISIBLE ON THE INTERIOR, EXTERIOR, ELECTRICAL AND MECHANICAL PARTS. Body • Exterior: Sunroof wind deflector worn. Signs of hail damage on some body panels. Minor dents, scratches and chip marks on various body panels.
