MFC Auction House  
M57 Pretoria Rd, Glenmarais, KEMPTON PARK  
Gauteng

| Vehicle Type | PASSENGER VEHICLE | Registered Owner | MFC AUCTION HOUSE |

## CONDITION REPORT

Report No: 2016311715

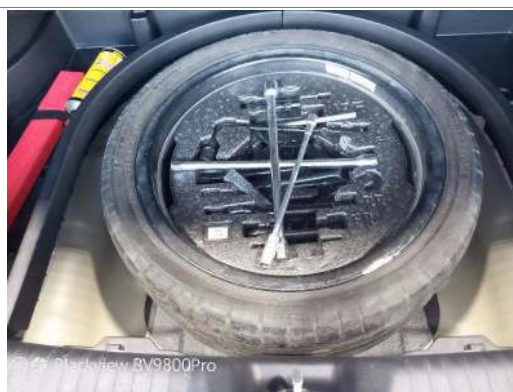
Spare wheel

| | Size | Load/Speed Index | Manufacture | Model | Type* | Production Date | Tread Depth (mm) |
|---|---|---|---|---|---|---|---|
| Spare | 255/35R18 | 94W | Bridgestone | Potenza | V | 0000 | 1 mm |

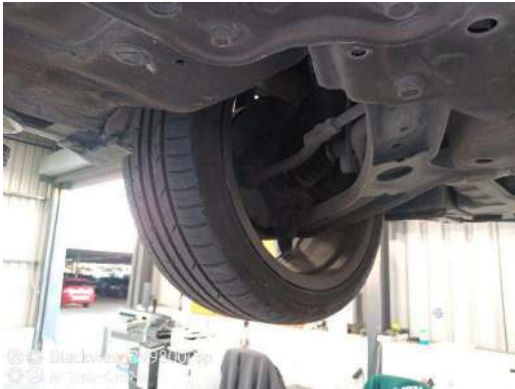
LF TYRE TREAD

| | Size | Load/Speed Index | Manufacture | Model | Type* | Production Date | Tread Depth (mm) |
|---|---|---|---|---|---|---|---|
| Front Left | 225/40R18 | 92W | Dunlop | Sp sport | V | 2020 | 3 mm |

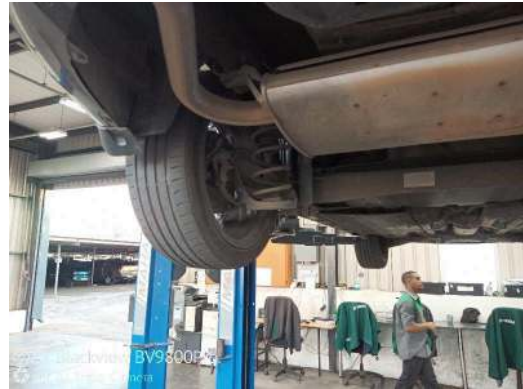
LR TYRE TREAD

| | Size | Load/Speed Index | Manufacture | Model | Type* | Production Date | Tread Depth (mm) |
|---|---|---|---|---|---|---|---|
| Rear Left | 225/40R18 | 92W | Nexen | N fera | V | 0619 | 2 mm |

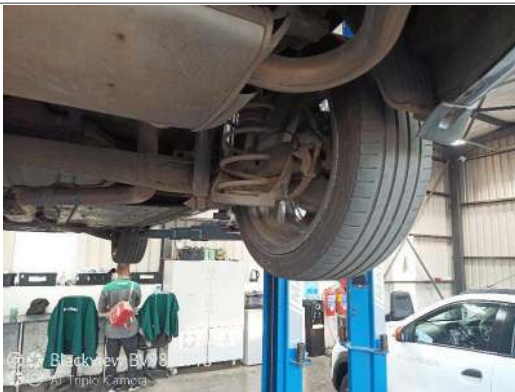
RR TYRE TREAD

| | Size | Load/Speed Index | Manufacture | Model | Type* | Production Date | Tread Depth (mm) |
|---|---|---|---|---|---|---|---|
| Rear Right | 225/40R18 | 92W | Nexen | N fera | V | 0619 | 2 mm |

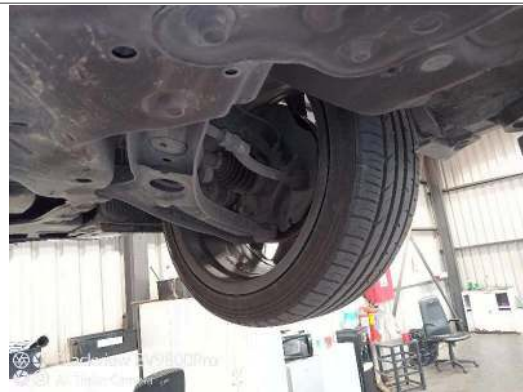
RF TYRE TREAD

| | Size | Load/Speed Index | Manufacture | Model | Type* | Production Date | Tread Depth (mm) |
|---|---|---|---|---|---|---|---|
| Front Right | 225/40R18 | 92W | Dunlop | Sp sport | V | 2020 | 3 mm |

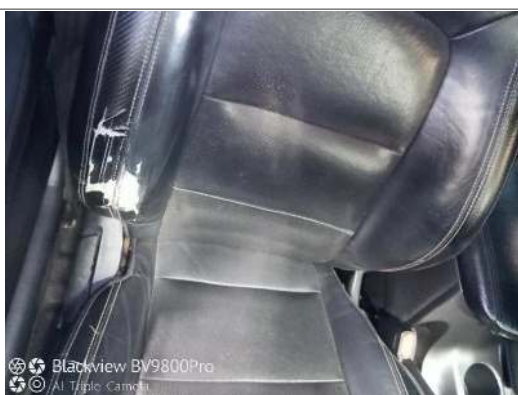
| Damage | Repair Way |
|---|---|
| Seat Front Right Damaged | Repair |

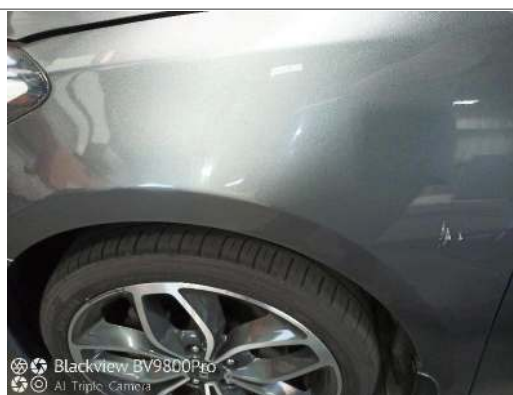
| Damage | Repair Way |
|---|---|
| Front Fender Left Paintwork • Scratched | Repair |

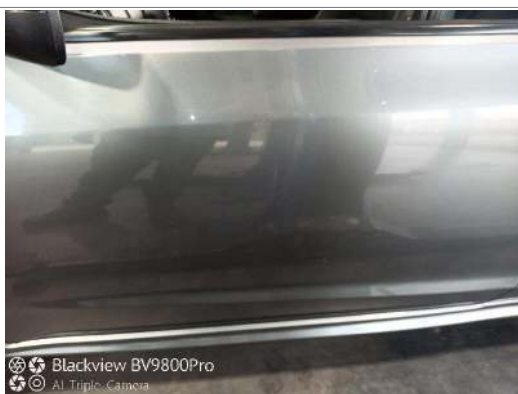
| Damage | Repair Way |
|---|---|
| Door Front Left Paintwork • Scratched | Repair |
