CONDITION REPORT

Report No: 2016270741

DATE
16/02/2024

MFC Auction House
M57 Pretoria Rd, Glenmarais, KEMPTON PARK
Gauteng

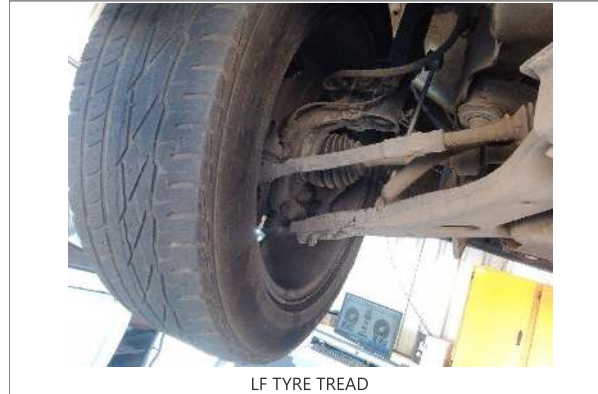
LF TYRE TREAD

Size	Load/Speed Index	Manufacture	Model	Type*	Production Date	Tread Depth (mm)
Front Left	225/55R18	98V	General	Grabber	V	1020	1 mm
Front Right	225/55R18	98V	General	Grabber	V	1020	1 mm
Rear Left	225/55R18	98H	Hankook	Optimo	V	3019	2 mm
Rear Right	225/55R18	98H	Hankook	Optimo	V	3019	2 mm
Spare	T155/90D16	110M	Maxxis	Temporary	V	///////	5 mm

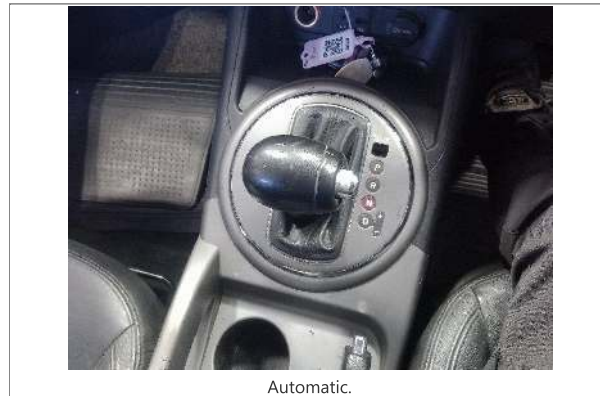
Automatic.

Signs of spray work done on some body panels.	
Some body panels misaligned.	
Automatic gear selection faulty.	
Minor dents scratches stone chips	on some body panels
Have to press the shift lock release button	to release button to select gears.

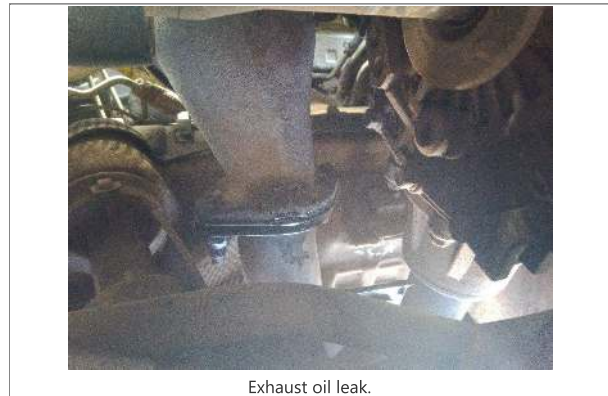
Damage	Repair Way
Engine Oil Leak	Repair
Switch Electrical Window Winder rear left Defective	Repair
Switch Electrical Window Winder rear right Defective	Repair
Interior Lights Defective	Replace
Fog Light Front Left Defective	Replace
Fog Light Rear Right Cracked	Replace
Wiring connections Defective	Repair
Front Bumper Paintwork • Scratched	Repair
Boot Lid / Hatch door Residual Traces of Repair	Repair
Caliper 1. Axle right Leak	Repair
Stabilizer Mounting Front Left Damaged	Replace
Control Arm Bush(es) Front Axle Right Cracked	Replace
Ball Joint(s) Front Axle Right Damaged	Replace
Bolt(s) / Nut(s) Front Wheel Left Missing	Replace
Bolt(s) / Nut(s) Front Wheel Right Missing	Replace
Prop Shaft Damaged	Replace
CV Joint(s) Front Left (inner/outer) Damaged	Repair
CV Joint(s) Front Right (inner/outer) Damaged	Repair
Engine Smoke Excessive	Repair
Gear Selections Malfunction	Repair
Multiple warning signs illuminated.	Repair.

Exhaust oil leak.

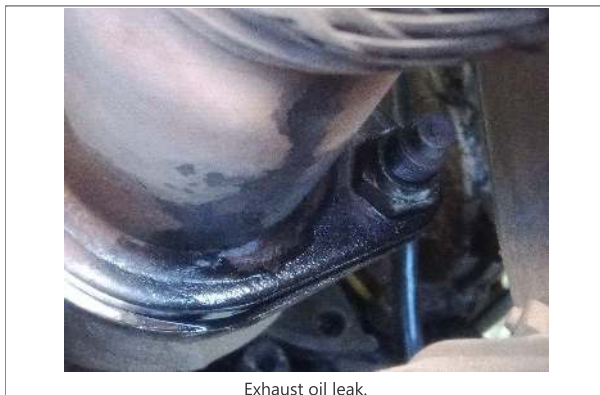
Exhaust oil leak.

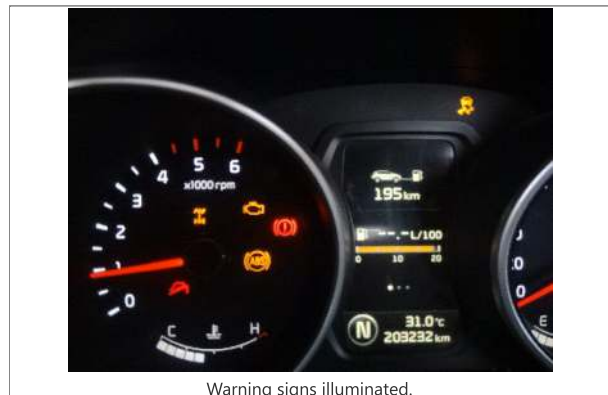
Warning signs illuminated.

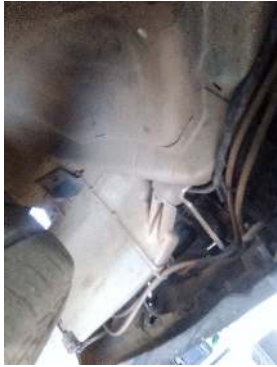
R/F fender liner missing.

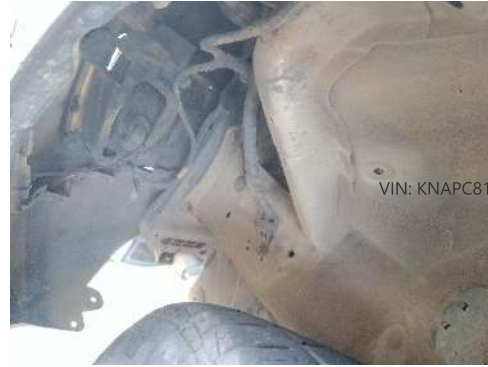
L/F fender liner missing.
