MFC Auction House
M57 Pretoria Rd, Glenmarais, KEMPTON PARK
Gauteng

DEKRA MFC
M57 Pretoria Rd - 1619
KEMPTON PARK - GT
08610 33572

VEHICLE INSPECTION

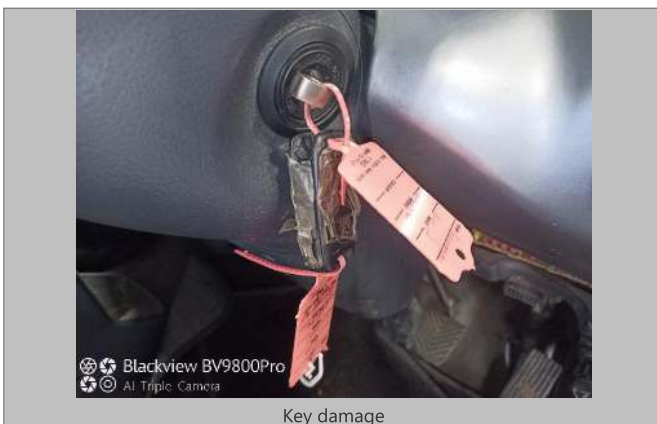
Key damage

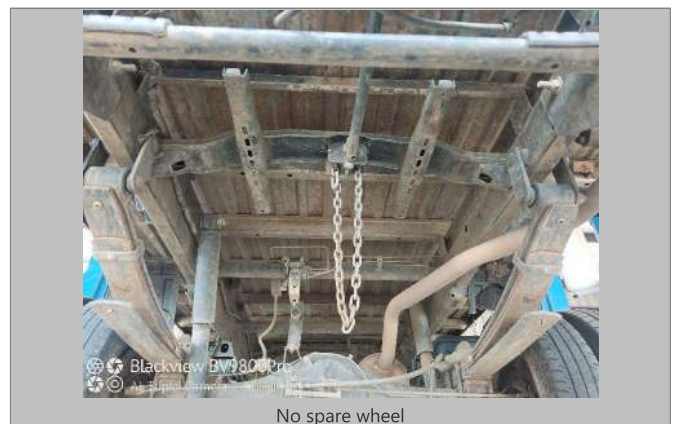
No spare wheel

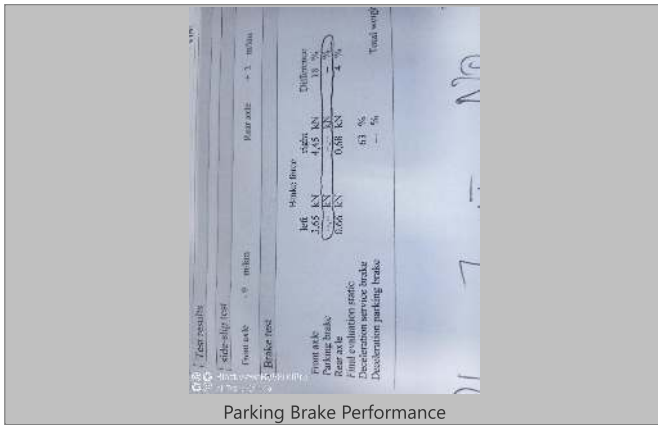
Parking Brake Performance

Left	Right	Axle Weight [KG]	Deceleration [m/s ²]
	Braking Force [KN]	Braking Force [KN]		
Front	3.6	4.4	-	
Rear	0.6	0.6	-	
Emergency / Parking	0	0	-

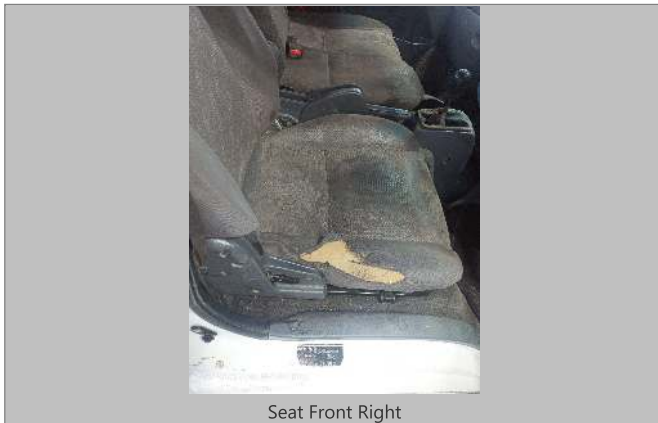
Damage	Repair Way
Tail Light Left Damaged	Replace
Tail Light Right Damaged	Replace
Seat Front Left Dirty	Repair
Seat Front Right Damaged	Repair
Door Panel Front Left Damaged	Repair
Dash Padding Defective	Replace
Gear Lever Dust Boot Excessive Wear & Tear	Repair
Side Mirror Right Damaged	Repair
Front Bumper Damaged	Replace
Bonnet Paintwork • Scratched	Repair
Door Front Left Paintwork • Scratched	Repair
Door Front Right Paintwork • Scratched	Repair
Tailgate Paintwork • Scratched	Repair
Rear bumper Dented	Repair
Fuel Cap Missing	Replace
Load Body Dented	Repair
Back Window Damaged	Replace
Parking Brake Performance Left / Right Difference out of legal range	Repair
Ball Joint(s) Front Axle Left Damaged	Replace
Ball Joint(s) Front Axle Right Damaged	Replace
Gearbox Oil Leak	Repair
No diagnostic plug malfunction	Repair
Key damage	Repair
Parking brake light on	Repair
