## CONDITION REPORT

Report No:  
2016919667  
DATE  
20/06/2025

| Manufacturer | KIA | Registration Number | KL54ZKGP |
| Model | K2700 | Register Number | |

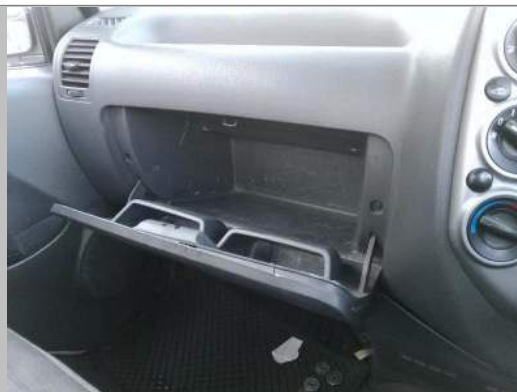
| Damage | Repair Way |
|---|---|
| Center Console / Cubbyhole + Lid Damaged | Repair |

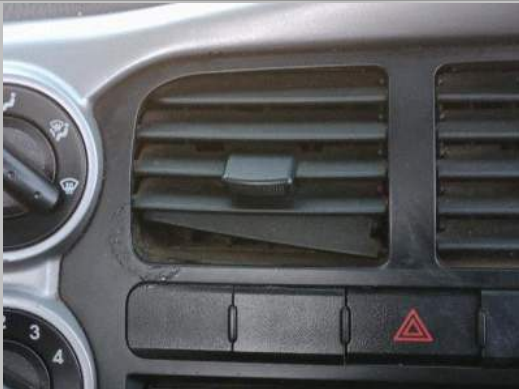
| Damage | Repair Way |
|---|---|
| Central Air Vent Damaged | Replace |

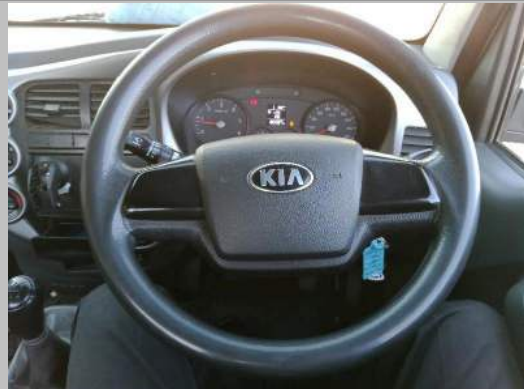
| Damage | Repair Way |
|---|---|
| Steering Wheel Trim Defective | Repair |

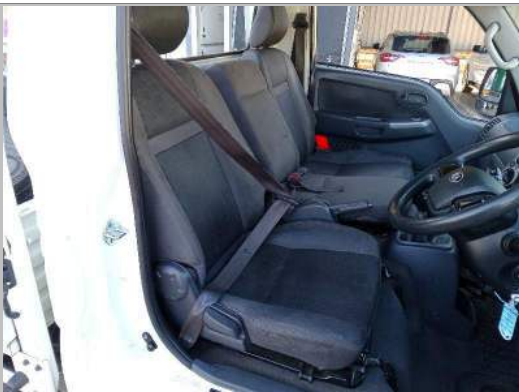
| Damage | Repair Way |
|---|---|
| Seat Front Right Damaged | Repair |

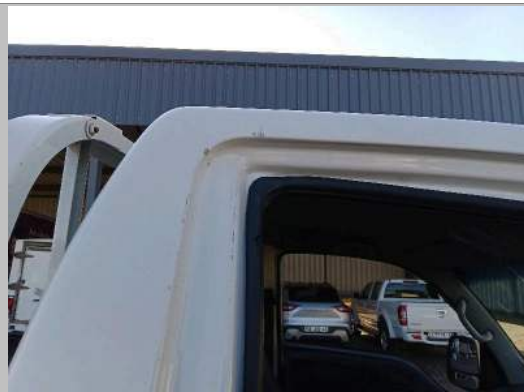
| Damage | Repair Way |
|---|---|
| B • Pillar Right Paintwork • Scratched | Repair |

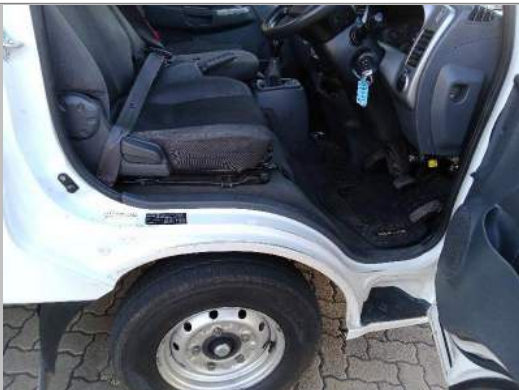
| Damage | Repair Way |
|---|---|
| Sill Panel Right Paintwork • Scratched | Repair |

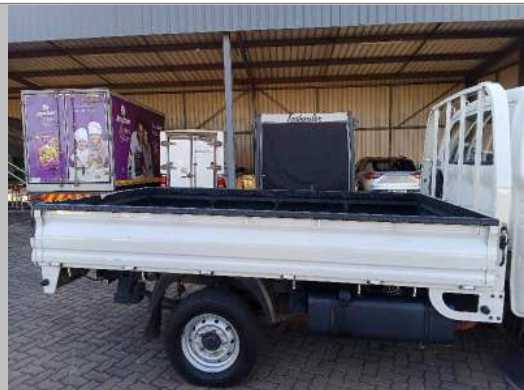
| Damage | Repair Way |
|---|---|
| Rear Fender Right Dented | Repair |

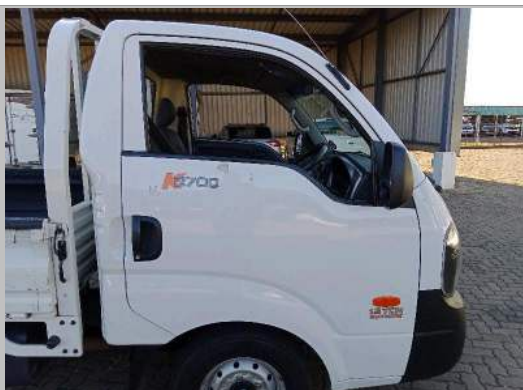
| Damage | Repair Way |
|---|---|
| Door Front Right Residual Traces of Repair | Repair |

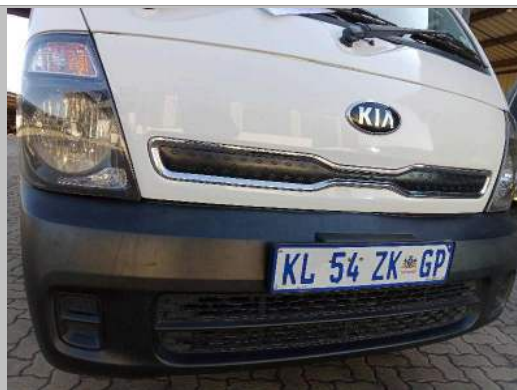
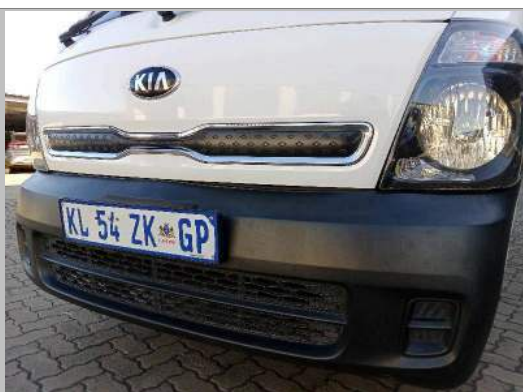
| Damage | Repair Way |
|---|---|
| Front Bumper Damaged | Repair |

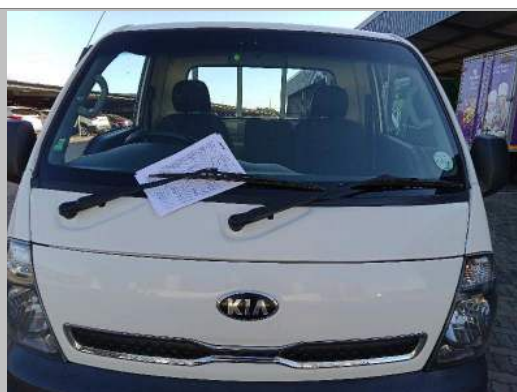
| Damage | Repair Way |
|---|---|
| Bonnet Dented | Repair |

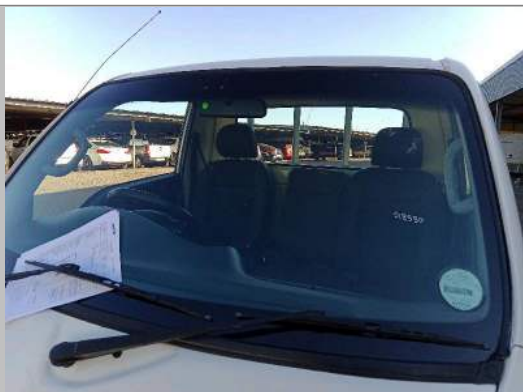
| Damage | Repair Way |
|---|---|
| Windscreen Damaged | Replace |

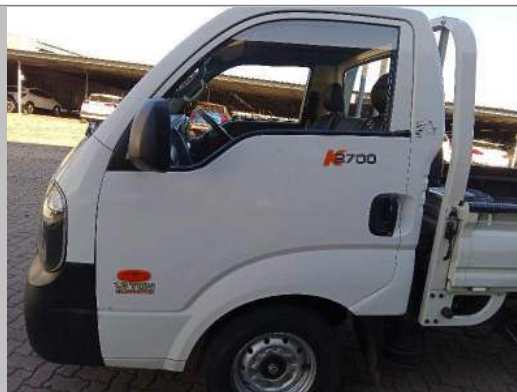
| Damage | Repair Way |
|---|---|
| Door Front Left Damaged | Repair |

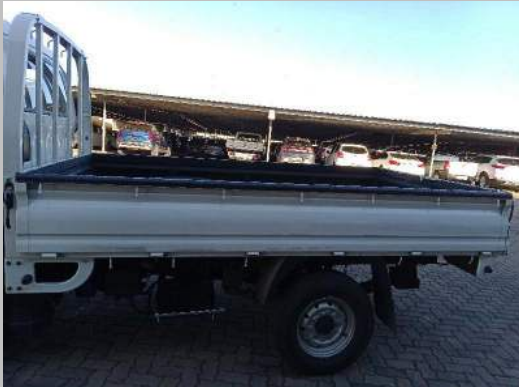
| Damage | Repair Way |
|---|---|
| Rear Fender Left Damaged | Repair |

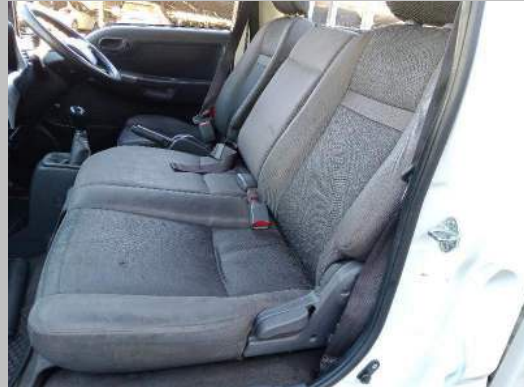
| Damage | Repair Way |
|---|---|
| Seat Front Left Damaged | Repair |

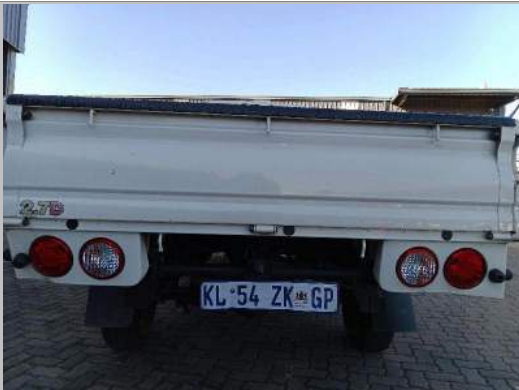
| Damage | Repair Way |
|---|---|
| Rear bumper Damaged | Repair |

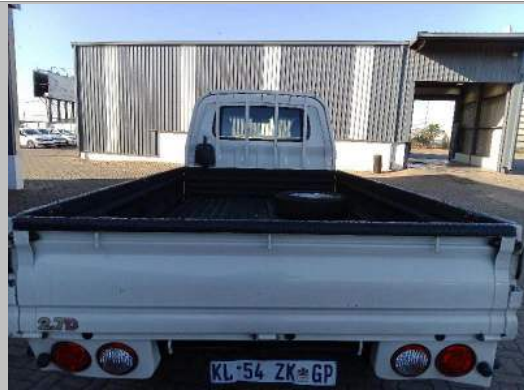
| Damage | Repair Way |
|---|---|
| Tailgate Damaged | Repair |

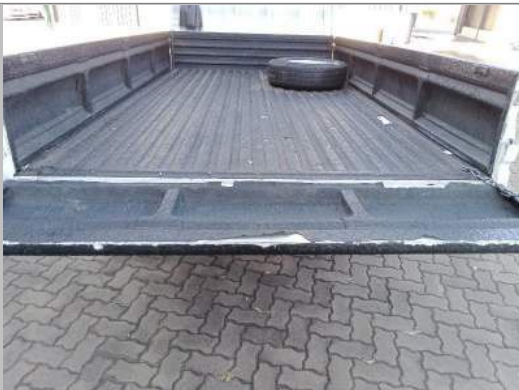
| Damage | Repair Way |
|---|---|
| Load Body Paintwork • Scratched | Repair |

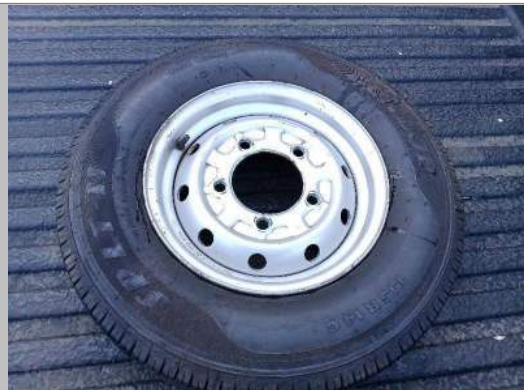
| Damage | Repair Way |
|---|---|
| Rim Spare Wheel Dented | Repair |

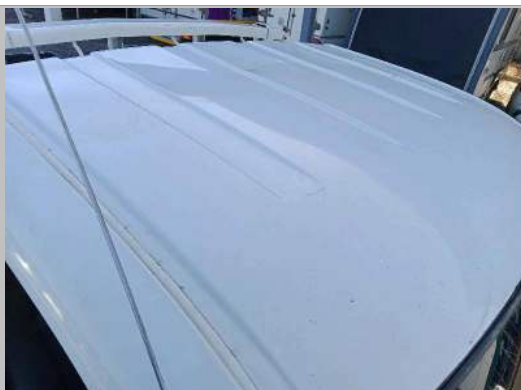
| Damage | Repair Way |
|---|---|
| Roof Damaged | Repair |

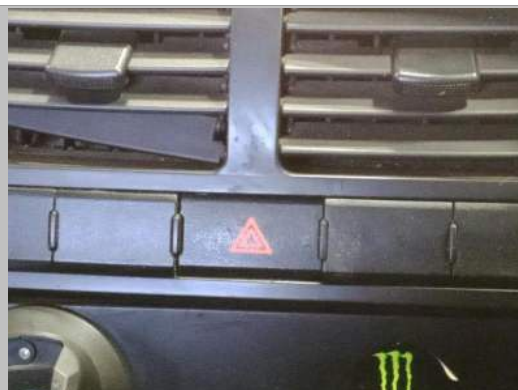
| Damage | Repair Way |
|---|---|
| Hazard Lights Damaged | Replace |

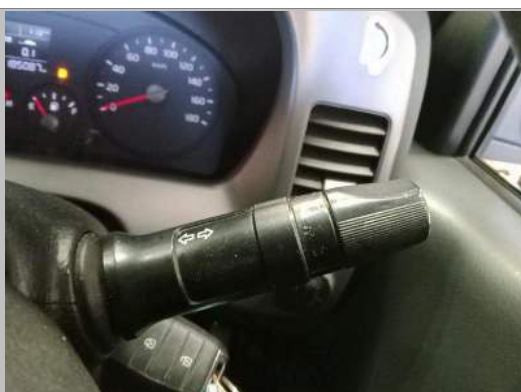
| Damage | Repair Way |
|---|---|
| Indicator Switch Damaged | Replace |

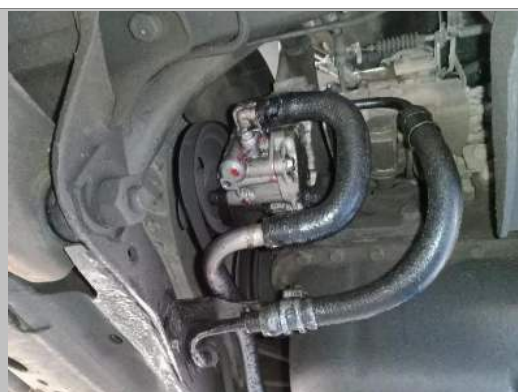
| Damage | Repair Way |
|---|---|
| Power Steering Pump / Electronic Unit Leak | Repair |

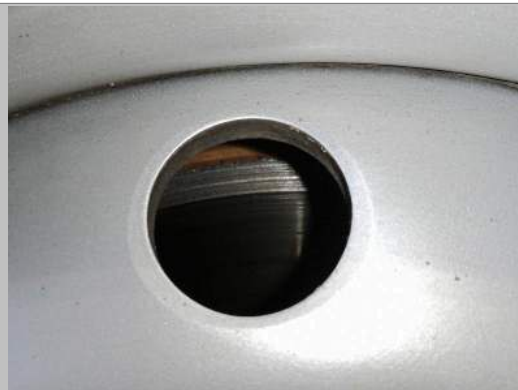
| Damage | Repair Way |
|---|---|
| Service Brake Performance Rear Axle Left / Right | Repair |
| Difference out of legal range | |

| Brake test | | Brake force | | Difference | | Quality | |
|---|--|---|---|---|--|---|---|
| Rear axle | | 0,21 kN | 0,81 kN | 13 % | | 84 % | 73 % |

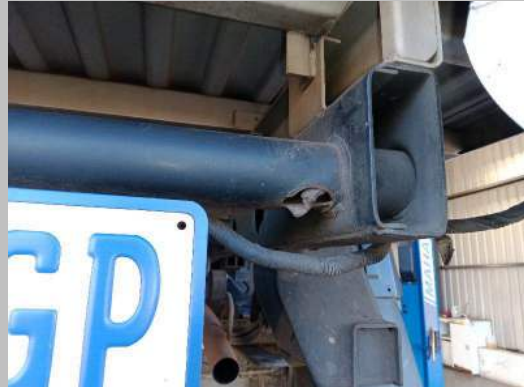
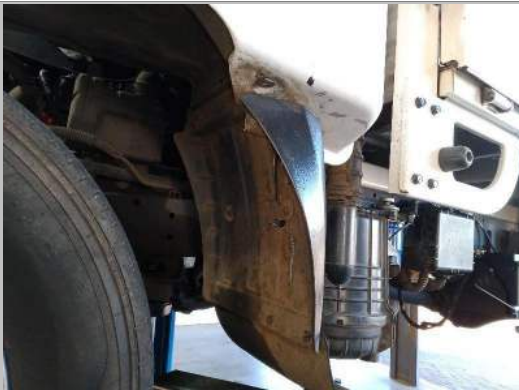
| Damage | Repair Way |
|---|---|
| Chassis Damaged | Repair |

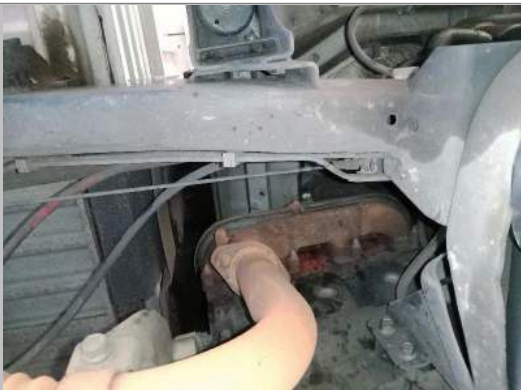
| Damage | Repair Way |
|---|---|
| Engine Oil Sweat | Repair |

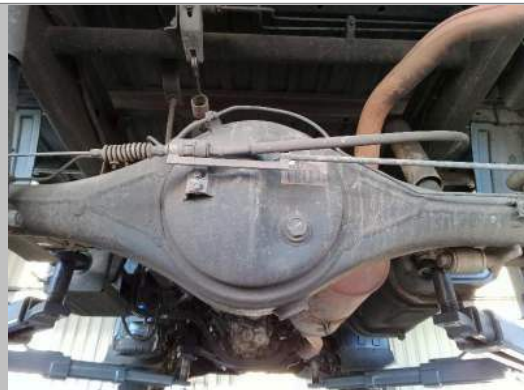
| Damage | Repair Way |
|---|---|
| Catalytic converter Missing | Replace |

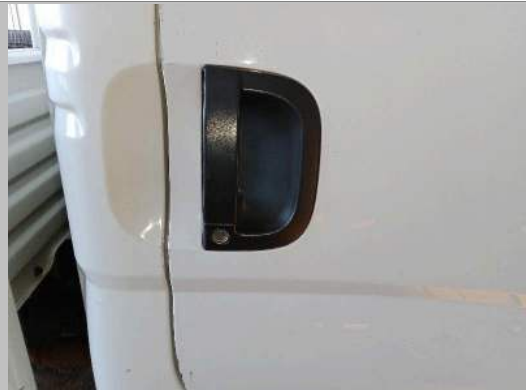
| Damage | Repair Way |
|---|---|
| Door Lock Front Right Damaged | Replace |

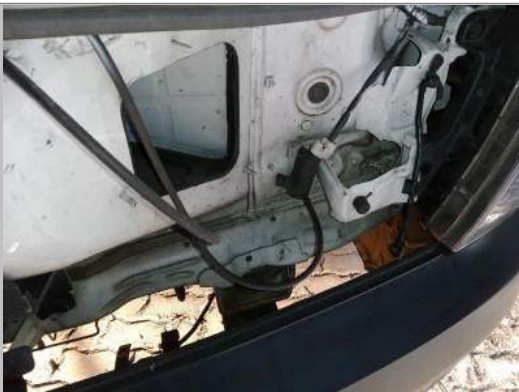
| Damage | Repair Way |
|---|---|
| Windscreen Washer Missing | Replace |
