CONDITION REPORT

Report No: 2016846222

MFC Auction House
M57 Pretoria Rd, Glenmarais, KEMPTON PARK
Gauteng

Vehicle Type	LIGHT LOAD VEHICLE	Registered Owner	
Manufacturer	GWM	Registration Number	LD94FCGP
Model	STEED 2.0 S DSL PU [2022-ON]	Register Number	
VIN	LGWCB374NB670649	Date Of First Licensing	
Engine Number		Last COR	
Doors	2	License Expiry Date	30/04/2025
Color	WHITE	Power / Displacement	
Year Model	2023	Paint Finish	C - COMMON
Km Reading	46,235 KM	Fuel	DIESEL
Cab / Body Type	SINGLE CAB	Transmission	MANUAL

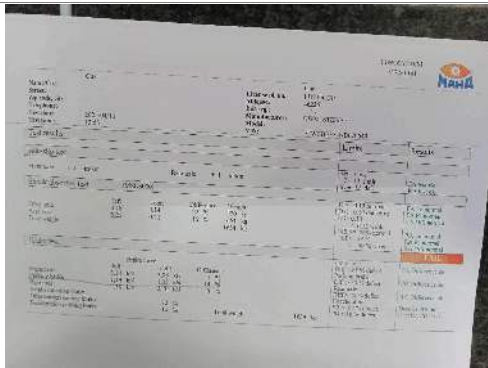
Shock and brake report

Left	Right		
	Braking Force [KN]	Braking Force [KN]	Axle Weight [KG]	Deceleration [m/s ²]
Front	3.3	3.3	-	
Rear	2.3	2.4	-	
Emergency / Parking	1.1	1	-

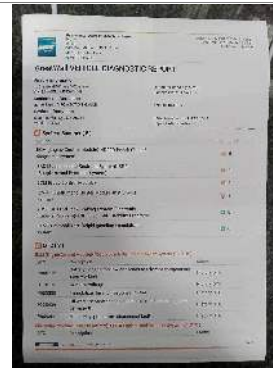
Diagnostic test

No	System	Code	Description	Status
1	ENGINE CONTROL MODULE	U110116	INM LOW VOLTAGE

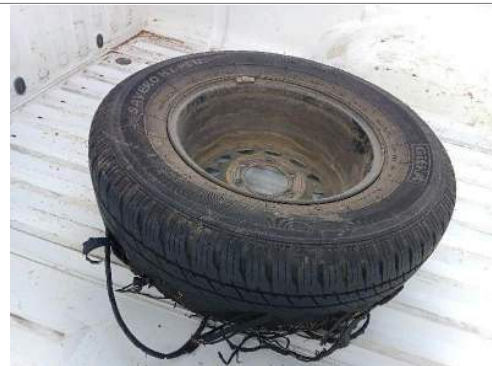
Sparewheel

Size	Load/Speed Index	Manufacture	Model	Type*	Production Date	Tread Depth (mm)
Front Left	235/70R16	106T	Giti	Savero	V	2122	5 mm
Front Right	235/70R16	106T	Giti	Savero	V	0000	4 mm
Rear Left	235/70R16	106T	Giti	Savero	V	0000	5 mm
Rear Right	235/70R16	106T	Giti	Savero	V	0000	5 mm
Spare	235/70R16	106T	Giti	Savero	V	0000	0 mm

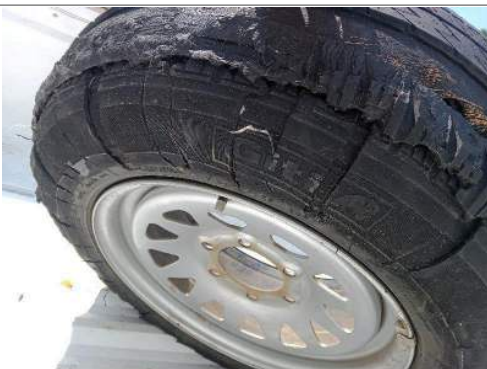
Damage	Repair Way
Tailgate Dented	Repair
Load Body Damaged	Repair
Parking Brake Performance Left / Right Difference out of legal range	Repair
Spare Tyre Excessive Wear & Tear	Replace
