CONDITION REPORT

Report No:  
2017299335  
DATE  
16/09/2026

| Manufacturer | GWM | Registration Number | LP86NZGP |
| Model | P-SERIES 2.0TD CV DLX 6-SP DSL D-CAB PU [2020-2025] | Register Number | |

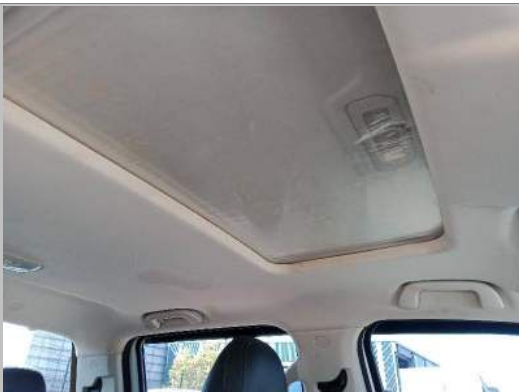
| Hood Lining Dirty | Repair |

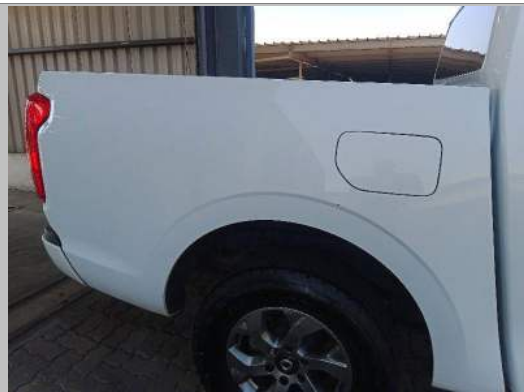
| Rear Fender Right Dented | Repair |

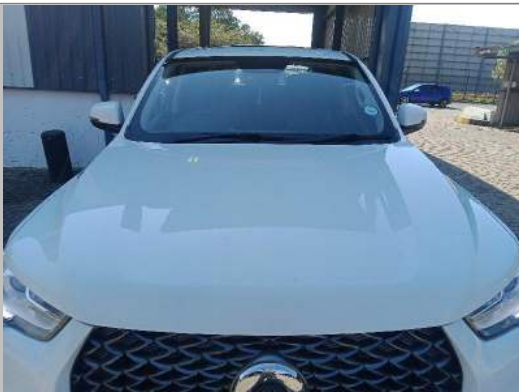
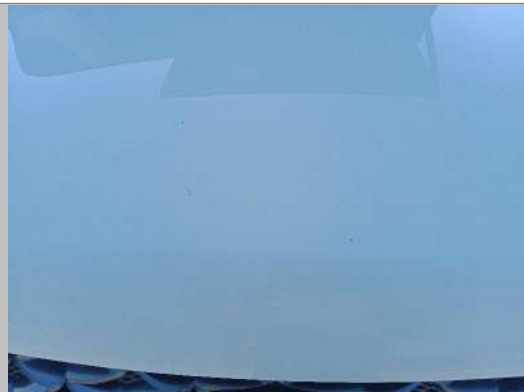
| Bonnet Dented | Repair |

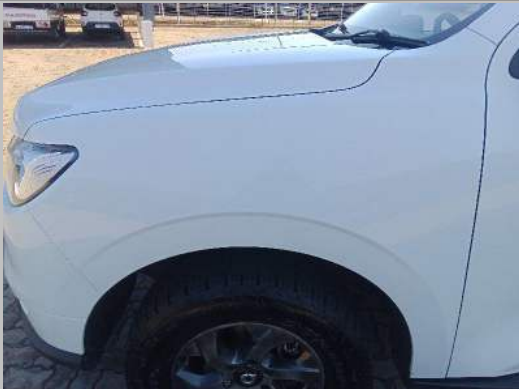
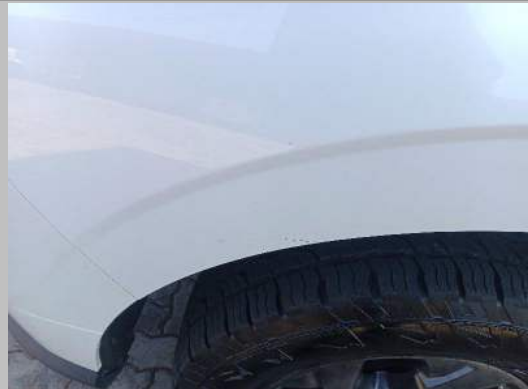
| Front Fender Left Paintwork • Scratched | Repair |

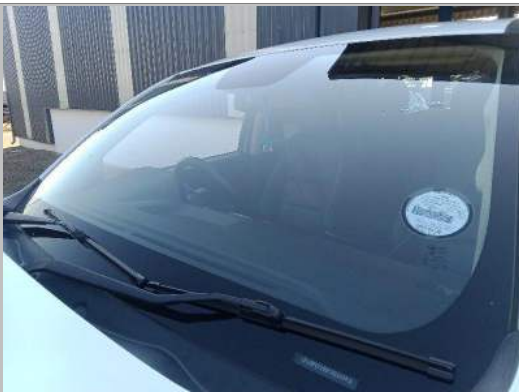
| Windscreen Chipped | Repair |

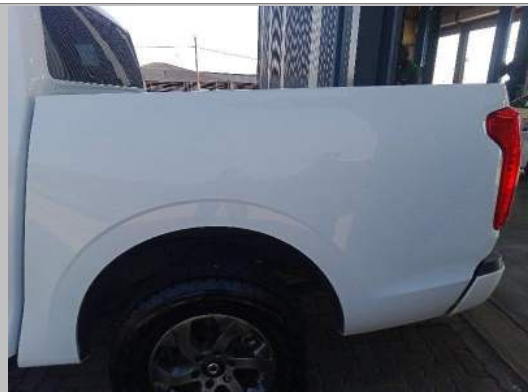
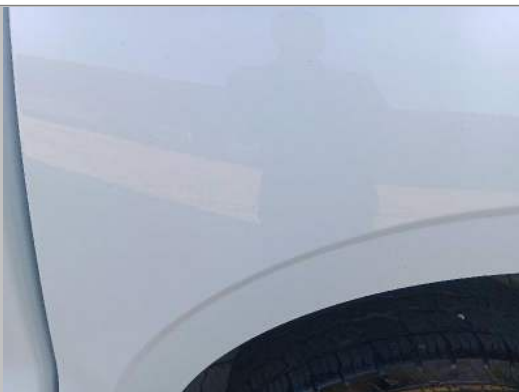
| Rear Fender Left Paintwork • Scratched | Repair |

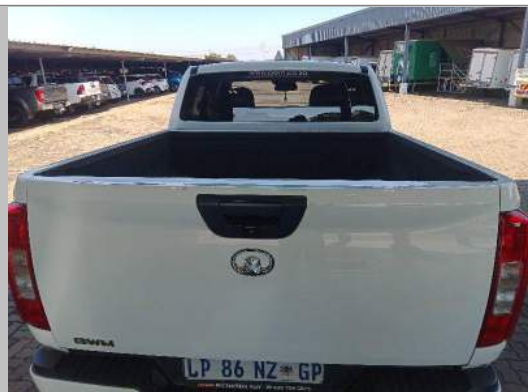
| Tailgate Dented | Repair |

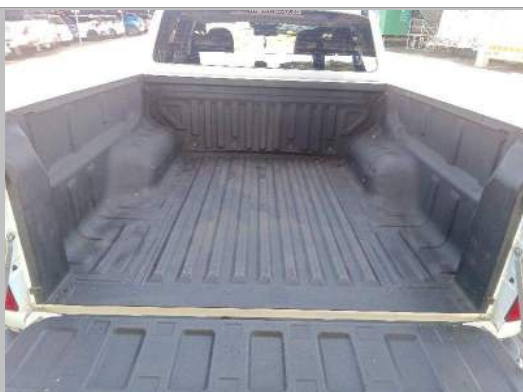
| Load Body Dented | Repair |

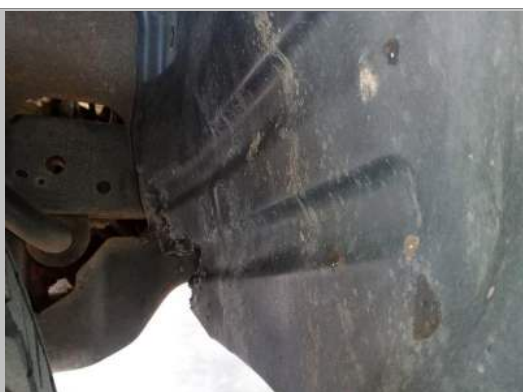
| Front Fender Right / Inner Tray Damaged | Repair |

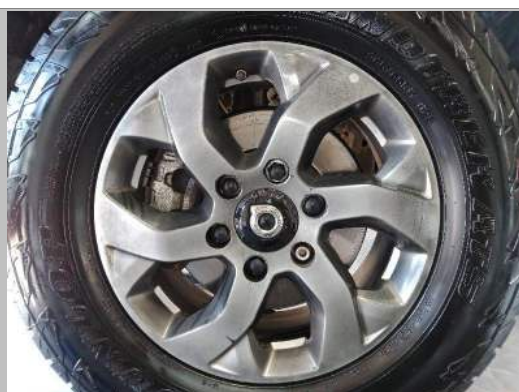
| Rim Front Right Scratched | Repair |

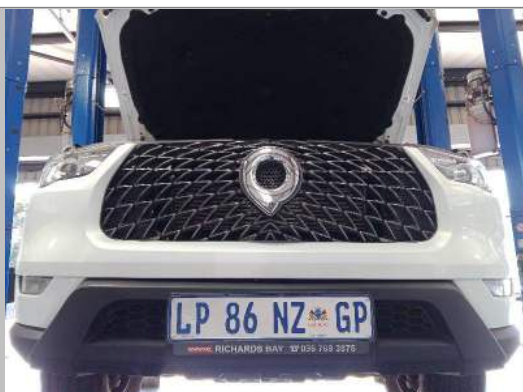
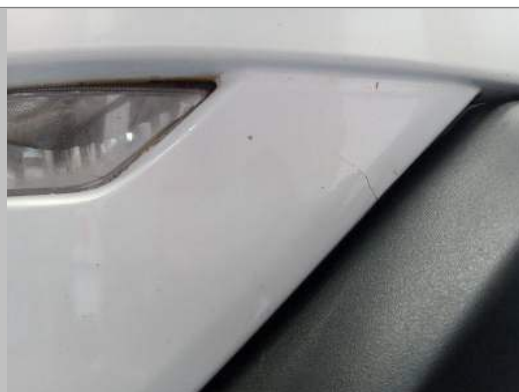
| Front Bumper Damaged | Repair |

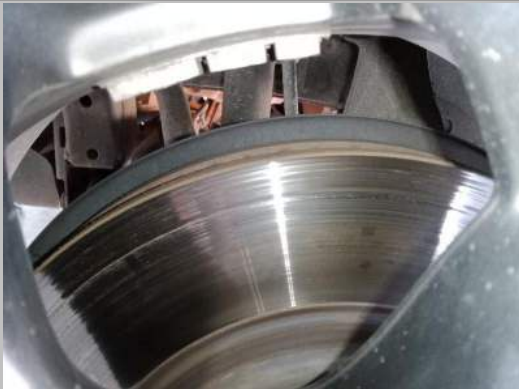
| Brake disc 1. Axle left Defective | Repair |

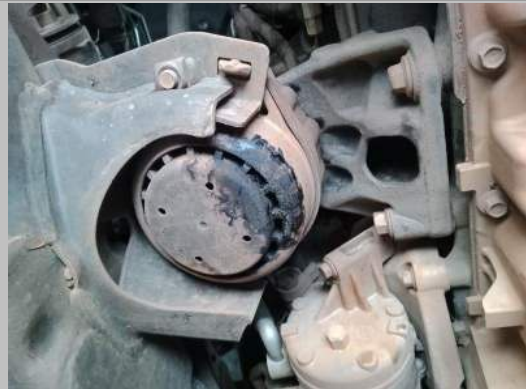
| Engine mountings Defective | Replace |

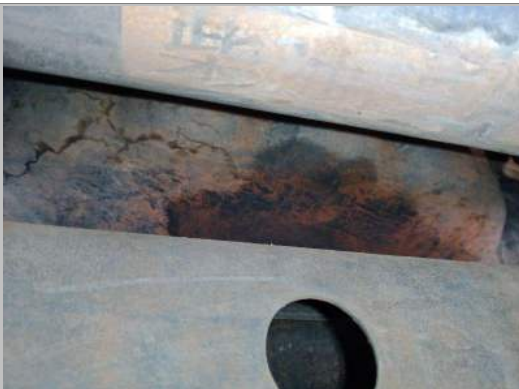
| Engine Oil Sweat | Repair |

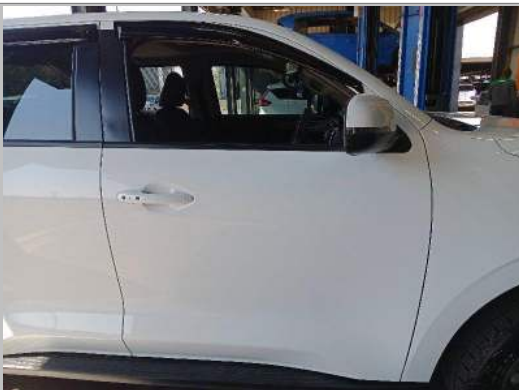
| Door Front Right Dented | Repair |

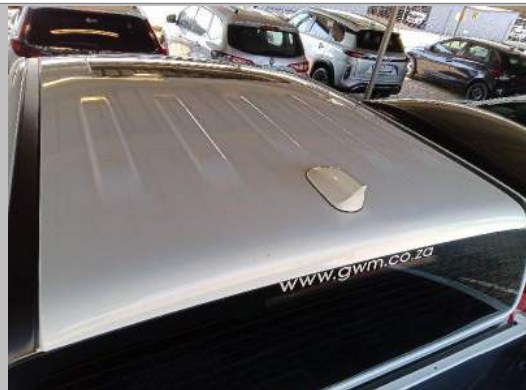
| Roof Dented | Repair |
