## CONDITION REPORT

Report No: 2016546840

Vehicle Type	PASSENGER VEHICLE	Registered Owner	
Manufacturer	HAVAL	Registration Number	KDY591MP
Model	H1 1.5 VVT-I [2019-2022]	Register Number	
VIN	LGWED2A33LE621200	Date Of First Licensing	
Engine Number		Last COR	
Doors	5	License Expiry Date	30/11/2022
Color	WHITE	Power / Displacement	
Year Model	2020	Paint Finish	TWO COAT METALLIC
Km Reading	68,500 KM	Fuel	PETROL
Cab / Body Type	HATCHBACK	Transmission	MANUAL

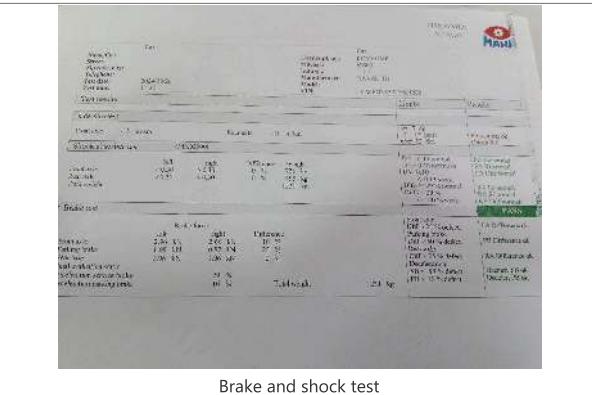
Brake and shock test

Left	Right	Axe Weight [KG]	Deceleration [m/s <sup>2</sup> ]
	Braking Force [kN]	Braking Force [kN]		
Front	2.96	2.66	-	-
Rear	1.96	1.96	-	-
Emergency / Parking	1.09	0.87	-	-

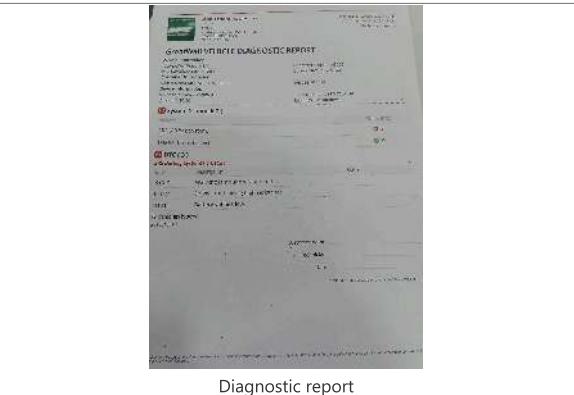
Diagnostic report

During the diagnostic no active error messages were detected. (See also attached Diagnostic Report. For more information regarding the Fault Codes (DTC) and the recommended rectifications please contact the workshops of the vehicle manufacture).

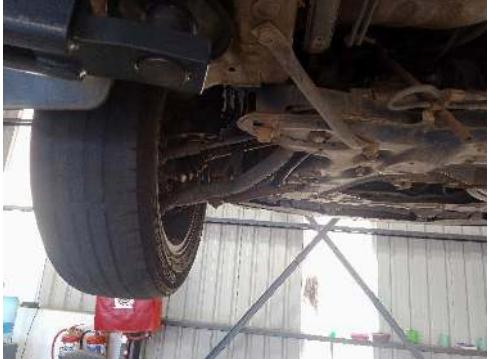
LF TYRE TREAD

Size	Load/Speed Index	Manufacture	Model	Type*	Production Date	Tread Depth (mm)
Front Left	205/60R16	92H	Giti	Radial	V	4819	0 mm
Front Right	205/55R16	94W	Dunlop	Sp	V	2720	0 mm
Rear Left	205/60R16	92H	Giti	Radial	V	4019	0 mm
Rear Right	205/60R18	92H	Giti	Radial	V	4819	1 mm

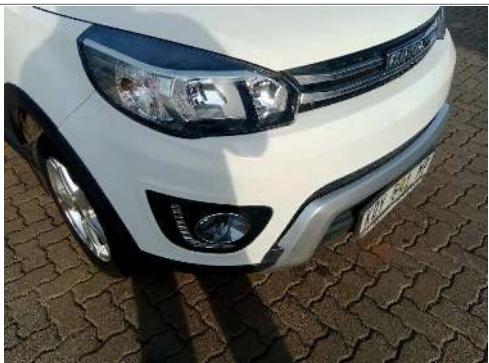
Damage	Repair Way
Center Console / Cubbyhole + Lid Damaged	Replace
Front Bumper Damaged	Repair
Bonnet Damaged	Repair
Door Rear Left Damaged	Repair
Rear bumper Damaged	Repair
Windscreen Damaged	Replace
Tyre Front Left Worn	Replace
Tyre Front Right Worn	Replace
Tyre Rear Left Worn	Replace
