## CONDITION REPORT

Report No: 2016865486

| Manufacturer | HAVAL | Registration Number | JM52NYGP |
| Model | H2 1.5 CITY [2020-2022] | Register Number | |

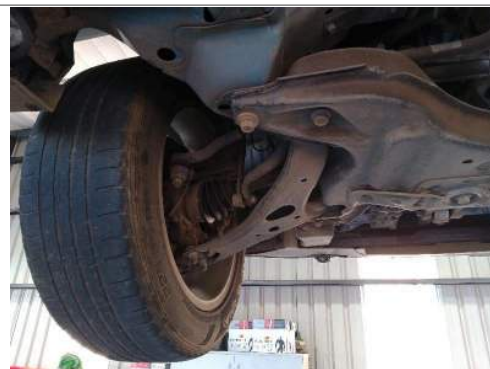
LF TYRE TREAD

| | Size | Load/Speed Index | Manufacture | Model | Type* | Production Date | Tread Depth (mm) |
|---|---|---|---|---|---|---|---|
| Front Left | 225/55 R18 | 98V | Apollo | Apterra | V | 1222 | 1 mm |

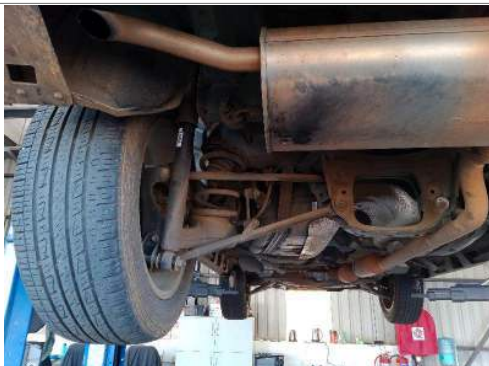
LR TYRE TREAD

| | Size | Load/Speed Index | Manufacture | Model | Type* | Production Date | Tread Depth (mm) |
|---|---|---|---|---|---|---|---|
| Rear Left | 235/55 R18 | 100H | Kumho | Solus | V | 4219 | 1 mm |

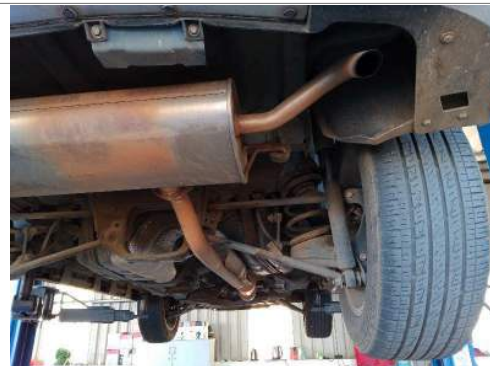
RR TYRE TREAD

| | Size | Load/Speed Index | Manufacture | Model | Type* | Production Date | Tread Depth (mm) |
|---|---|---|---|---|---|---|---|
| Rear Right | 235/55 R18 | 100H | Kumho | Solus | V | 4219 | 1 mm |

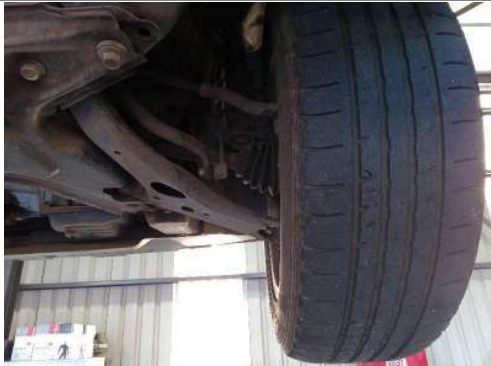
RF TYRE TREAD

| | Size | Load/Speed Index | Manufacture | Model | Type* | Production Date | Tread Depth (mm) |
|---|---|---|---|---|---|---|---|
| Front Right | 225/55 R18 | 98V | Apollo | Apterra | V | 1222 | 2 mm |

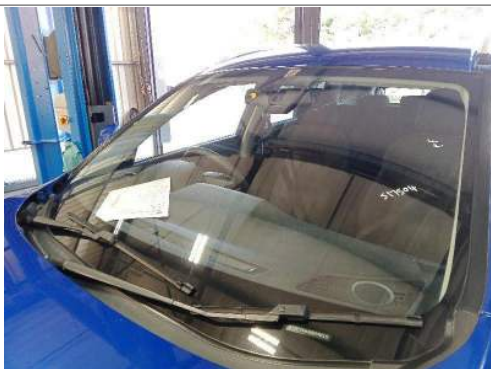
| Damage | Repair Way |
|---|---|
| Body and Exterior | Vehicle license disk missing |

No license disc

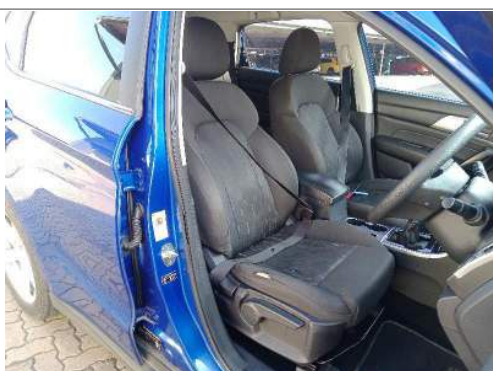
| Damage | Repair Way |
|---|---|
| Seat Front Right Damaged | Repair |

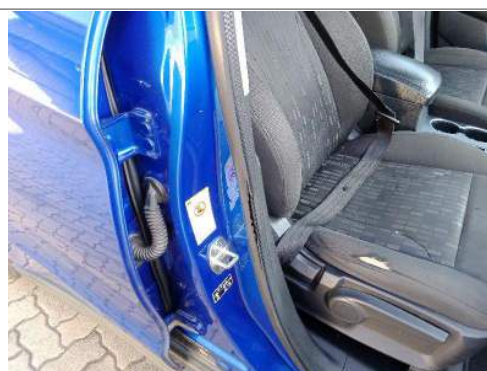
| Damage | Repair Way |
|---|---|
| Door Sealing Rubber Front Right Damaged | Replace |

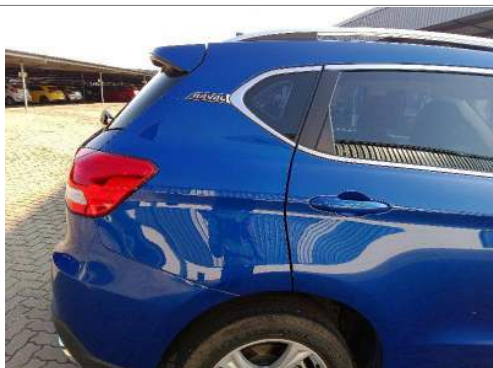
| Damage | Repair Way |
|---|---|
| Rear Fender Right Dented | Repair |

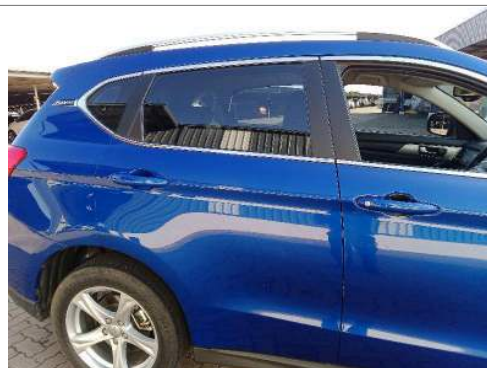
| Damage | Repair Way |
|---|---|
| Door Rear Right Paintwork • Scratched | Repair |

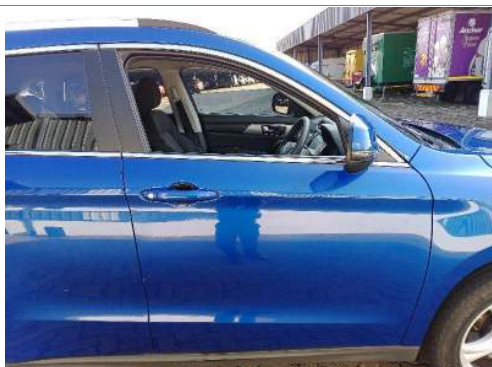
| Damage | Repair Way |
|---|---|
| Door Front Right Damaged | Repair |

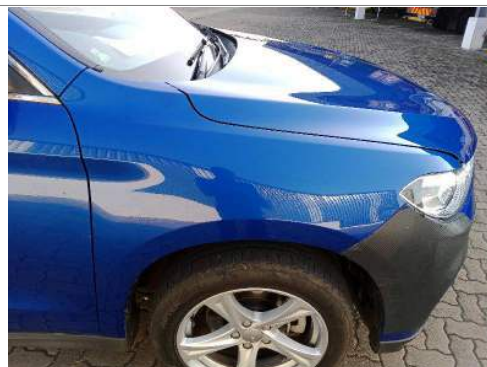
| Damage | Repair Way |
|---|---|
| Front Fender Right Damaged | Repair |

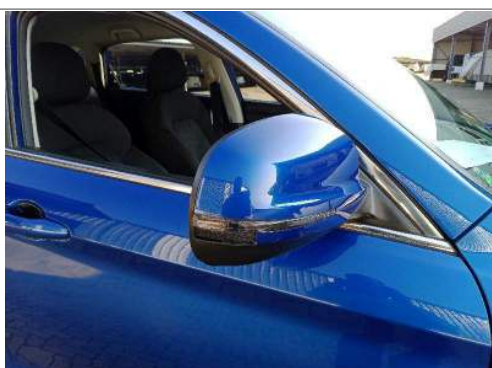
| Damage | Repair Way |
|---|---|
| Side Mirror Right Damaged | Replace |

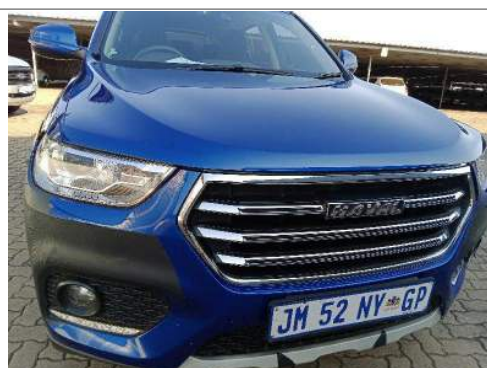
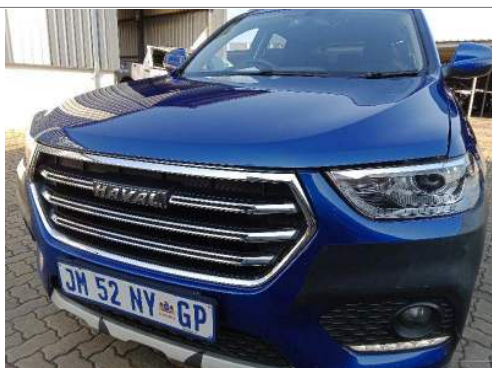
| Damage | Repair Way |
|---|---|
| Front Bumper Damaged | Repair |

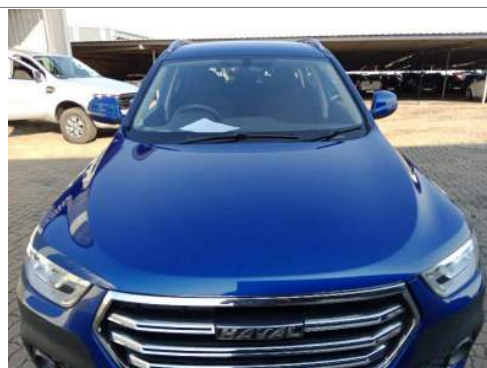
| Damage | Repair Way |
|---|---|
| Bonnet Paintwork • Scratched | Repair |

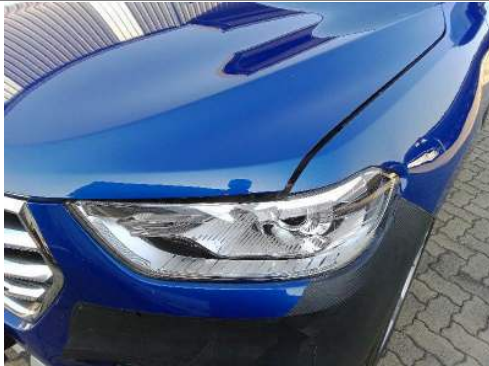
| Damage | Repair Way |
|---|---|
| Headlight Left Damaged | Replace |

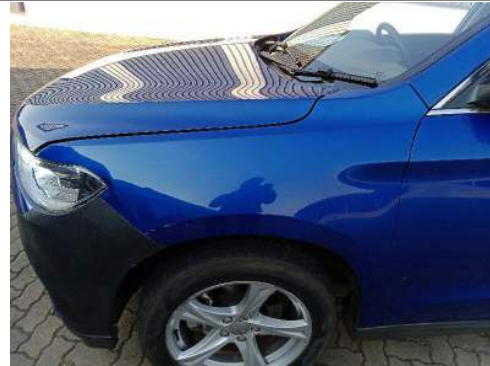
| Damage | Repair Way |
|---|---|
| Front Fender Left Damaged | Repair |

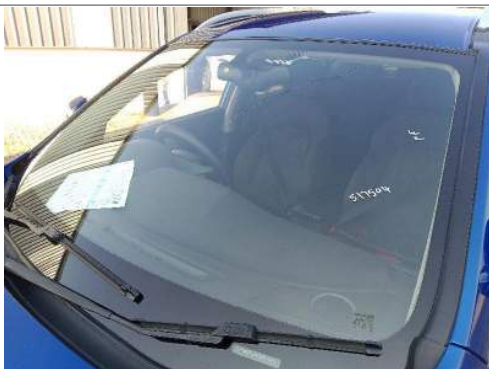
| Damage | Repair Way |
|---|---|
| Windscreen Cracked | Replace |

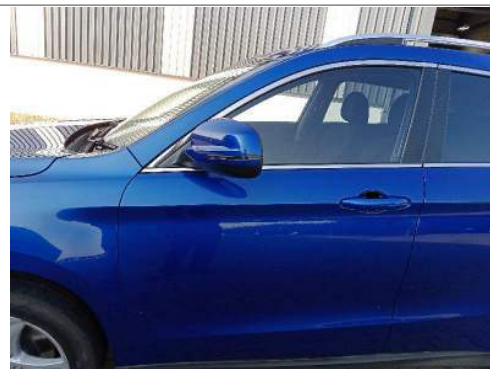
| Damage | Repair Way |
|---|---|
| Door Front Left Paintwork • Scratched | Repair |

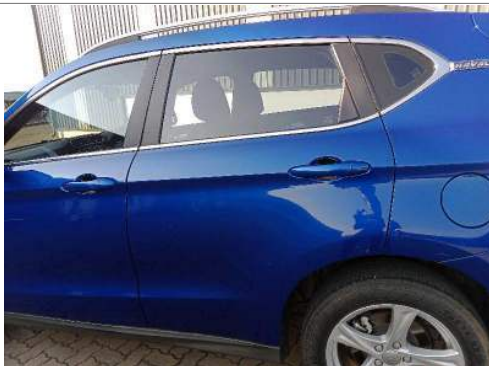
| Damage | Repair Way |
|---|---|
| Door Rear Left Damaged | Repair |

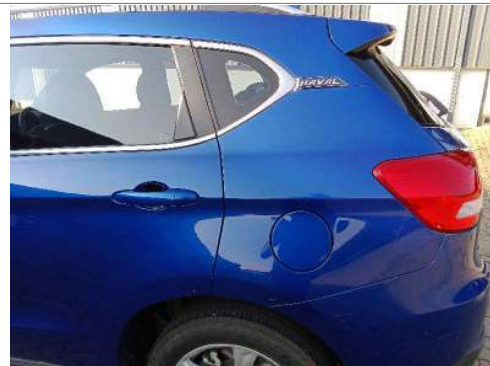
| Damage | Repair Way |
|---|---|
| Rear Fender Left Damaged | Repair |

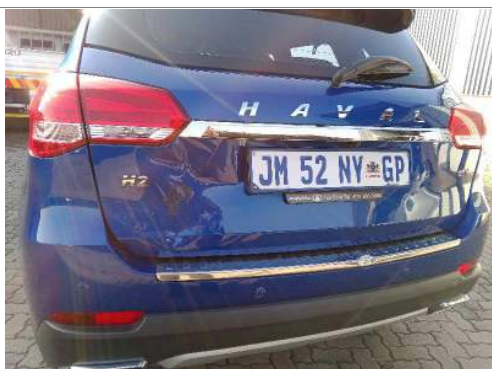
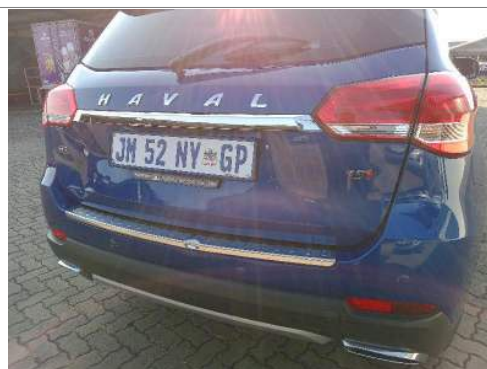
| Damage | Repair Way |
|---|---|
| Rear bumper Damaged | Repair |

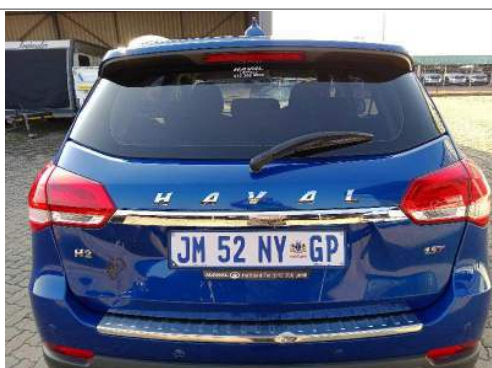
| Damage | Repair Way |
|---|---|
| Boot Lid / Hatch door Damaged | Repair |

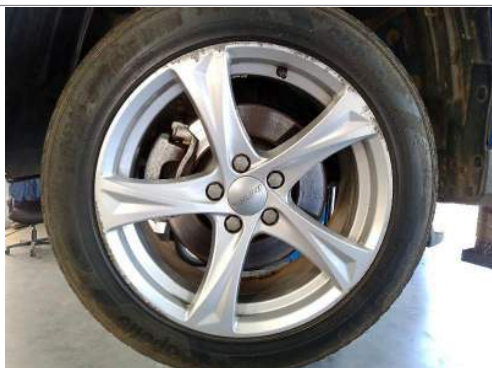
| Damage | Repair Way |
|---|---|
| Rim Front Left Scratched | Repair |

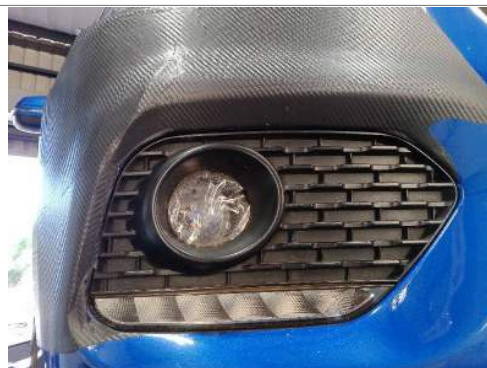
| Damage | Repair Way |
|---|---|
| Fog Light Front Right Damaged | Replace |

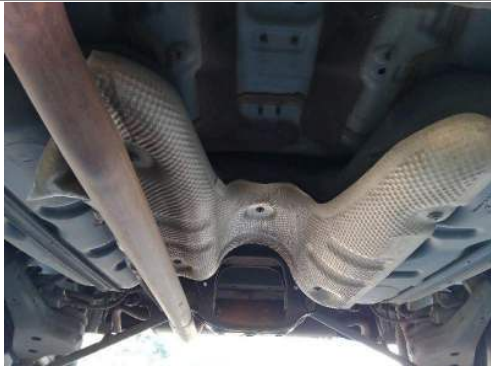
| Damage | Repair Way |
|---|---|
| Belly plates Damaged | Repair |
