CONDITION REPORT

Report No: 2016207749

MFC Auction House
M57 Pretoria Rd, Glenmarais, KEMPTON PARK
Gauteng

Vehicle Type	PASSENGER VEHICLE	Registered Owner	MFC
Manufacturer	HAVAL	Registration Number	JV00TXGP
Model	H2	Register Number	
VIN	LGWEE4A48LH917376	Date Of First Licensing	
Engine Number		Last COR	
Doors	5	License Expiry Date	30/09/2024
Color	RED	Power / Displacement	
Year Model		Paint Finish	TWO COAT METALLIC
Km Reading	106,733 KM	Fuel	PETROL
Cab / Body Type	STATION WAGON	Transmission	AUTOMATIC

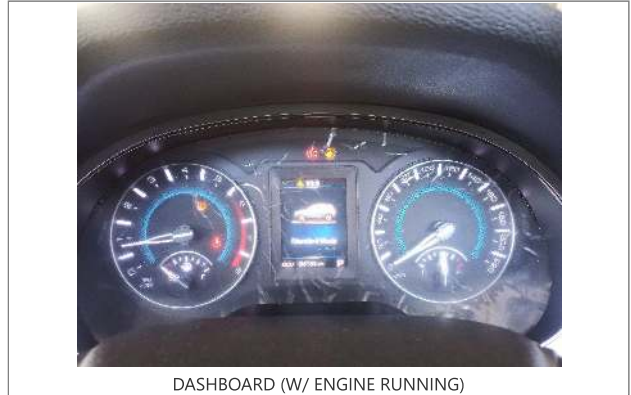
DASHBOARD (W/ ENGINE RUNNING)

General Comments: ENGINE MANAGEMENT LIGHTS ILLUMINATED ON CLUSTER. SHOCK ABSORBER TEST NOT PERFORMED.

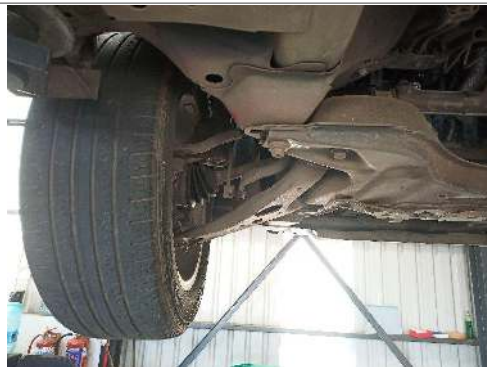
LF TYRE TREAD

Size	Load/Speed Index	Manufacture	Model	Type*	Production Date	Tread Depth (mm)
Front Left	235/55R18	100H	Kumho	Radial	V	4819	0 mm
Front Right	235/55R18	100H	Kumho	Radial	V	4819	0 mm
Rear Left	235/55R18	100H	Kumho	Radial	V	4819	2 mm
Rear Right	235/55R18	100H	Kumho	Radial	V	4819	3 mm

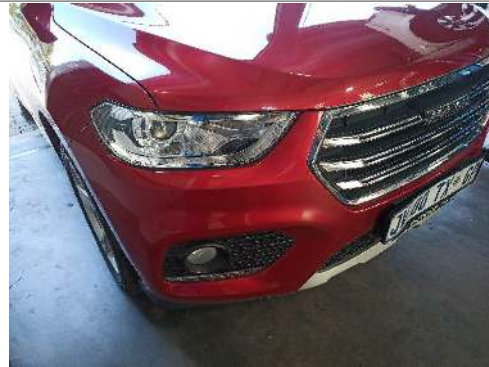
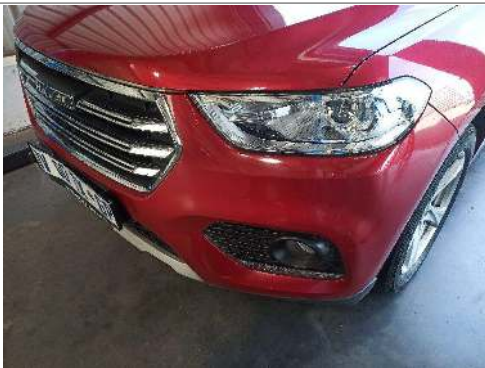
Damage	Repair Way
Engine Oil Leak	Repair
Front Bumper Damaged	Repair
Bonnet Damaged	Repair
Front Fender Left Damaged	Repair
Front Fender Right Damaged	Repair
Rear Fender Left Damaged	Repair
Rear Fender Right Damaged	Repair
Door Front Left Damaged	Repair
Door Front Right Damaged	Repair
Door Rear Left Damaged	Repair
Door Rear Right Damaged	Repair
Rear bumper Damaged	Repair
Windscreen Damaged	Replace
Tyre Front Left Worn	Replace
