MFC Auction House  
M57 Pretoria Rd, Glenmarais, KEMPTON PARK  
Gauteng

| Manufacturer | GWM | Registration Number | FB19RHGP |

## CONDITION REPORT

Report No: 2016226947

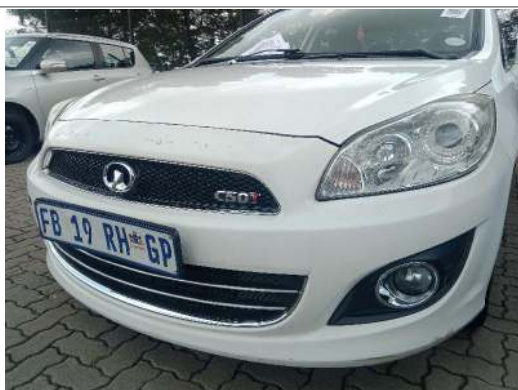
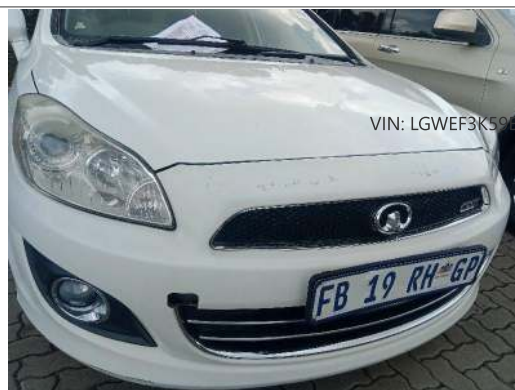
| Damage | Repair Way |
|---|---|
| Front Bumper Damaged | Repair |

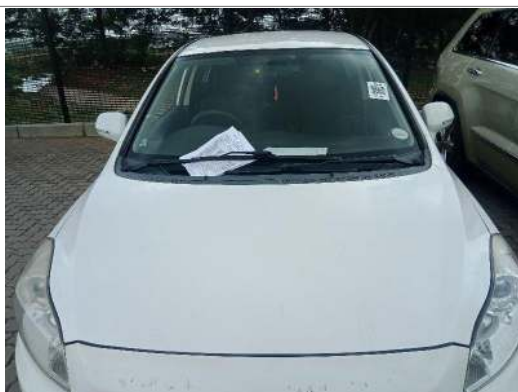
| Damage | Repair Way |
|---|---|
| Bonnet Paintwork • Scratched | Repair |

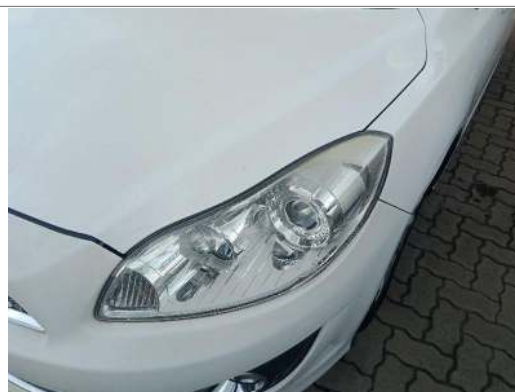
| Damage | Repair Way |
|---|---|
| Headlight Left Defective | Repair |

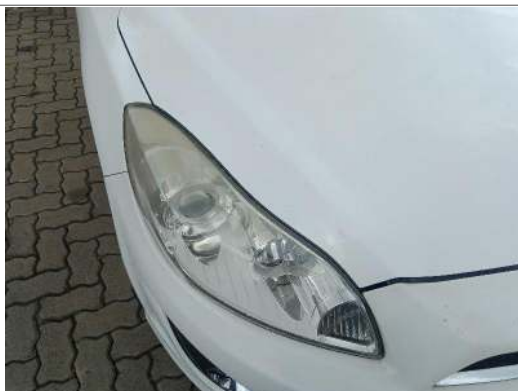
| Damage | Repair Way |
|---|---|
| Headlight Right Defective | Repair |

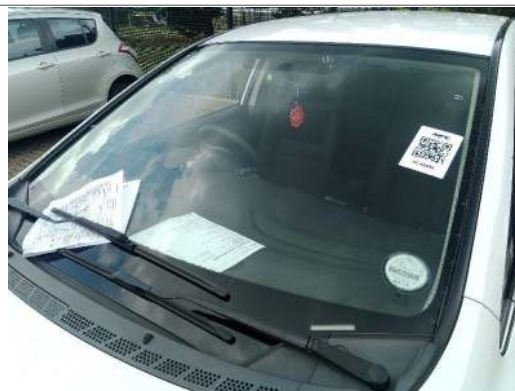
| Damage | Repair Way |
|---|---|
| Windscreen Chipped | Replace |

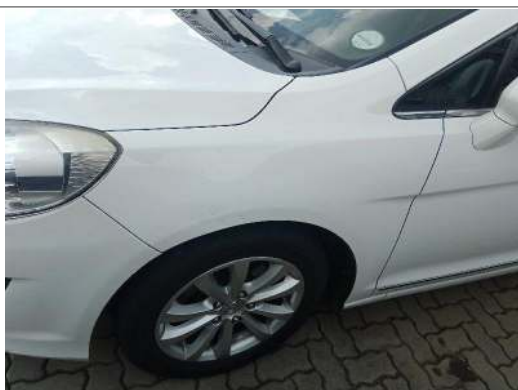
| Damage | Repair Way |
|---|---|
| Front Fender Left Dented | Repair |

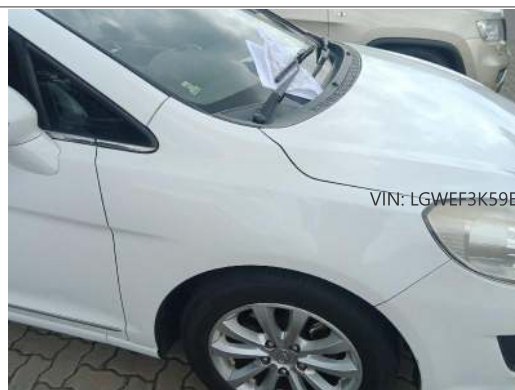
| Damage | Repair Way |
|---|---|
| Front Fender Right Paintwork • Scratched | Repair |

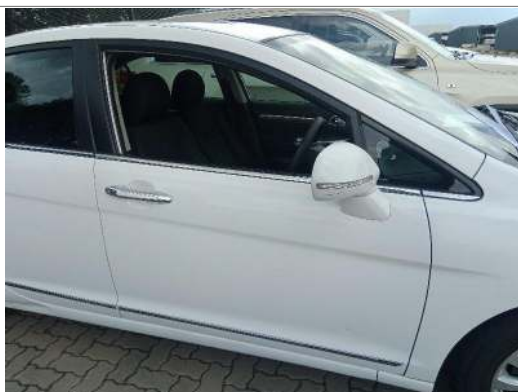
| Damage | Repair Way |
|---|---|
| Door Front Right Dented | Repair |

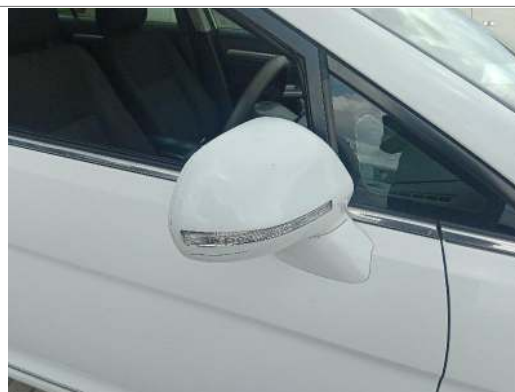
| Damage | Repair Way |
|---|---|
| Side Mirror Right Paintwork • Scratched | Repair |

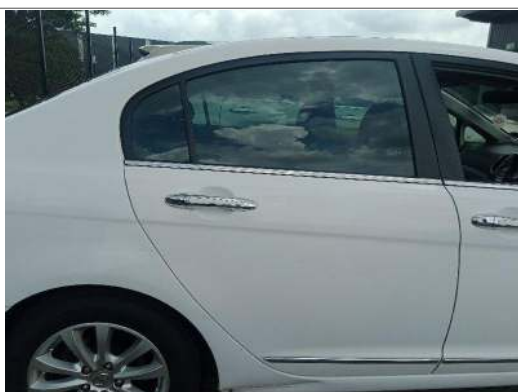
| Damage | Repair Way |
|---|---|
| Door Rear Right Dented | Repair |

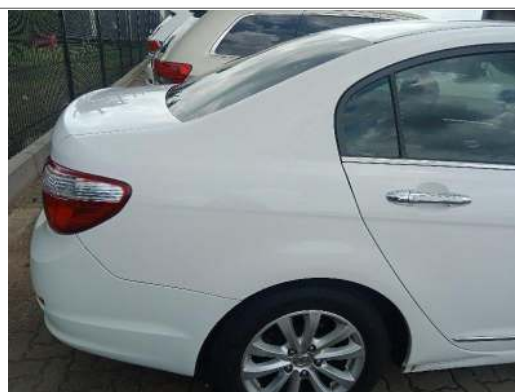
| Damage | Repair Way |
|---|---|
| Rear Fender Right Paintwork • Scratched | Repair |

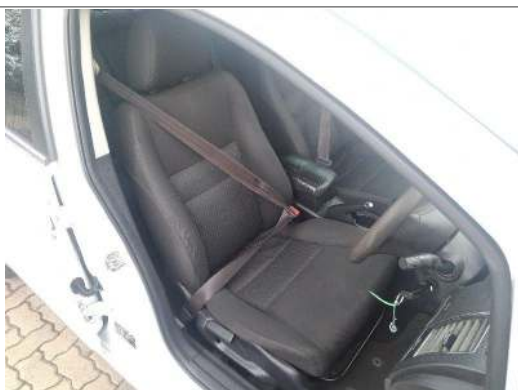
| Damage | Repair Way |
|---|---|
| Seat Front Right Damaged | Repair |

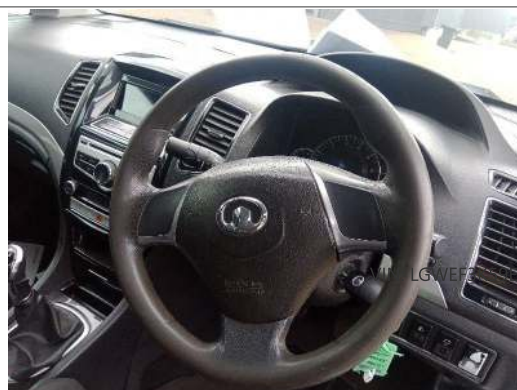
| Damage | Repair Way |
|---|---|
| Steering Wheel Trim Damaged | Repair |

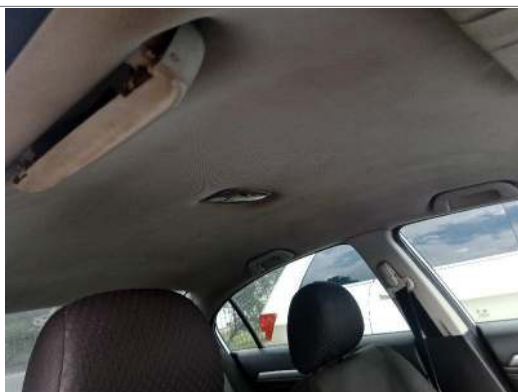
| Damage | Repair Way |
|---|---|
| Hood Lining Dirty | Repair |

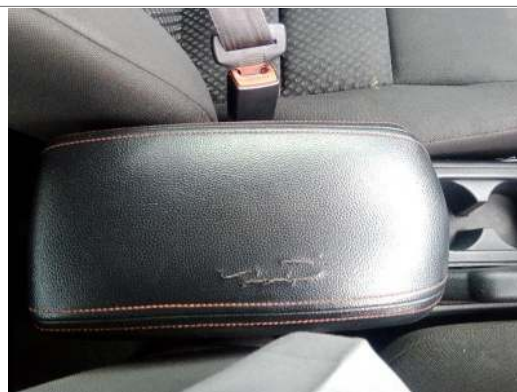
| Damage | Repair Way |
|---|---|
| Center Console / Cubbyhole + Lid Defective | Repair |

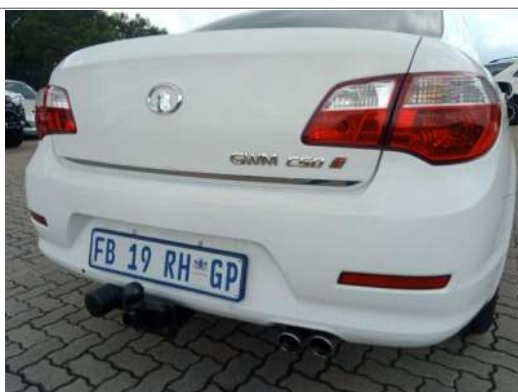
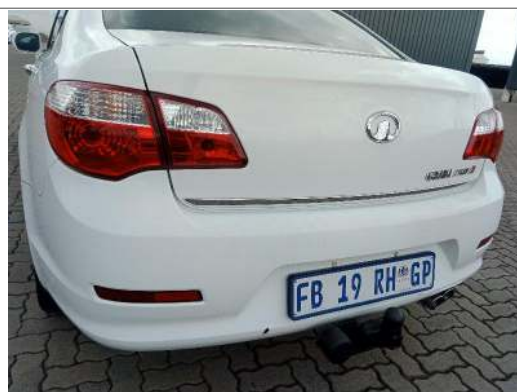
| Damage | Repair Way |
|---|---|
| Rear bumper Damaged | Repair |

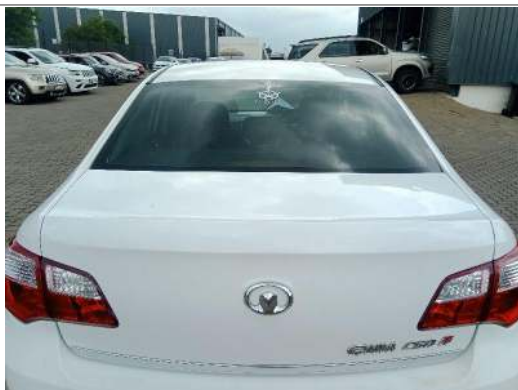
| Damage | Repair Way |
|---|---|
| Boot Lid / Hatch door Paintwork • Scratched | Repair |

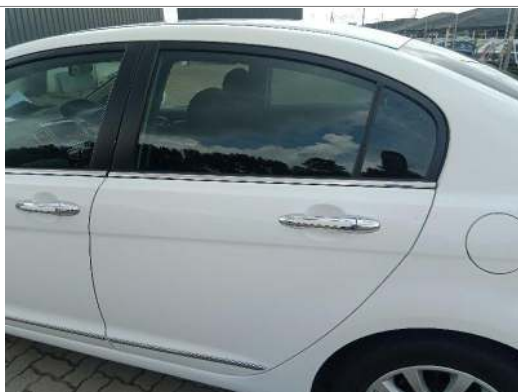
| Damage | Repair Way |
|---|---|
| Door Rear Left Dented | Repair |

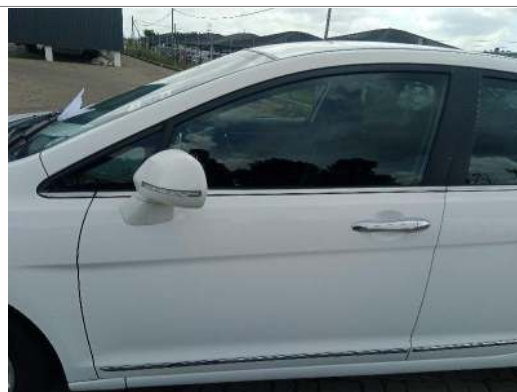
| Damage | Repair Way |
|---|---|
| Door Front Left Dented | Repair |

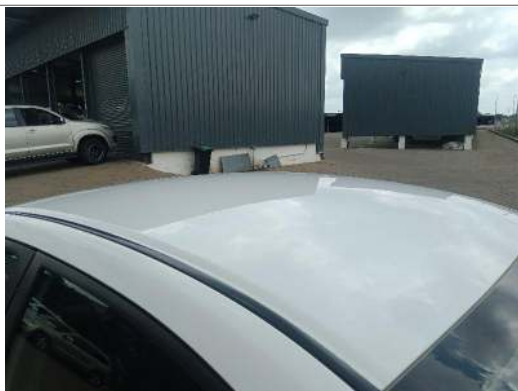
| Damage | Repair Way |
|---|---|
| Roof Dented | Repair |

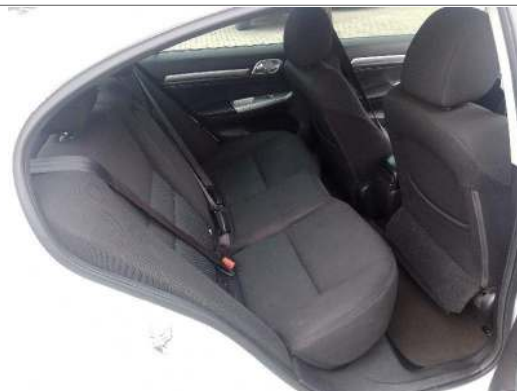
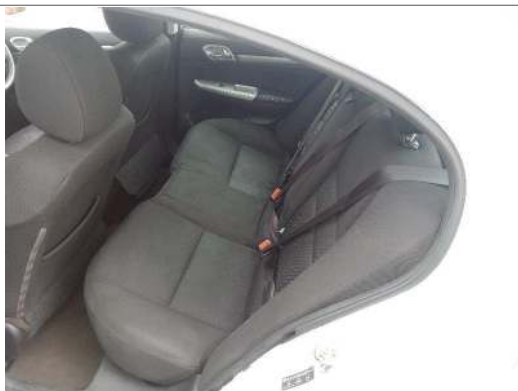
| Damage | Repair Way |
|---|---|
| Seat Rear Damaged | Repair |

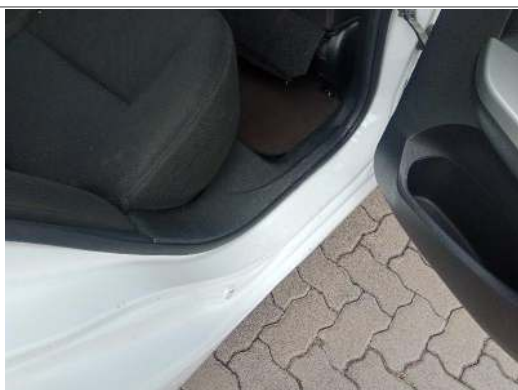
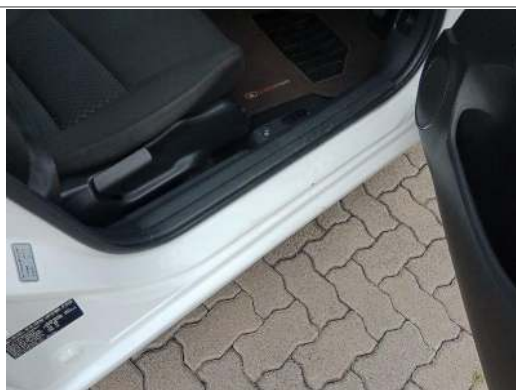
| Damage | Repair Way |
|---|---|
| Sill Panel Right Paintwork • Scratched | Repair |

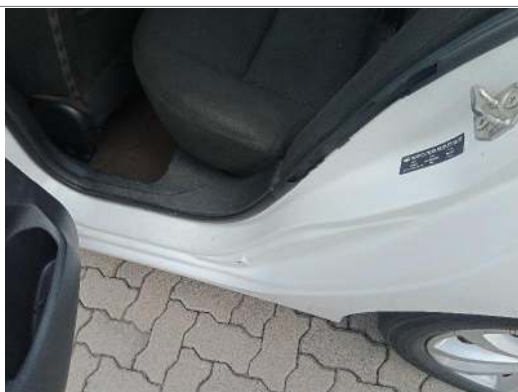
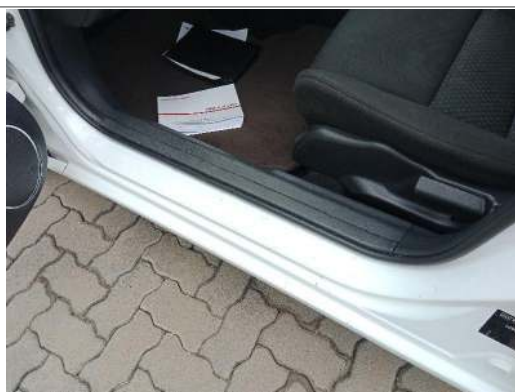
| Damage | Repair Way |
|---|---|
| Sill Panel Left Paintwork • Scratched | Repair |

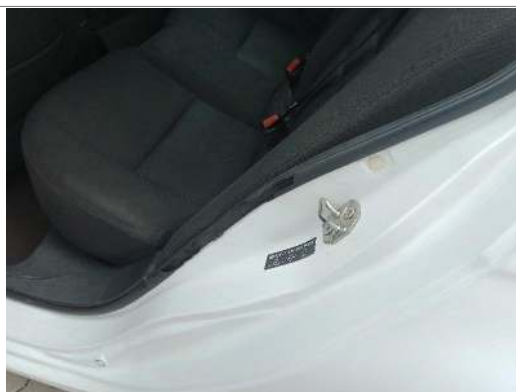
| Damage | Repair Way |
|---|---|
| Door Sealing Rubber Rear Left Damaged | Replace |

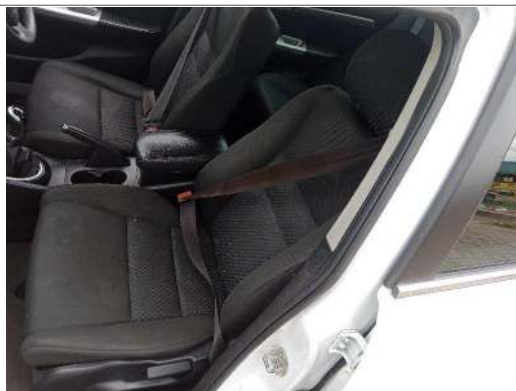
| Damage | Repair Way |
|---|---|
| Seat Front Left Defective | Repair |

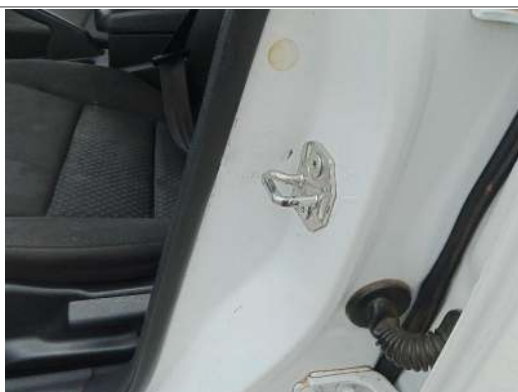
| Damage | Repair Way |
|---|---|
| B • Pillar Left Dented | Repair |

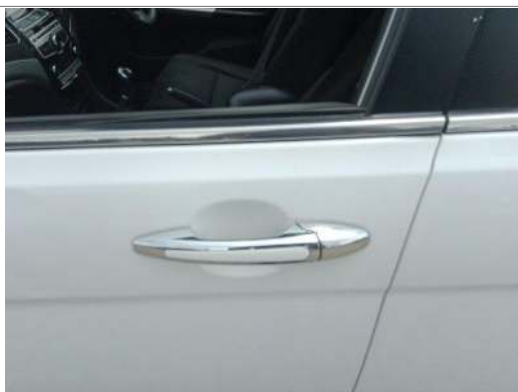
| Damage | Repair Way |
|---|---|
| Door Handle Front Left Damaged | Replace |

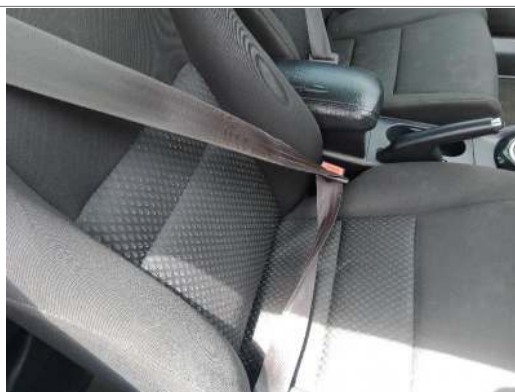
| Damage | Repair Way |
|---|---|
| Seat Belt Front Right Defective | Replace |

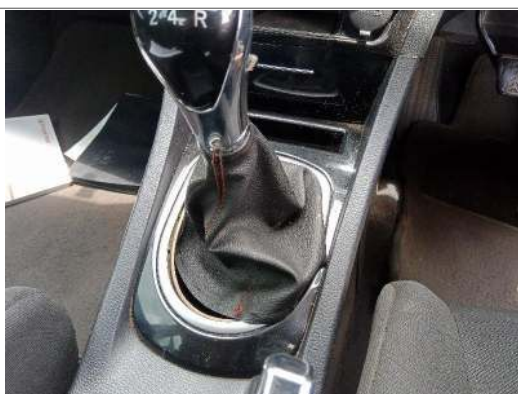
| Damage | Repair Way |
|---|---|
| Gear Lever Dust Boot Defective | Repair |

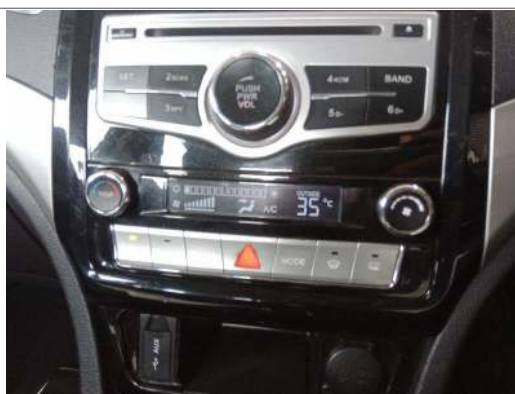
| Damage | Repair Way |
|---|---|
| Air Conditioner Insufficient | Replace |

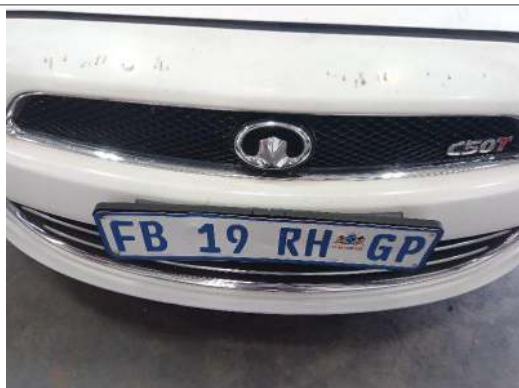
| Damage | Repair Way |
|---|---|
| Number Plate Front Dented | Replace |

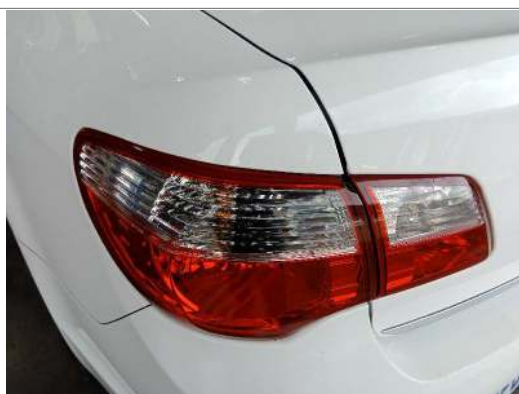
| Damage | Repair Way |
|---|---|
| Tail Light Left Damaged | Replace |

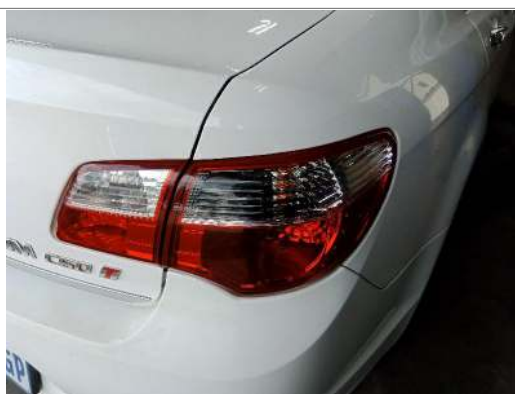
| Damage | Repair Way |
|---|---|
| Tail Light Right Scratched | Replace |

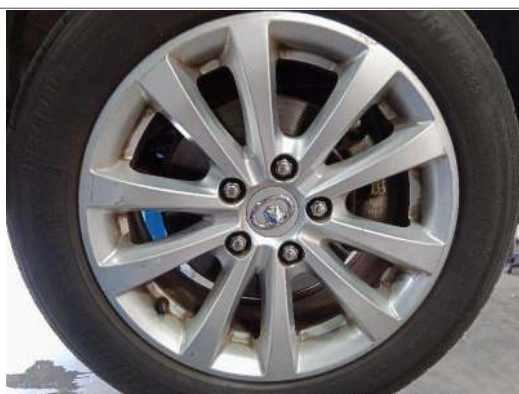
| Damage | Repair Way |
|---|---|
| Wheel bearing Front Right Loose / Excessive Play | Replace |

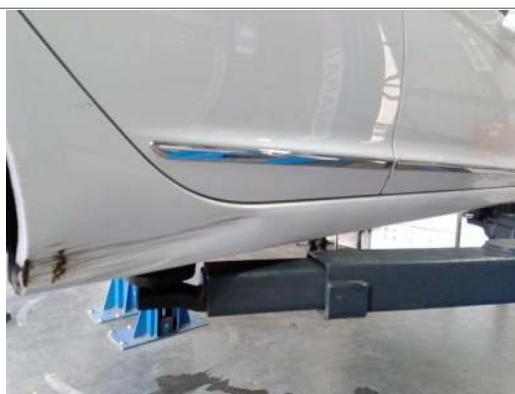
| Damage | Repair Way |
|---|---|
| Rocker Panel Right Damaged | Repair |

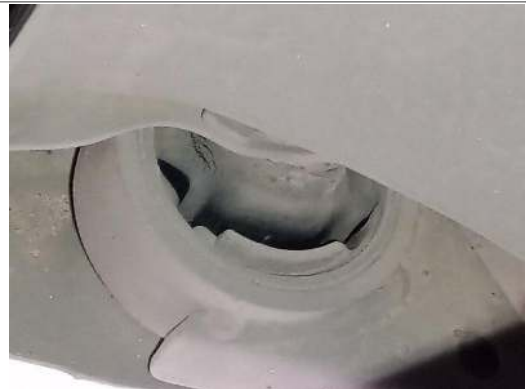
| Damage | Repair Way |
|---|---|
| Control Arm Bush(es) Front Axle Left Cracked | Replace |

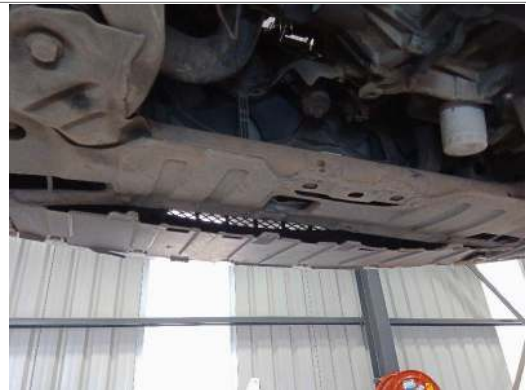
| Damage | Repair Way |
|---|---|
| Belly plates Damaged | Replace |

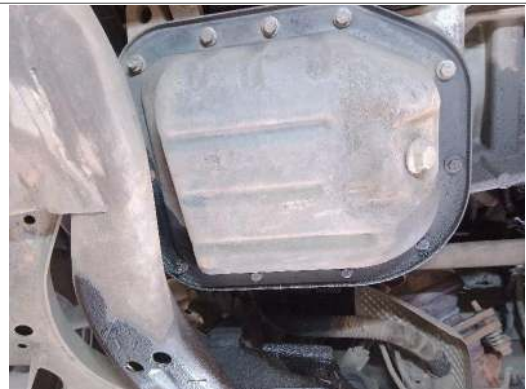
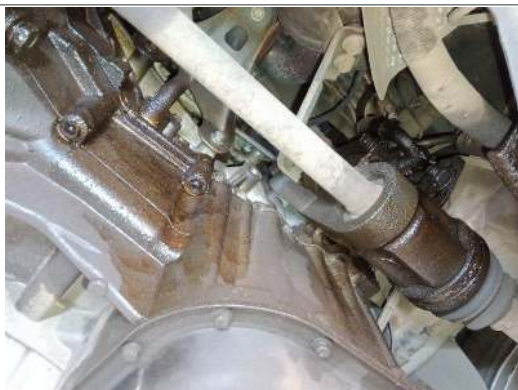
| Damage | Repair Way |
|---|---|
| Engine Oil Leak | Repair |

| Damage | Repair Way |
|---|---|
| Engine Noise Excessive | Repair |

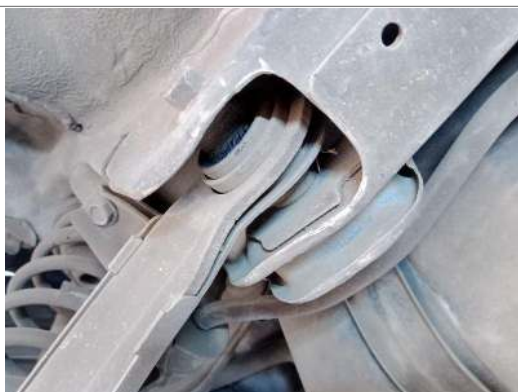
| Damage | Repair Way |
|---|---|
| Control Arm Bush(es) Rear Axle Left Cracked | Replace |

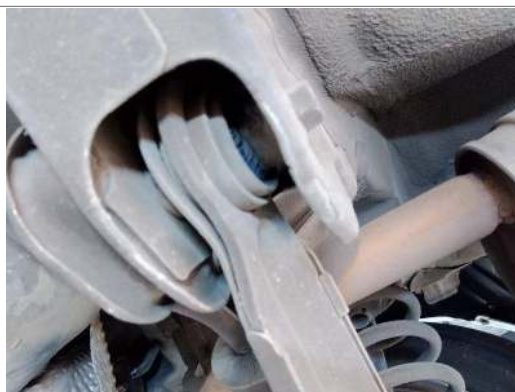
| Damage | Repair Way |
|---|---|
| Control Arm Bush(es) Rear Axle Right Cracked | Replace |

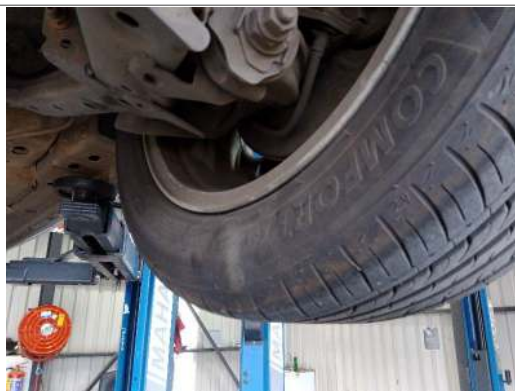
| Damage | Repair Way |
|---|---|
| Tyre Rear Right Damaged | Replace |

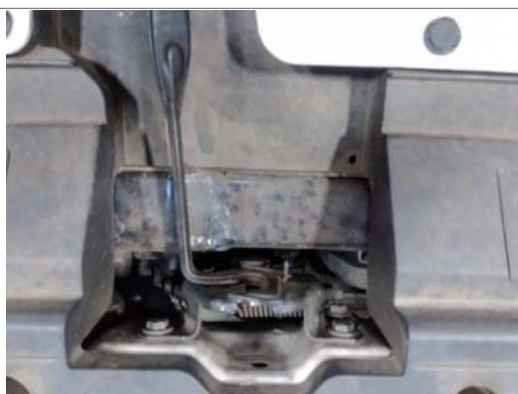
| Damage | Repair Way |
|---|---|
| Bonnet slam plate (Shock tower/ Inner tray) Welded | Replace |

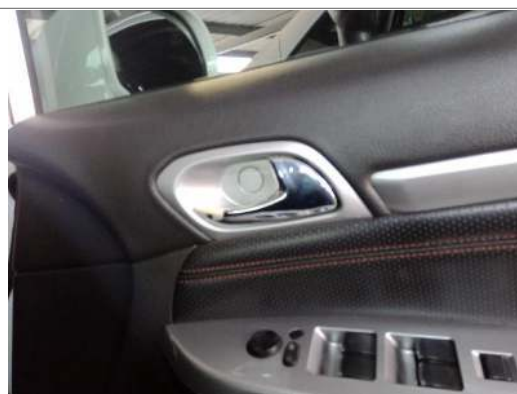
| Damage | Repair Way |
|---|---|
| Door Handle Front Right Defective | Repair |
