## CONDITION REPORT

Report No: 2016865978

| Manufacturer | HAVAL | Registration Number | FKN173L |
| Model | H6 C 2.0T LUXURY DCT [2017-2022] | Register Number | |

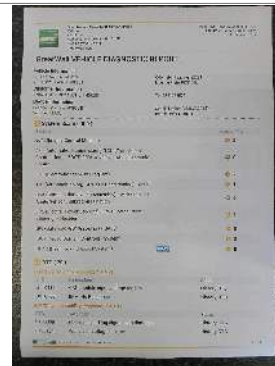
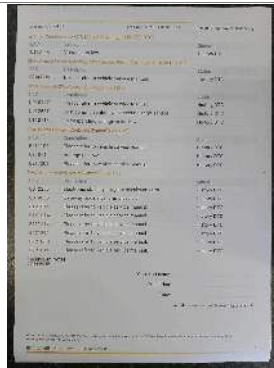
Diagnostic report page 1

| No | System | Code | Description | Status |
|---|---|---|---|---|
| 1 | ECM(ENGINE CONTROL MODULE) | U110116 | CAN MODULE INPUT VOLTAGE LOW | |

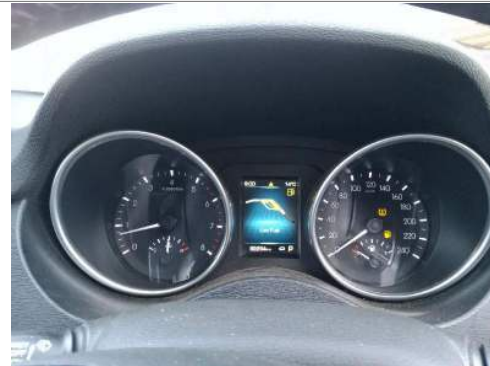
DASHBOARD (W/ ENGINE RUNNING)

| Damage | Repair Way |
|---|---|
| Warning light illuminated on dashboard | Repair |

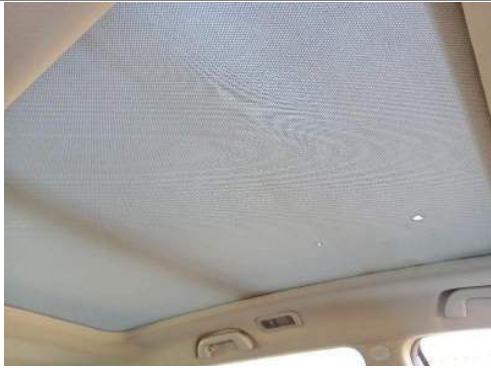
| Damage | Repair Way |
|---|---|
| Hood Lining Damaged | Repair |

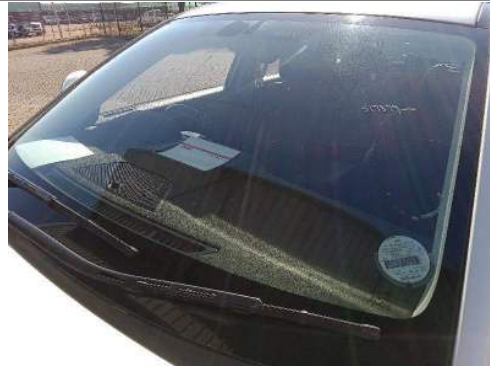
| Damage | Repair Way |
|---|---|
| Windscreen Cracked | Replace |

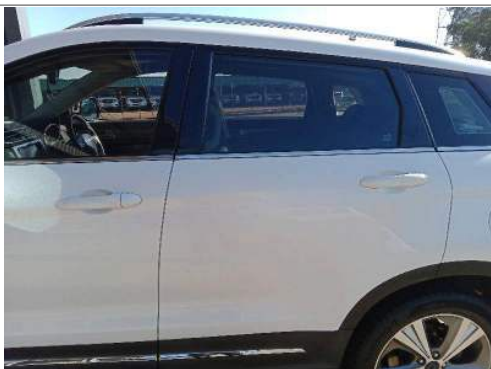
| Damage | Repair Way |
|---|---|
| Door Rear Left Paintwork • Scratched | Repair |

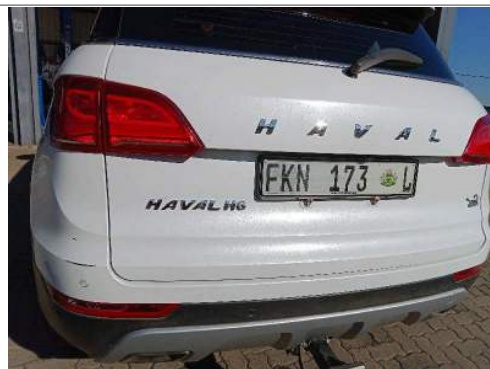
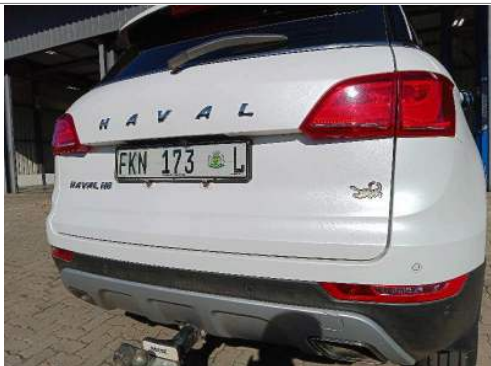
| Damage | Repair Way |
|---|---|
| Rear bumper Paintwork • Scratched | Repair |

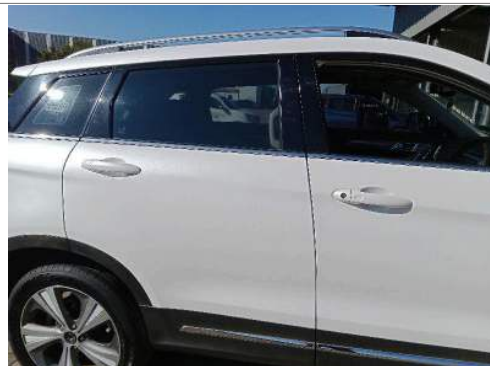
| Damage | Repair Way |
|---|---|
| Door Rear Right Dented | Repair |

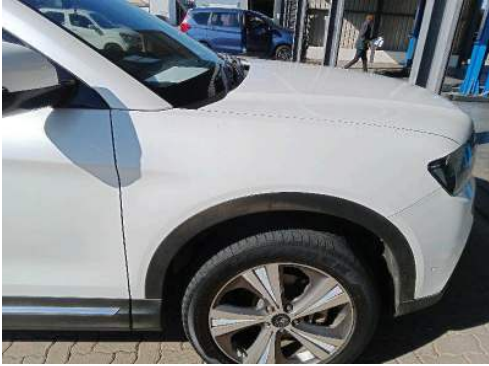
| Damage | Repair Way |
|---|---|
| Front Fender Right Paintwork • Scratched | Repair |

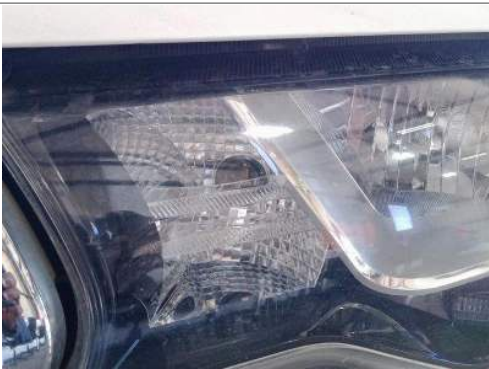
| Damage | Repair Way |
|---|---|
| Indicator Light Front Left Missing | Replace |

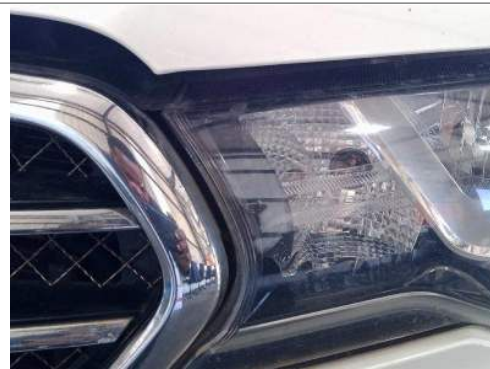
| Damage | Repair Way |
|---|---|
| Park Light Front Left Missing | Replace |

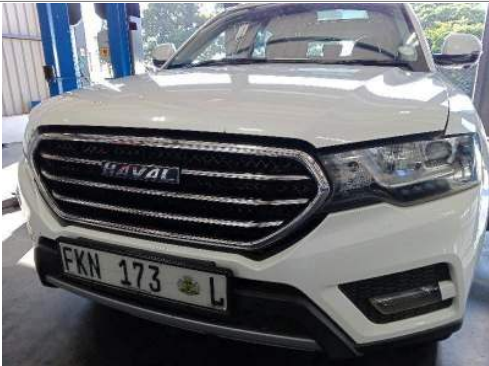
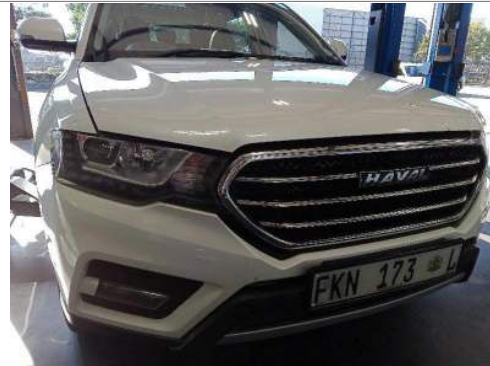
| Damage | Repair Way |
|---|---|
| Front Bumper Damaged | Repair |

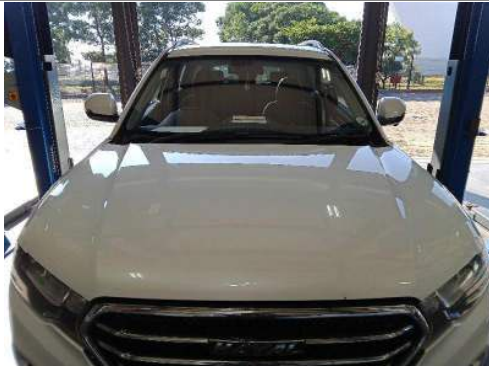
| Damage | Repair Way |
|---|---|
| Bonnet Dented | Repair |

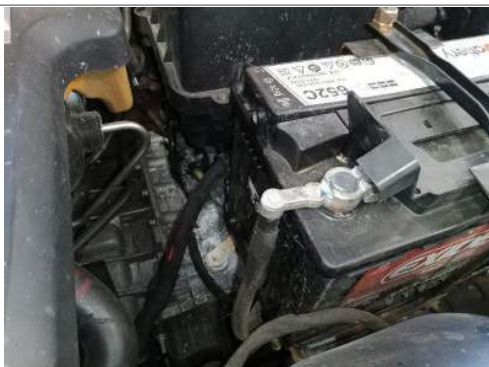
| Damage | Repair Way |
|---|---|
| Battery box Corrosion | Repair |

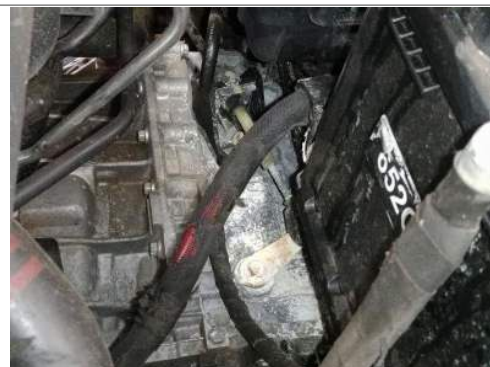
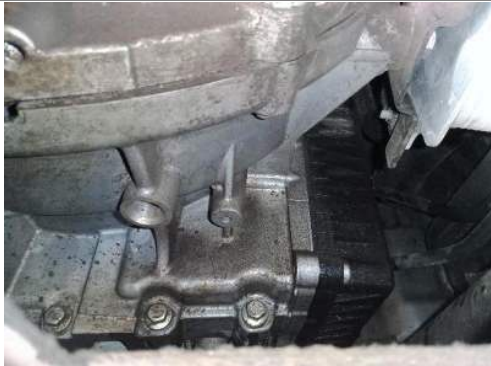
| Damage | Repair Way |
|---|---|
| Gearbox Defective | Repair |

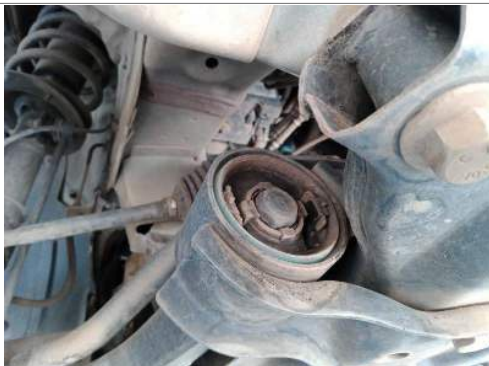
| Damage | Repair Way |
|---|---|
| Control Arm Bush(es) Front Axle Left Cracked | Replace |

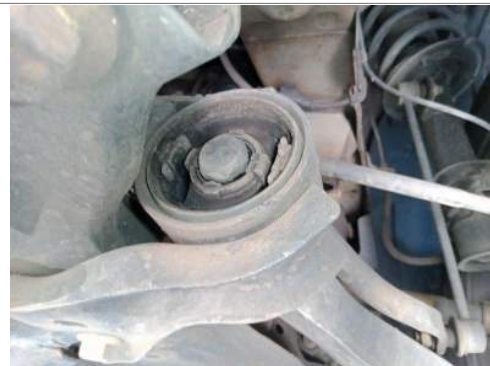
| Damage | Repair Way |
|---|---|
| Control Arm Bush(es) Front Axle Right Cracked | Replace |

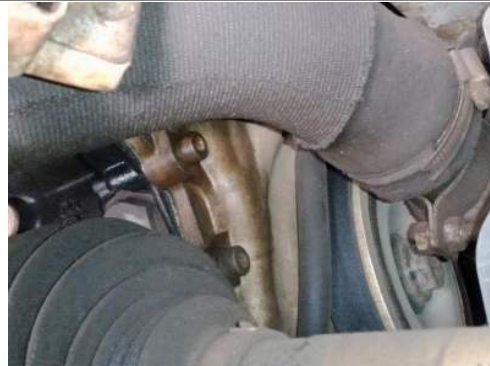
| Damage | Repair Way |
|---|---|
| Engine Oil Leak | Repair |

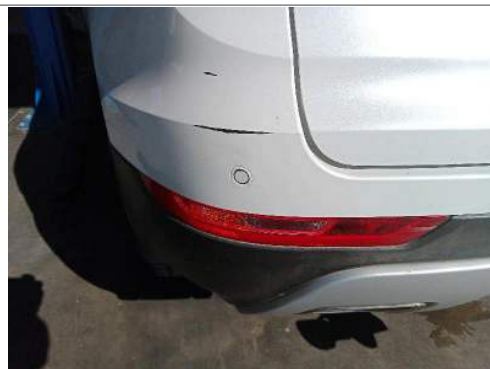
| Damage | Repair Way |
|---|---|
| Indicator Light Rear Left Defective | Repair |

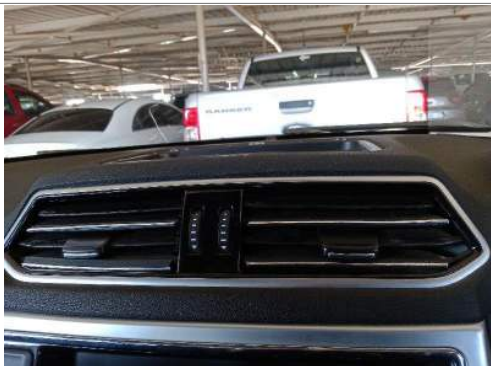
| Damage | Repair Way |
|---|---|
| Central Air Vent Damaged | Replace |
