CONDITION REPORT

Report No:  
2017297345  
DATE  
11/09/2026

MFC Auction House  
M57 Pretoria Rd, Glenmarais, KEMPTON PARK  
Gauteng

| Manufacturer | HAVAL | Registration Number | MW99VGGP |

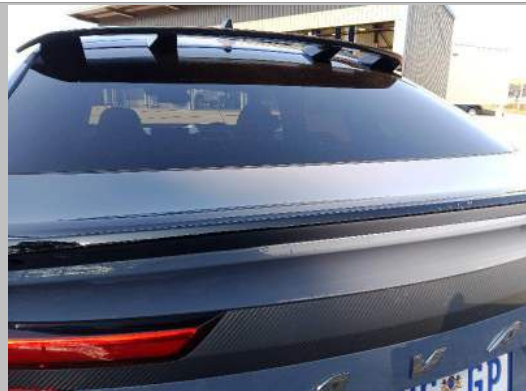
Indicator Light Front Right Scratched  
 Seat Rear Dirty  
 Carpet Front Damaged  
 Boot Carpet Damaged  
 Bonnet Dented  
 C • Pillar Left Paintwork • Scratched  
 Door Front Left Paintwork • Scratched  
 Rear bumper Paintwork • Scratched  
 Windscreen Cracked  
 Sub Frame Scratched  
 Belly plates Damaged  
 Gearbox Mountings Damaged  
 Boot spoiler scratched

Repair  
 Repair  
 Repair  
 Repair  
 Repair  
 Repair  
 Repair  
 Repair  
 Replace  
 Repair  
 Repair  
 Repair  
 Repair
