CONDITION REPORT

Report No:  
2017305017  
DATE  
29/09/2026

MFC Auction House  
M57 Pretoria Rd, Glenmarais, KEMPTON PARK  
Gauteng

| Manufacturer | HAVAL | Registration Number | MF27FPGP |

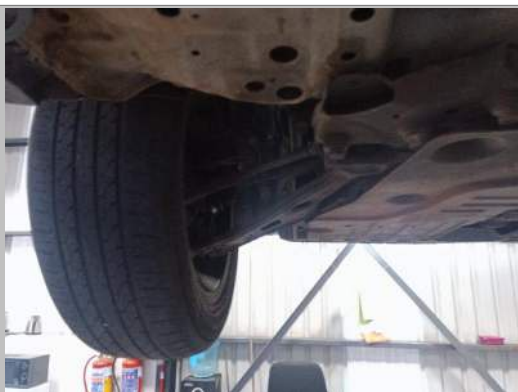
LF TYRE TREAD

| | Size | Load/Speed Index | Manufacture | Model | Type* | Production Date | Tread Depth (mm) |
|---|---|---|---|---|---|---|---|
| Front Left | 235/55R19 | 105H | Cooper | Radial | V | 3724 | 2 mm |

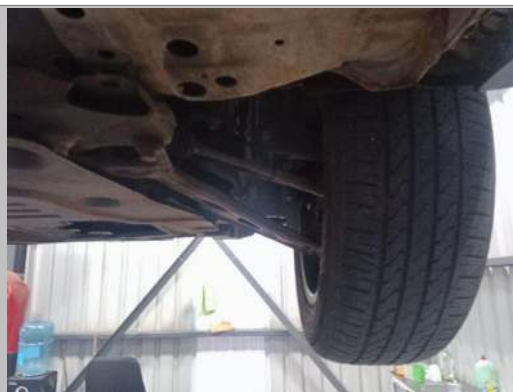
RF TYRE TREAD

| | Size | Load/Speed Index | Manufacture | Model | Type* | Production Date | Tread Depth (mm) |
|---|---|---|---|---|---|---|---|
| Front Right | 235/55R19 | 105H | Cooper | Radial | V | 3724 | 1 mm |

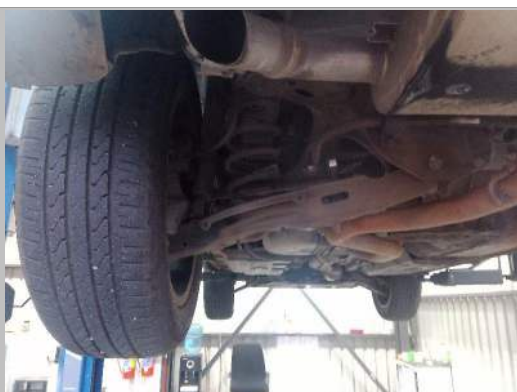
LR TYRE TREAD

| | Size | Load/Speed Index | Manufacture | Model | Type* | Production Date | Tread Depth (mm) |
|---|---|---|---|---|---|---|---|
| Rear Left | 235/55R19 | 105H | Cooper | Radial | V | 3724 | 1 mm |

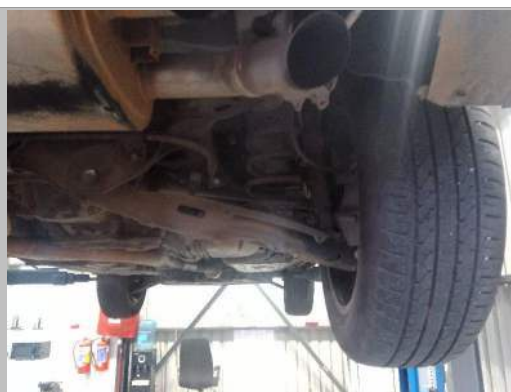
RR TYRE TREAD

| | Size | Load/Speed Index | Manufacture | Model | Type* | Production Date | Tread Depth (mm) |
|---|---|---|---|---|---|---|---|
| Rear Right | 235/55R19 | 105H | Cooper | Radial | V | 3724 | 2 mm |

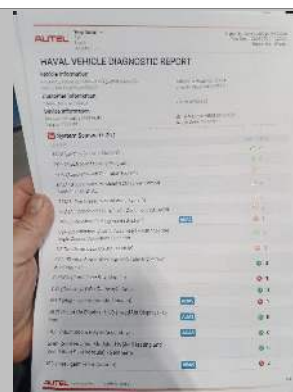
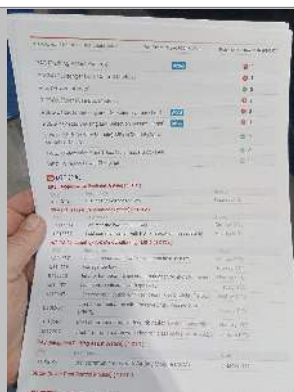
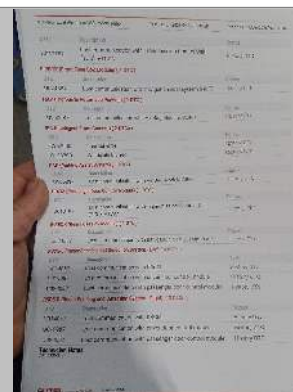
During the diagnostic no active error messages were detected. (See also attached Diagnostic Report. For more information regarding the Fault Codes (DTC) and the recommended rectifications please contact the workshops of the vehicle manufacture).

Diagnostic Report page 1

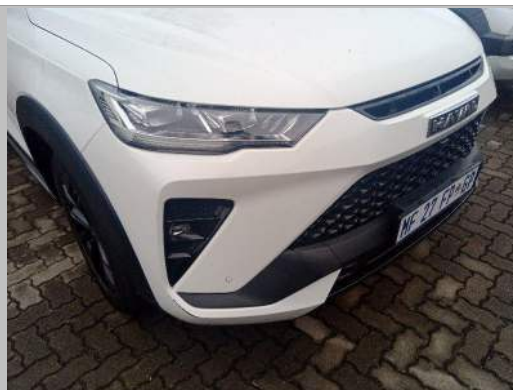
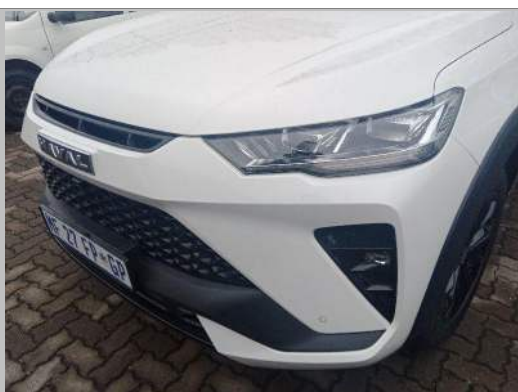
| | Damage | Repair Way |
|---|---|---|
| | Front Bumper Damaged | Repair |

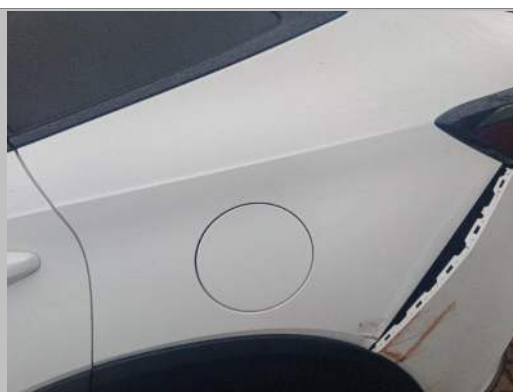
| | Damage | Repair Way |
|---|---|---|
| | Rear Fender Left Damaged | Repair |

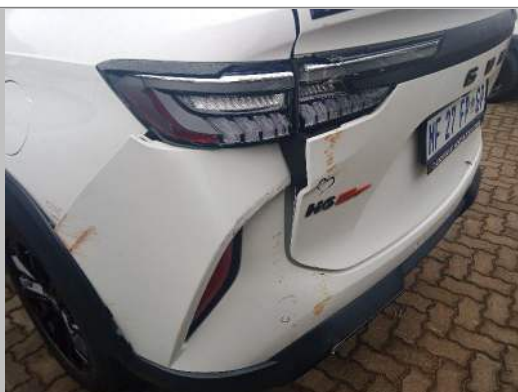
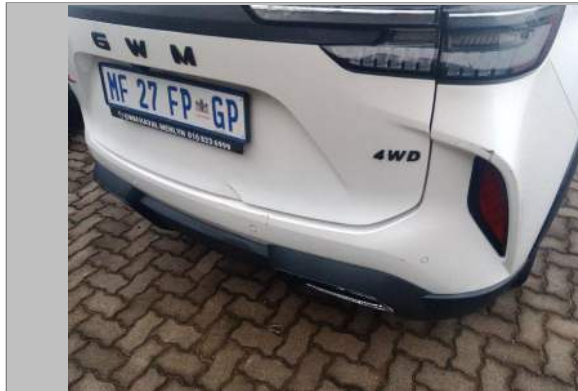
| | Damage | Repair Way |
|---|---|---|
| | Rear bumper Damaged | Repair |

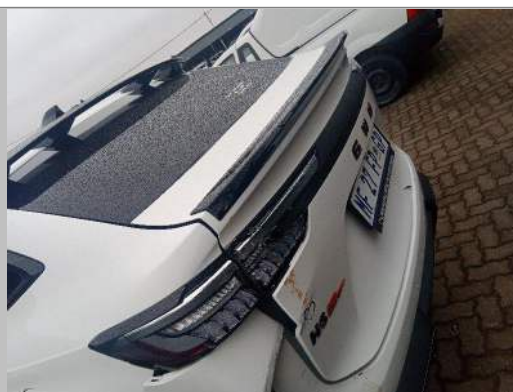
| | Damage | Repair Way |
|---|---|---|
| | Boot Lid / Hatch door Damaged | Repair |

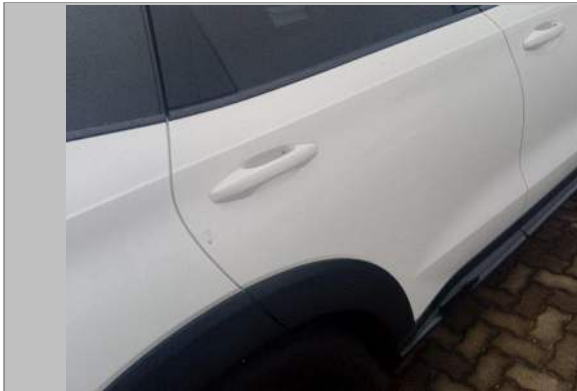
| | Damage | Repair Way |
|---|---|---|
| | Door Rear Right Damaged | Repair |

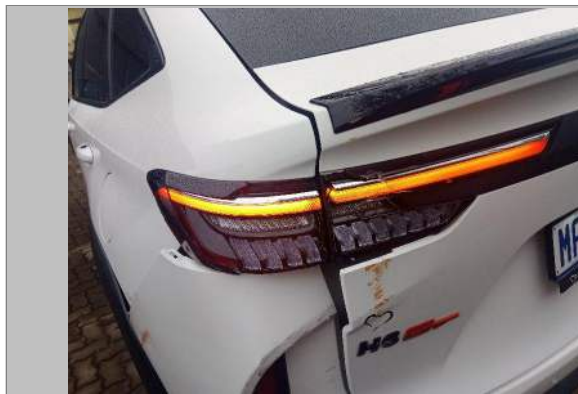
| | Damage | Repair Way |
|---|---|---|
| | Tail Light Left Damaged | Replace |
