MFC Auction House  
M57 Pretoria Rd, Glenmarais, KEMPTON PARK  
Gauteng

| Manufacturer | CHERY | Registration Number | KX90WDGP |

## CONDITION REPORT

Report No: 2016785801

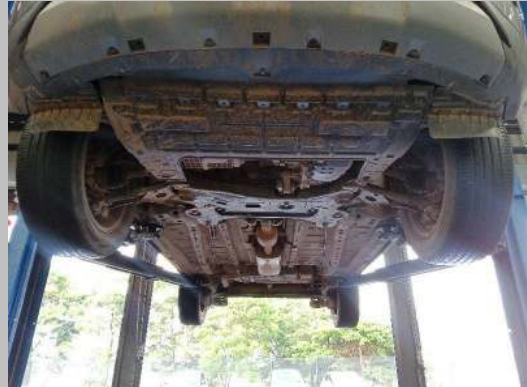
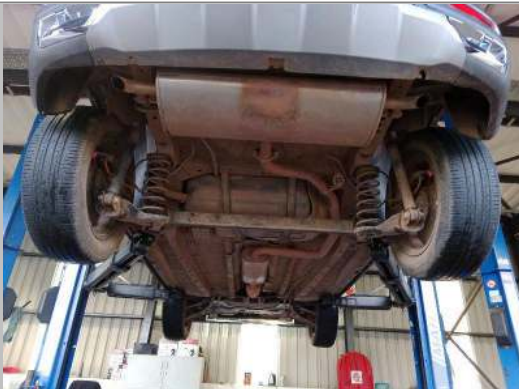
| Damage | Repair Way |
|---|---|
| Undercarriage | Bottom of engine and gearbox covered |
| Undercarriage | Vehicle undercarriage dirty |

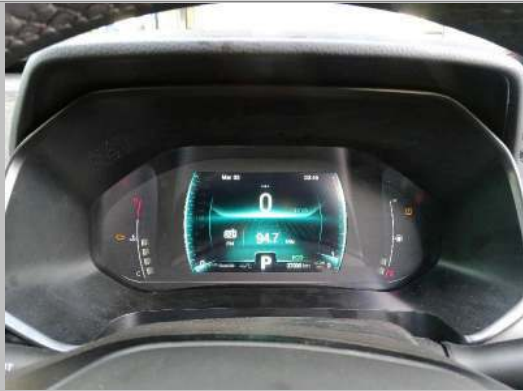
DASHBOARD (W/ ENGINE RUNNING)

| Damage | Repair Way |
|---|---|
| Warning lights illuminated on dashboard | Repair |

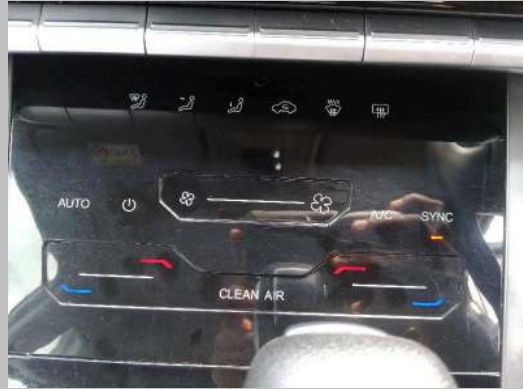
| Damage | Repair Way |
|---|---|
| Heater control Damaged | Replace |

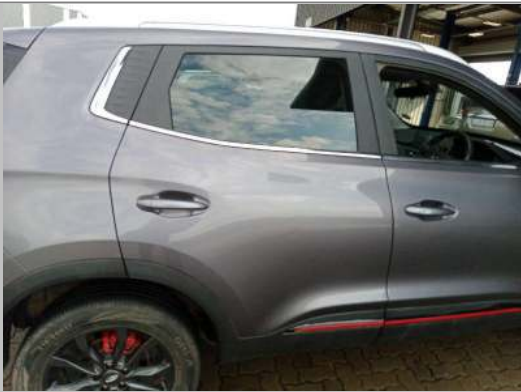
| Damage | Repair Way |
|---|---|
| Door Rear Right Paintwork • Scratched | Smart Repair |

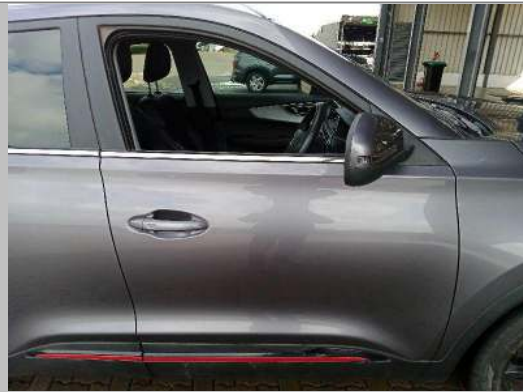
| Damage | Repair Way |
|---|---|
| Door Front Right Paintwork • Scratched | Repair |

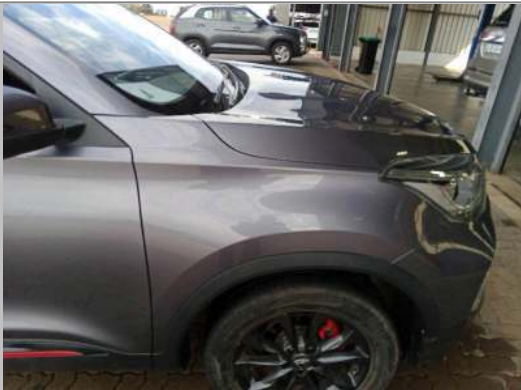
| Damage | Repair Way |
|---|---|
| Front Fender Right Paintwork • Scratched | Repair |

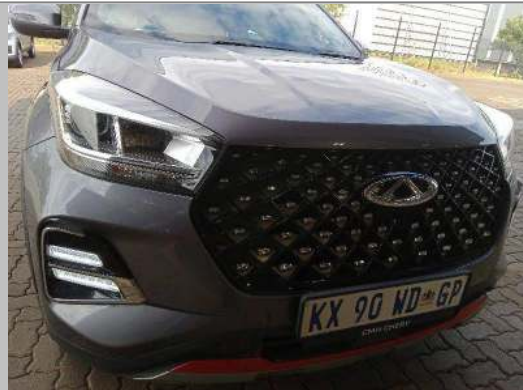
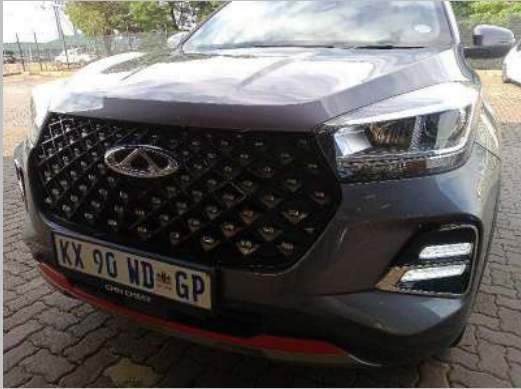
| Damage | Repair Way |
|---|---|
| Front Bumper Paintwork • Scratched | Repair |

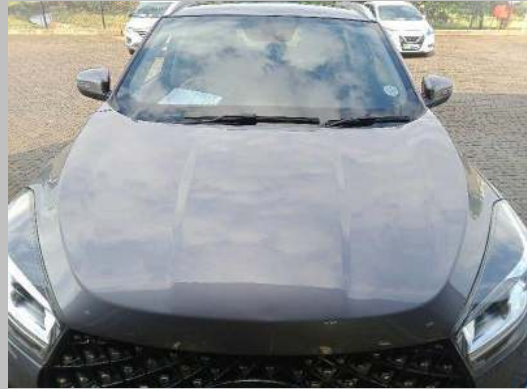
| Damage | Repair Way |
|---|---|
| Bonnet Dented | Repair |

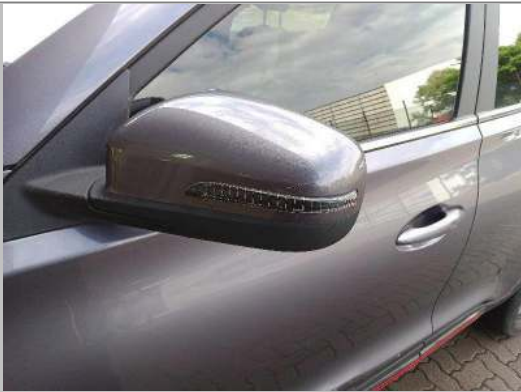
| Damage | Repair Way |
|---|---|
| Side Mirror Left Paintwork • Scratched | Repair |

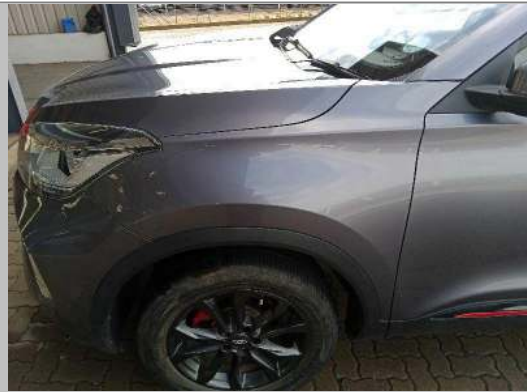
| Damage | Repair Way |
|---|---|
| Front Fender Left Paintwork • Scratched | Repair |

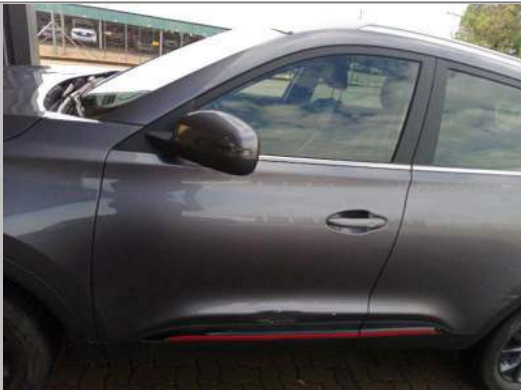
| Damage | Repair Way |
|---|---|
| Door Front Left Damaged | Repair |

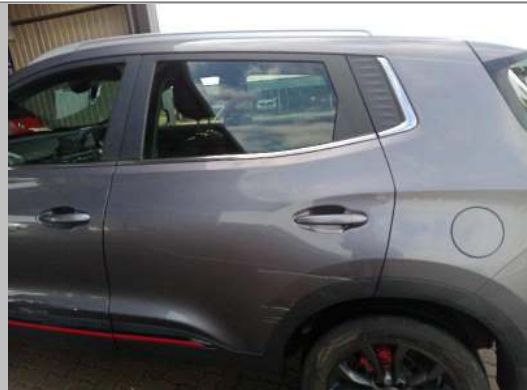
| Damage | Repair Way |
|---|---|
| Door Rear Left Damaged | Repair |

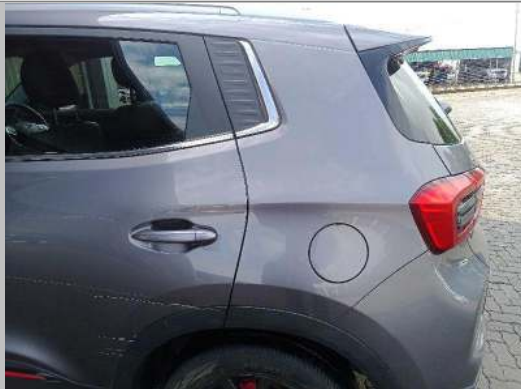
| Damage | Repair Way |
|---|---|
| Rear Fender Left Paintwork • Scratched | Repair |

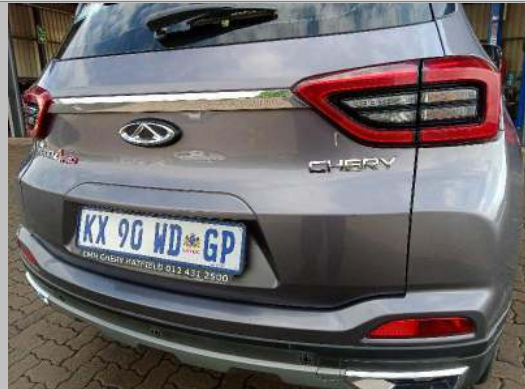
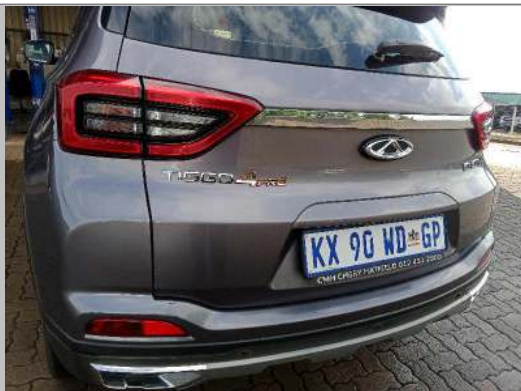
| Damage | Repair Way |
|---|---|
| Rear bumper Damaged | Repair |

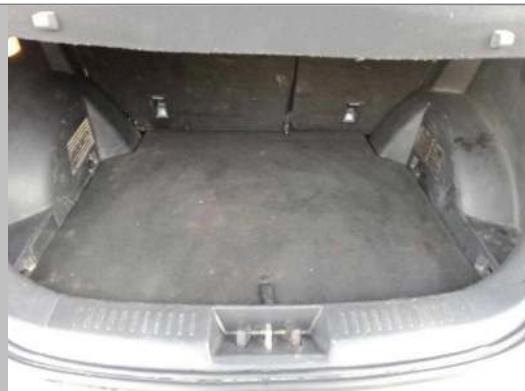
| Damage | Repair Way |
|---|---|
| Boot Carpet Damaged | Repair |

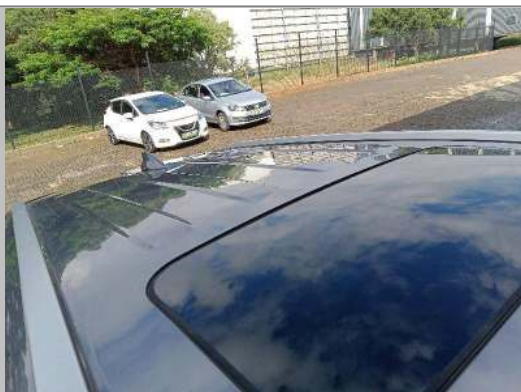
| Damage | Repair Way |
|---|---|
| Roof Dented | Repair |

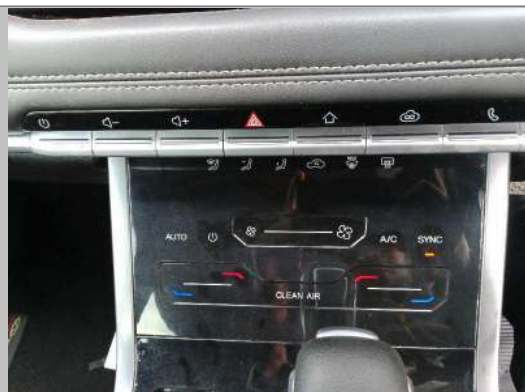
| Damage | Repair Way |
|---|---|
| Air Conditioner Damaged | Replace |

| No | System | Code | Description | Status |
|---|---|---|---|---|
| 1 | ECM(ENGINE SYSTEM)-<br>EMS(ENGINE MANAGEMENT<br>SYSTEM | U016487 | LOST COMMUNICATION WITH A/C CONTROLLER | |
