MFC Auction House  
M57 Pretoria Rd, Glenmarais, KEMPTON PARK  
Gauteng

DEKRA MFC  
M57 Pretoria Rd - 1619  
KEMPTON PARK - GT  
08610 33572

## VEHICLE INSPECTION

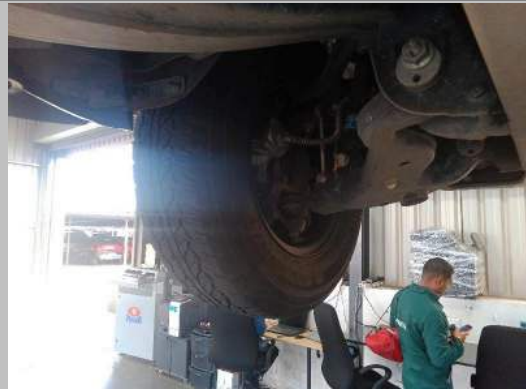
LF TYRE TREAD

| | Size | Load/Speed Index | Manufacture | Model | Type* | Production Date | Tread Depth (mm) |
|---|---|---|---|---|---|---|---|
| Front Left | 215/75R15 | 100T | Royal black | Royal a/t | V | 4621 | 2 mm |

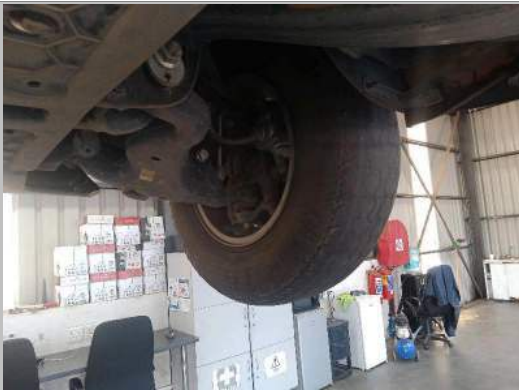
RF TYRE TREAD

| | Size | Load/Speed Index | Manufacture | Model | Type* | Production Date | Tread Depth (mm) |
|---|---|---|---|---|---|---|---|
| Front Right | 215R15 | 109/107S | Autogrip | Blazer | V | 1317 | 0 mm |

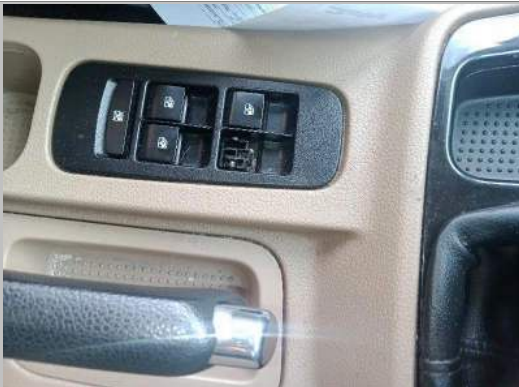
| Damage | Repair Way |
|---|---|
| Switch Electrical Window Winder front right Damaged | Replace |

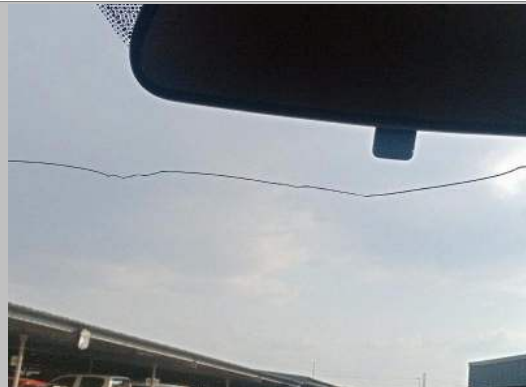
| Damage | Repair Way |
|---|---|
| Windscreen Cracked | Replace |

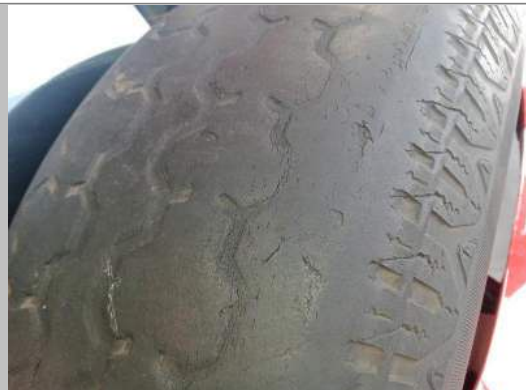
| Damage | Repair Way |
|---|---|
| Spare Tyre Smooth | Replace |

| | Size | Load/Speed Index | Manufacture | Model | Type* | Production Date | Tread Depth (mm) |
|---|---|---|---|---|---|---|---|
| Spare | 215R15 | 109/107S | Autogrip | Blazer | V | 1417 | 0 mm |

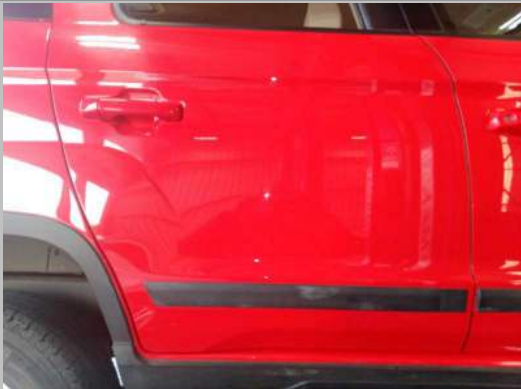
| Damage | Repair Way |
|---|---|
| Door Rear Right Paintwork • Scratched | Repair |

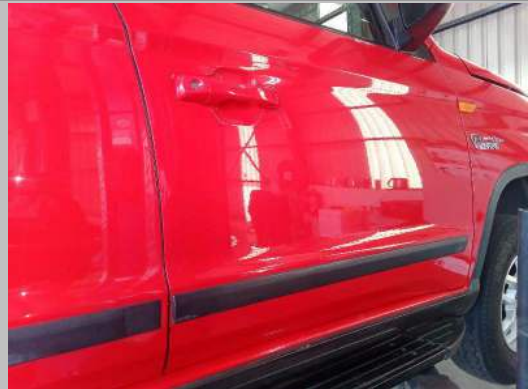
| Damage | Repair Way |
|---|---|
| Door Front Right Paintwork • Scratched | Repair |

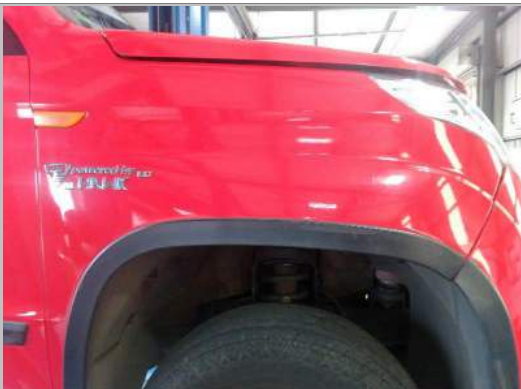
| Damage | Repair Way |
|---|---|
| Front Fender Right Paintwork • Scratched | Repair |

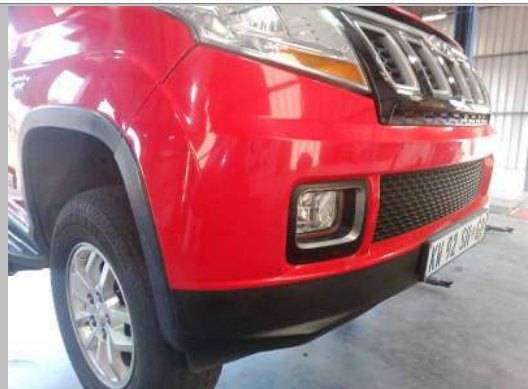
| Damage | Repair Way |
|---|---|
| Front Bumper Paintwork • Scratched | Repair |

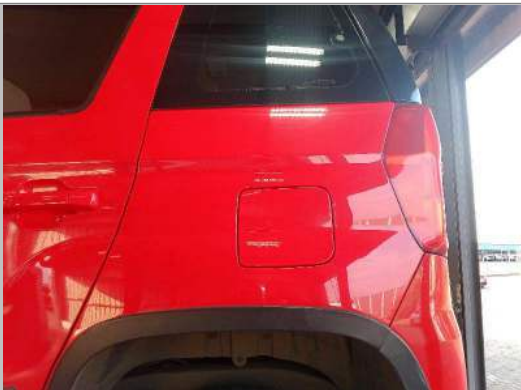
| Damage | Repair Way |
|---|---|
| Rear Fender Left Paintwork • Scratched | Repair |

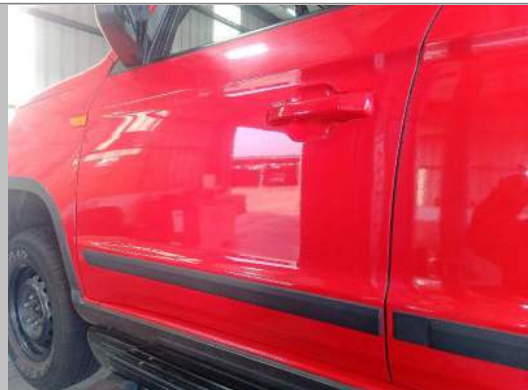
| Damage | Repair Way |
|---|---|
| Door Front Left Paintwork • Scratched | Repair |

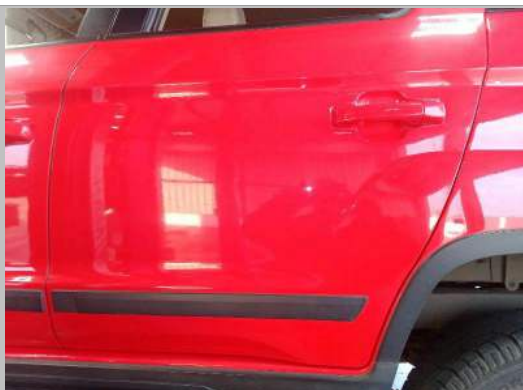
| Damage | Repair Way |
|---|---|
| Door Rear Left Paintwork • Scratched | Repair |

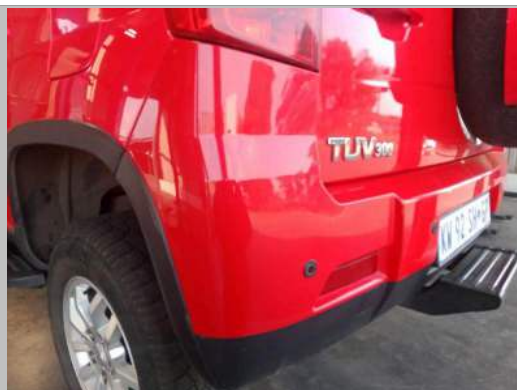
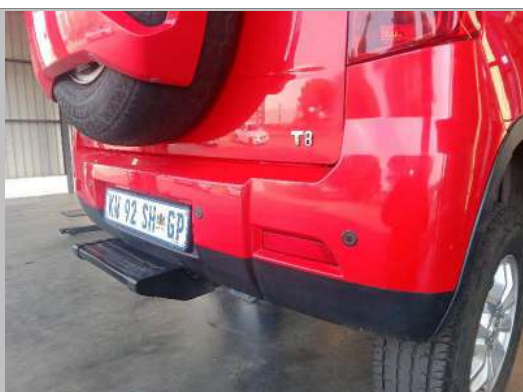
| Damage | Repair Way |
|---|---|
| Rear bumper Paintwork • Scratched | Repair |

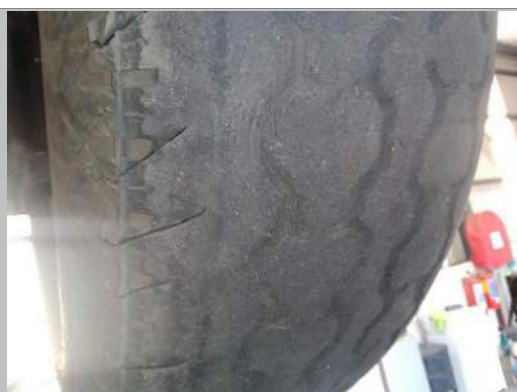
| Damage | Repair Way |
|---|---|
| Tyre Front Right Smooth | Replace |
