MFC Auction House
M57 Pretoria Rd, Glenmarais, KEMPTON PARK
Gauteng

DEKRA MFC
M57 Pretoria Rd - 1619
KEMPTON PARK - GT
08610 33572

Vehicle Data

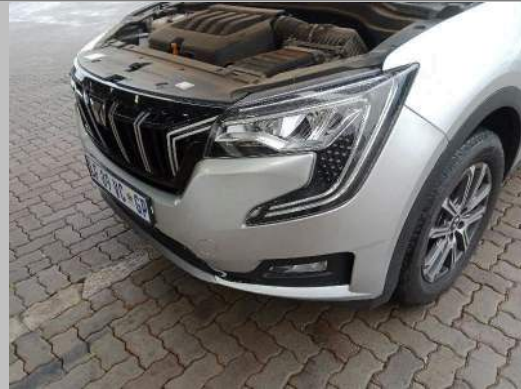
Damage	Repair Way
Engine Management Lights Set	Repair
Front Bumper Damaged	Repair
Bonnet Damaged	Repair
Front Fender Right Damaged	Repair
Door Front Left Damaged	Repair
Door Rear Left Damaged	Repair
Boot Lid / Hatch door Damaged	Repair
Rear bumper Damaged	Repair
Windscreen Damaged	Replace
Engine Smoke Excessive	Repair
