CONDITION REPORT

Report No:  
2017303943  
DATE  
28/09/2026

| Manufacturer | MAHINDRA | Registration Number | KLZ590NW |
| Model | KUV 100 NXT 1.2 K6+ MFALCON 5-DR [2018-2023] | Register Number | |

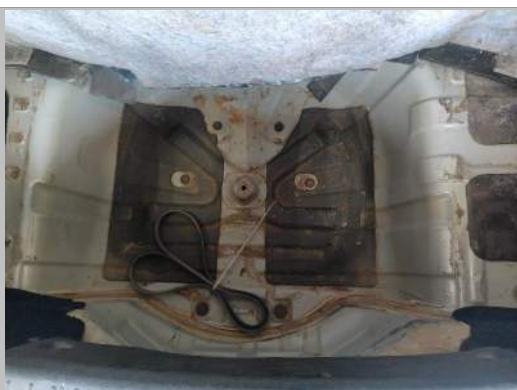
No sparewheel

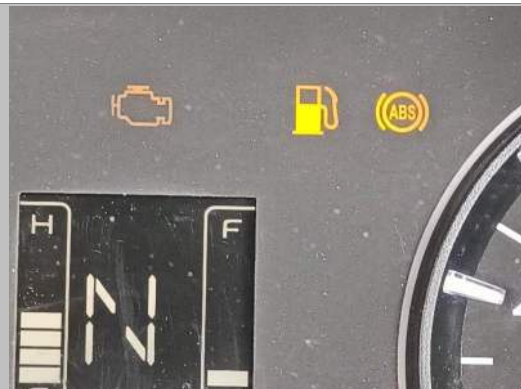
| Damage | Repair Way |
|---|---|
| Warning lights illuminated | Repair |

| No | System | Code | Description | Status |
|---|---|---|---|---|
| 1 | ENGINE MANAGEMENT SYSTEM | P030300 | CYLINDER 3 MISFIRE DETECTED | |

Warning lights illuminated

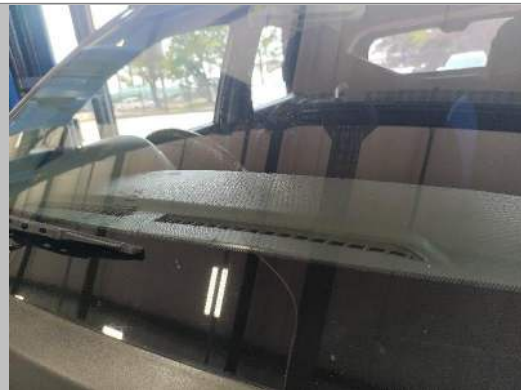
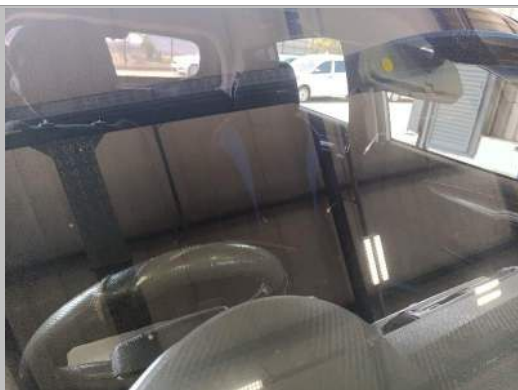
| Damage | Repair Way |
|---|---|
| Windscreen Cracked | Replace |

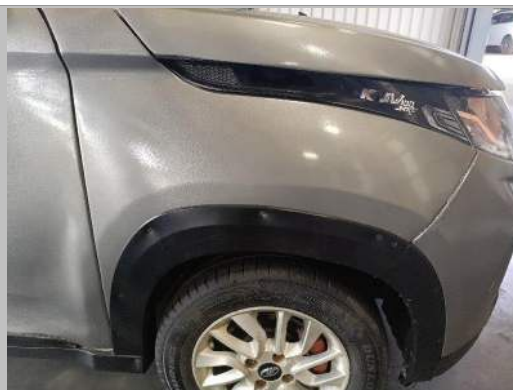
| Damage | Repair Way |
|---|---|
| Front Fender Right Residual Traces of Repair | Repair |

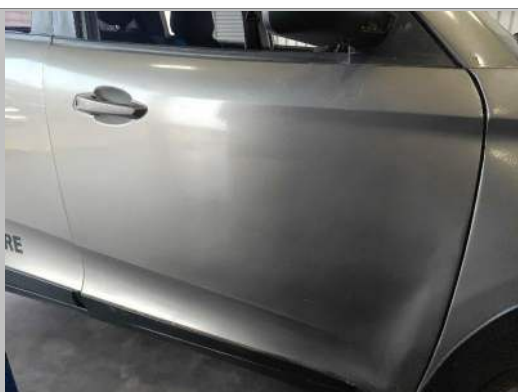
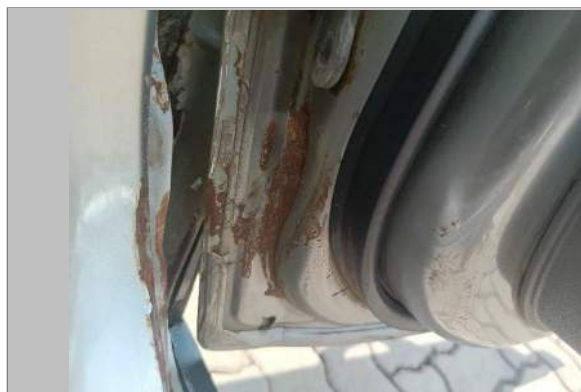
| Damage | Repair Way |
|---|---|
| Door Front Right Residual Traces of Repair | Repair |

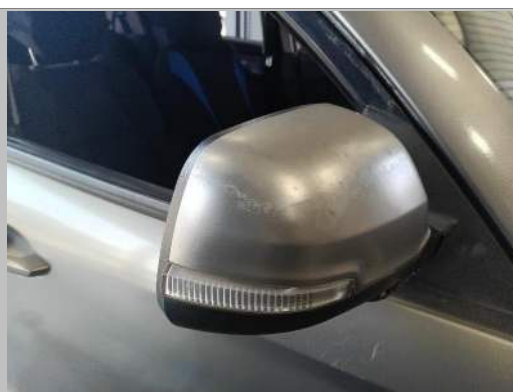
| Damage | Repair Way |
|---|---|
| Side Mirror Right Residual Traces of Repair | Repair |

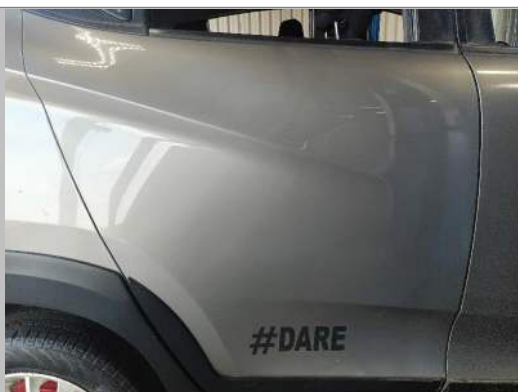
| Damage | Repair Way |
|---|---|
| Door Rear Right Paintwork • Scratched | Repair |

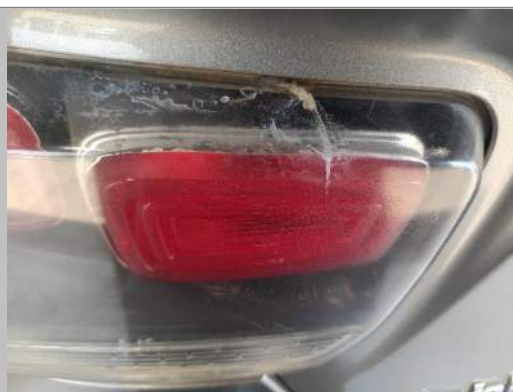
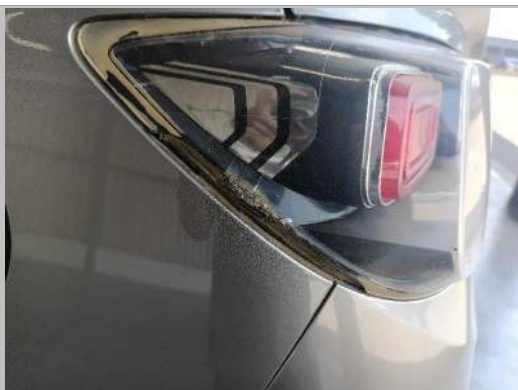
| Damage | Repair Way |
|---|---|
| Tail Light Left Cracked | Replace |

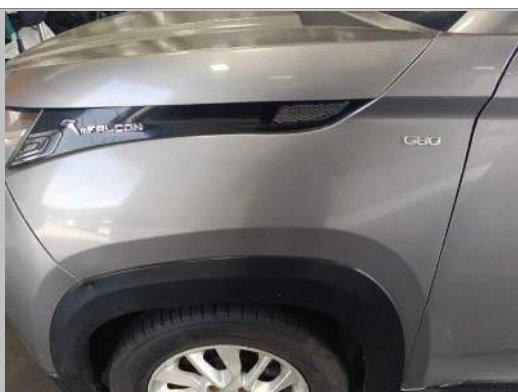
| Damage | Repair Way |
|---|---|
| Front Fender Left Residual Traces of Repair | Repair |

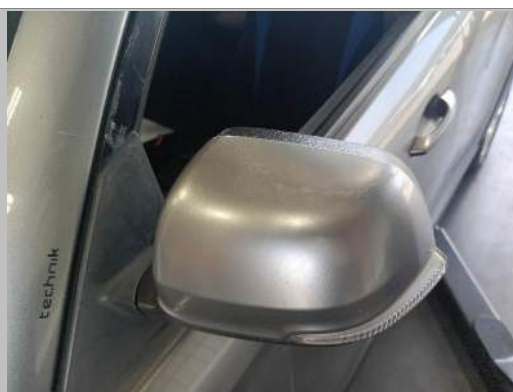
| Damage | Repair Way |
|---|---|
| Side Mirror Left Residual Traces of Repair | Repair |

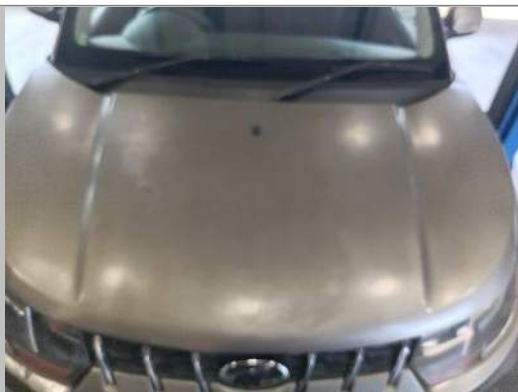
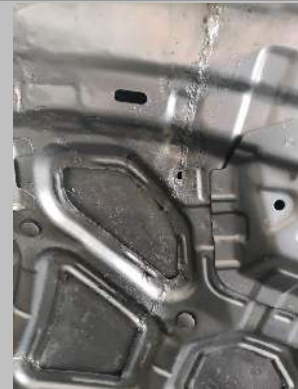
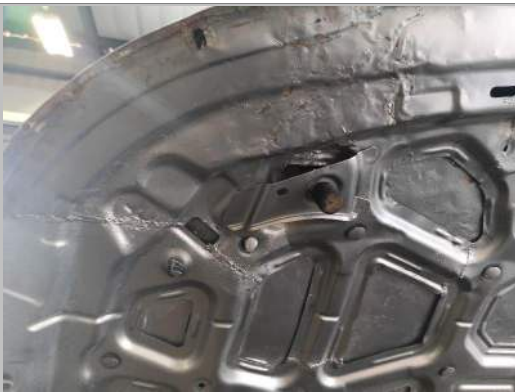
| Damage | Repair Way |
|---|---|
| Bonnet Residual Traces of Repair | Repair |

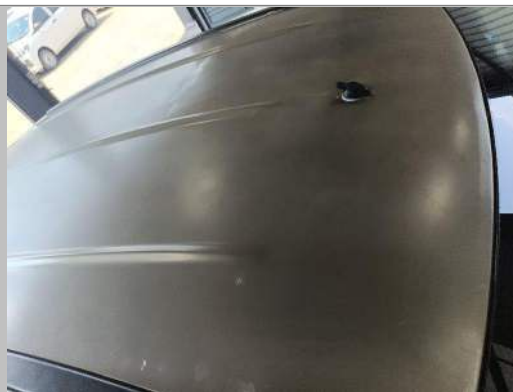
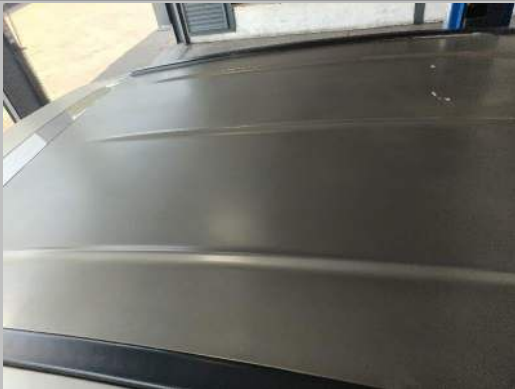
| Damage | Repair Way |
|---|---|
| Roof Residual Traces of Repair | Repair |

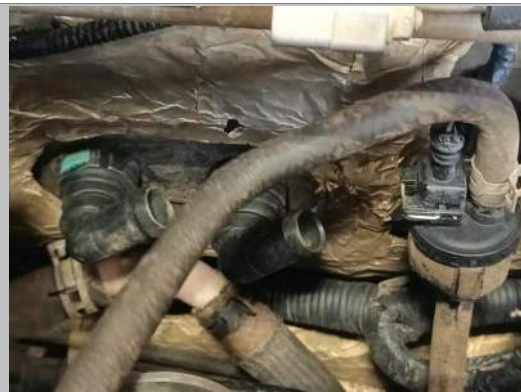
| Damage | Repair Way |
|---|---|
| Hoses Torn / Cut | Replace |

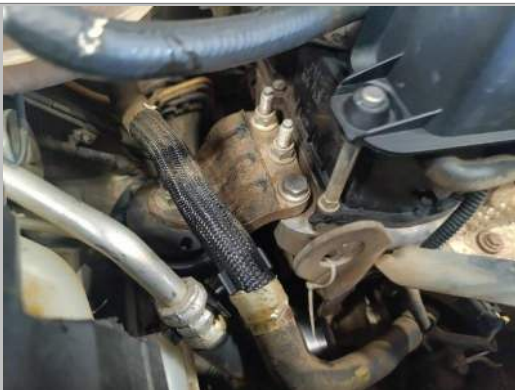
| Damage | Repair Way |
|---|---|
| Engine mountings Loose / Excessive Play | Replace |

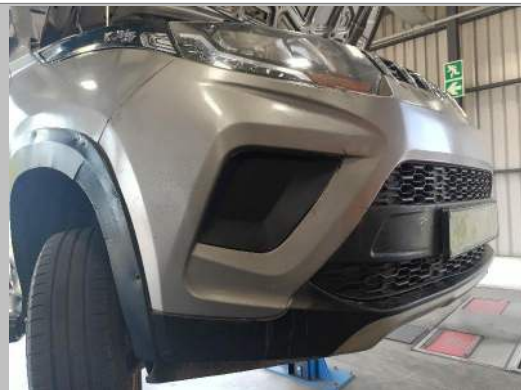
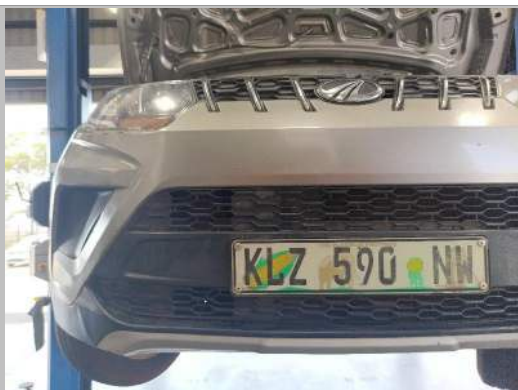
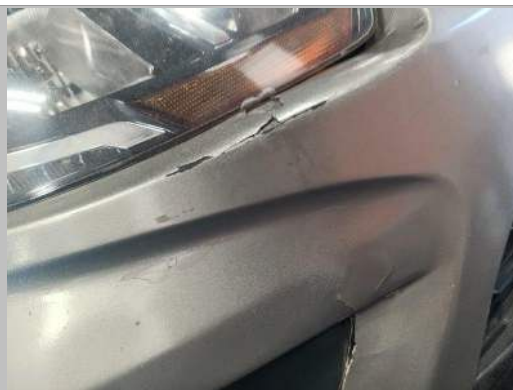
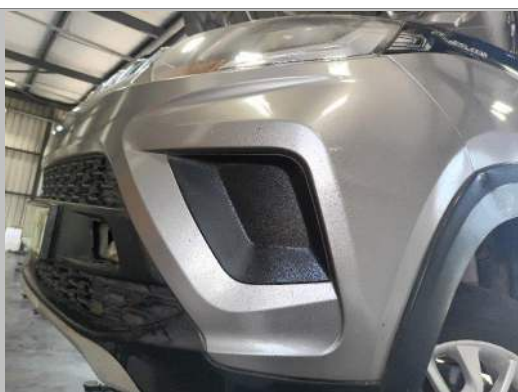
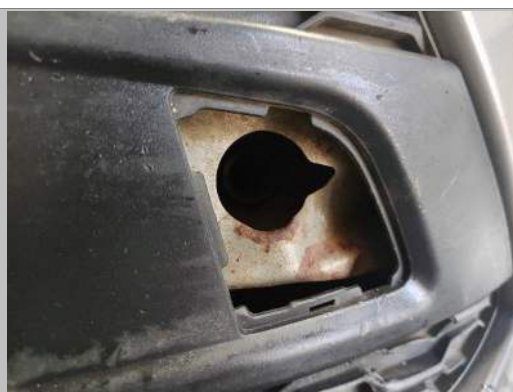
| Damage | Repair Way |
|---|---|
| Front Bumper Residual Traces of Repair | Repair |

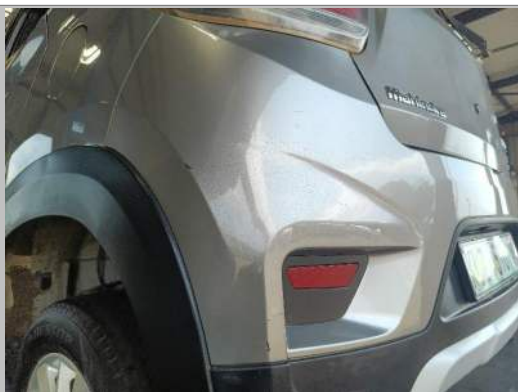
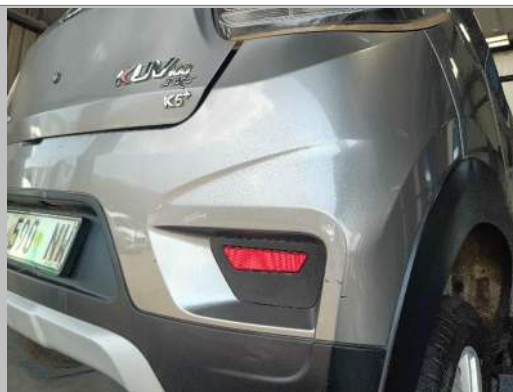
| Damage | Repair Way |
|---|---|
| Rear bumper Paintwork • Scratched | Repair |

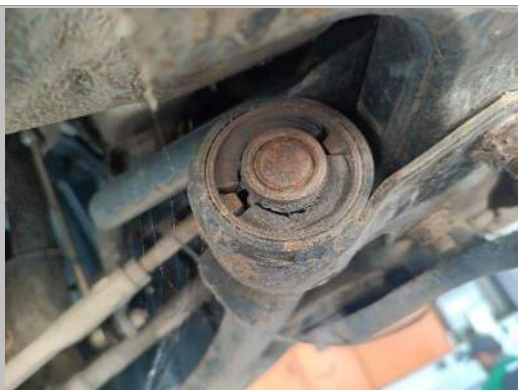
| Damage | Repair Way |
|---|---|
| Control Arm Bush(es) Front Axle Left Cracked | Replace |

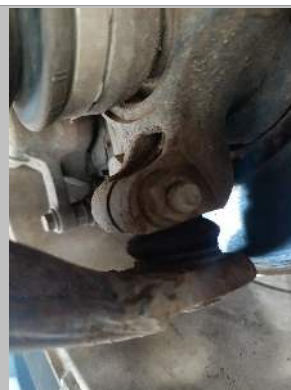
| Damage | Repair Way |
|---|---|
| Ball Joint(s) Front Axle Right Loose / Excessive Play | Replace |

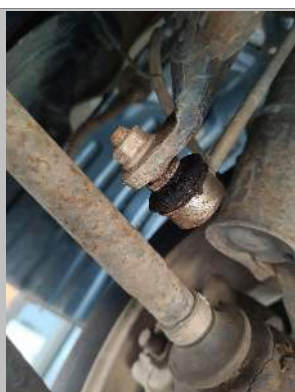
| Damage | Repair Way |
|---|---|
| Stabilizer Mounting Front Right Damaged | Replace |

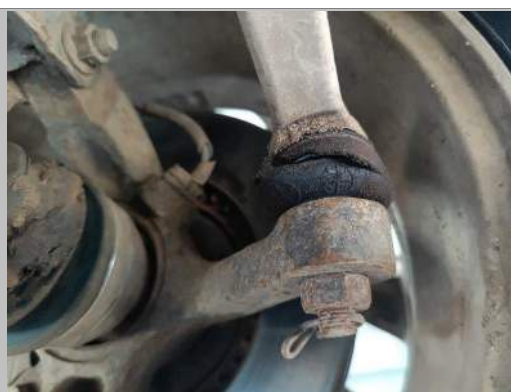
| Damage | Repair Way |
|---|---|
| Tie Rod End right Damaged | Replace |

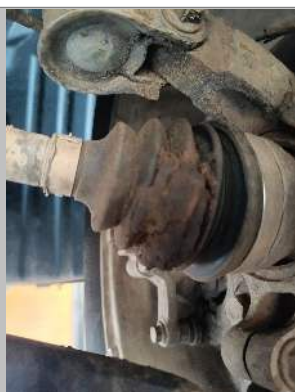
| Damage | Repair Way |
|---|---|
| CV Joint(s) Boot(s) Front Right (inner/outer) Damaged | Replace |

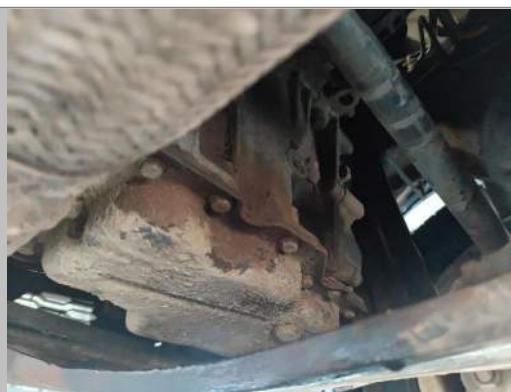
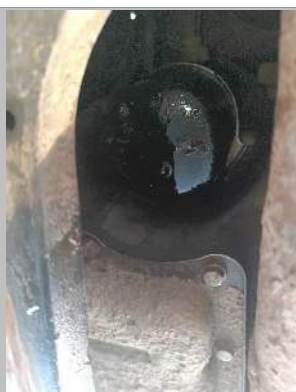
| Damage | Repair Way |
|---|---|
| Engine Oil Sweat | Repair |
| Engine Noise Excessive | Repair |

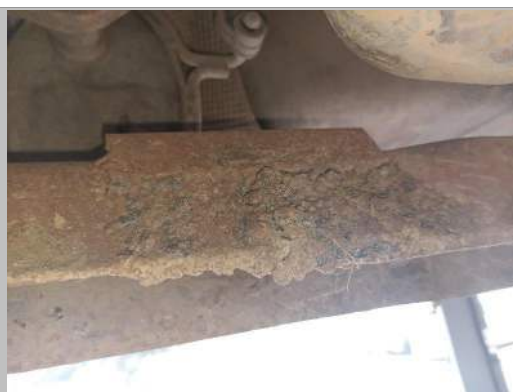
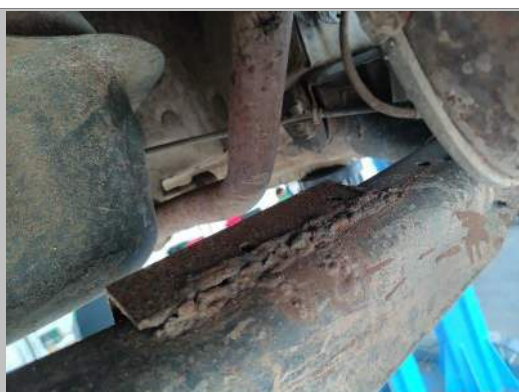
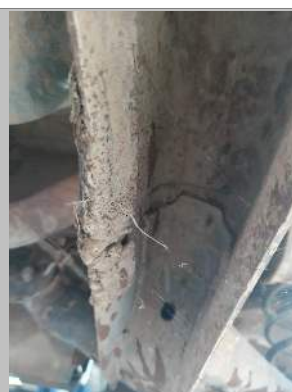
| Damage | Repair Way |
|---|---|
| Rear Axle Welded | Replace |

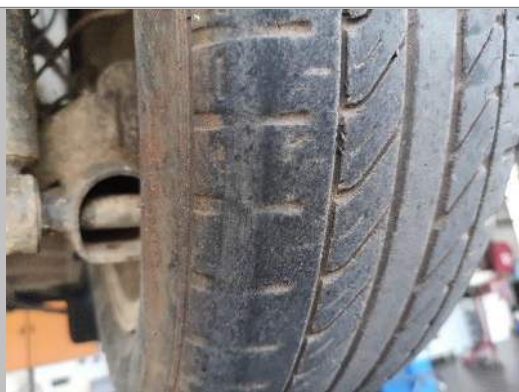
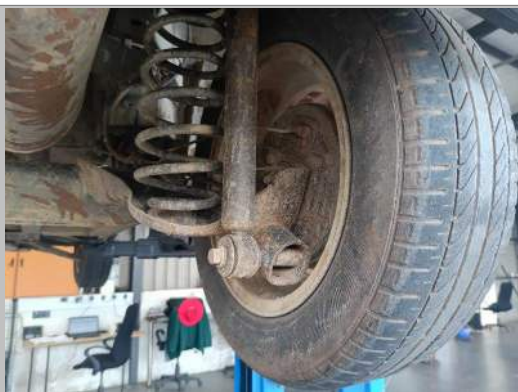
| Damage | Repair Way |
|---|---|
| Tyre Rear Right Smooth | Replace |

| | Size | Load/Speed Index | Manufacture | Model | Type* | Production Date | Tread Depth (mm) |
|---|---|---|---|---|---|---|---|
| Rear Right | 185/65R14 | 86H | Dunlop | Sport | V | 4723 | 0 mm |

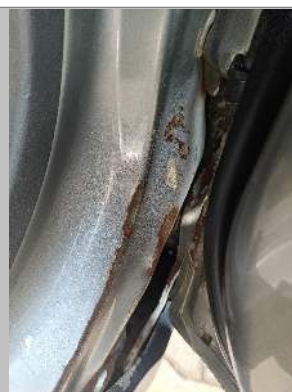
| Damage | Repair Way |
|---|---|
| A • Pillar Right Corrosion | Repair |

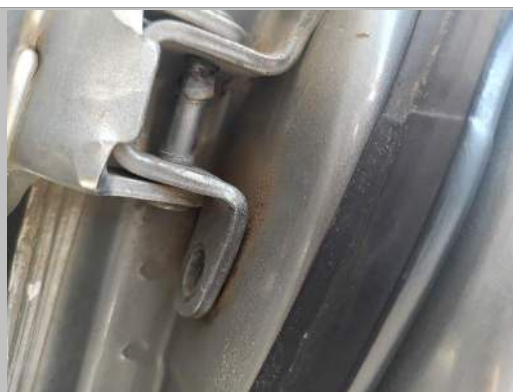
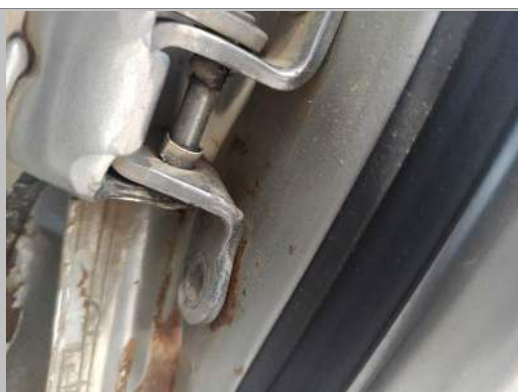
| Damage | Repair Way |
|---|---|
| Door Hinges Front Right Defective | Replace |

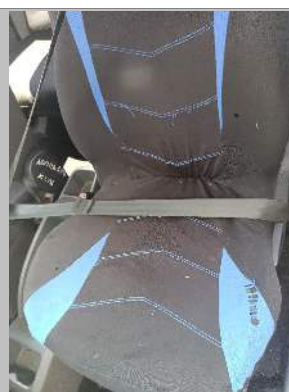
| Damage | Repair Way |
|---|---|
| Seat Front Left Torn / Cut | Repair |

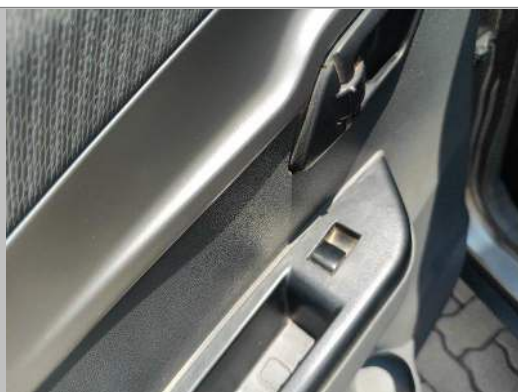
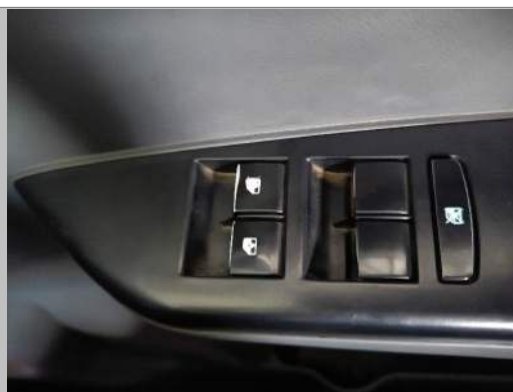
| Damage | Repair Way |
|---|---|
| Switch Electrical Window Winder rear left Defective | Repair |
| left rear electric window not closing | Repair |
