CONDITION REPORT

Report No: 2016867662

Vehicle Type	LIGHT LOAD VEHICLE	Registered Owner	
Manufacturer	MAHINDRA	Registration Number	KR07NMGP
Model	BOLERO	Register Number	
VIN	MA1ZP2TAKN2C85912	Date Of First Licensing	
Engine Number		Last COR	
Doors	2	License Expiry Date	31/03/2025
Color	WHITE	Power / Displacement	
Year Model		Paint Finish	TWO COAT UNI
Km Reading	36,644 KM	Fuel	DIESEL
Cab / Body Type	SINGLE CAB	Transmission	MANUAL

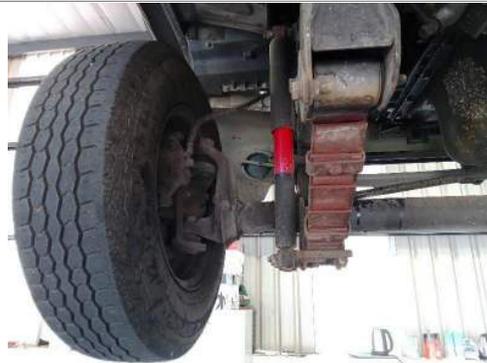
LF TYRE TREAD

Size	Load/Speed Index	Manufacture	Model	Type*	Production Date	Tread Depth (mm)
Front Left	195R15LT	106Q	Jk tyre	Radial	V	5121	5 mm
Front Right	195R15LT	106Q	Jk tyre	Radial	V	0522	5 mm
Rear Left	195R15LT	106Q	Jk tyre	Radial	V	0522	4 mm
Rear Right	195R15LT	106Q	Jk tyre	Radial	V	0522	4 mm
Spare	195R15LT	106Q	Jk tyre	Radial	V	5221	7 mm

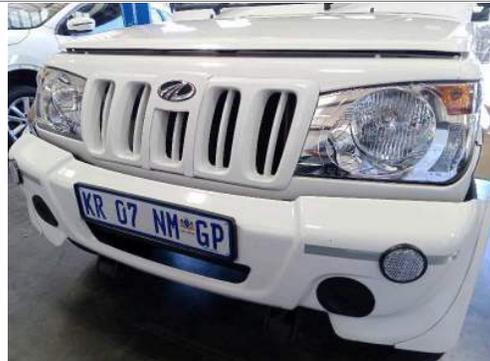
Damage	Repair Way
Engine Oil Leak	Repair
Front Bumper Paintwork • Scratched	Repair
Bonnet Paintwork • Chipmarks	Repair
C • Pillar Left Paintwork • Scratched	Repair
Rear Fender Left Dented	Repair
Door Front Left Paintwork • Scratched	Repair
Tailgate Paintwork • Scratched	Repair
Load Body Paintwork • Scratched	Repair
Windscreen Cracked	Replace
Mounting Rubber(s) Front Axle Left Cracked	Replace
Mounting Rubber(s) Front Axle Right Cracked	Replace
