## CONDITION REPORT

Report No:  
2017302486  
DATE  
23/09/2026

| Manufacturer | SUZUKI | Registration Number | LM86BFGP |
| Model | CIAZ | Register Number | |

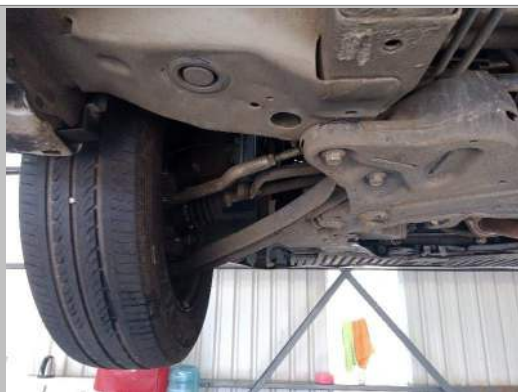
LF TYRE TREAD

| | Size | Load/Speed Index | Manufacture | Model | Type* | Production Date | Tread Depth (mm) |
|---|---|---|---|---|---|---|---|
| Front Left | 185/65R15 | 88H | Goodyear | Assurance | V | 4822 | 2 mm |

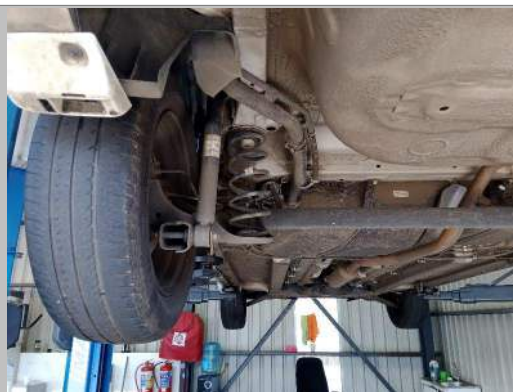
LR TYRE TREAD

| | Size | Load/Speed Index | Manufacture | Model | Type* | Production Date | Tread Depth (mm) |
|---|---|---|---|---|---|---|---|
| Rear Left | 185/65R15 | 88H | Goodyear | Assurance | V | 4922 | 1 mm |

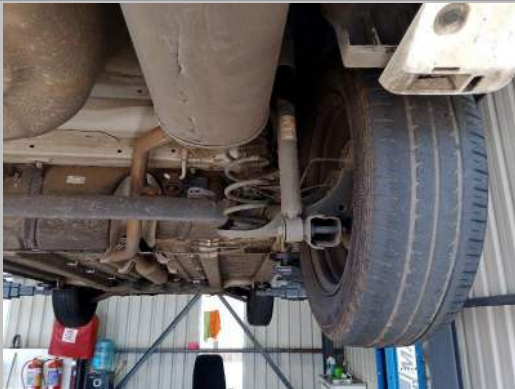
RR TYRE TREAD

| | Size | Load/Speed Index | Manufacture | Model | Type* | Production Date | Tread Depth (mm) |
|---|---|---|---|---|---|---|---|
| Rear Right | 185/65R15 | 88H | Goodyear | Assurance | V | 4822 | 1 mm |

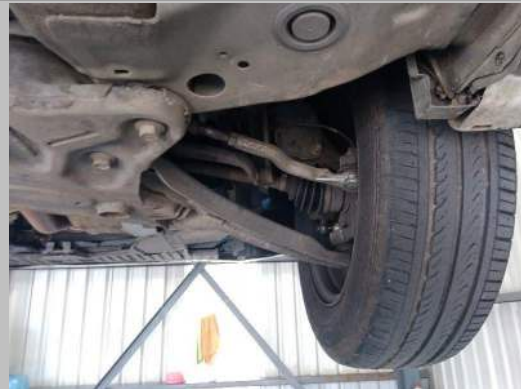
RF TYRE TREAD

| | Size | Load/Speed Index | Manufacture | Model | Type* | Production Date | Tread Depth (mm) |
|---|---|---|---|---|---|---|---|
| Front Right | 185/65R15 | 88H | Goodyear | Assurance | V | 4922 | 3 mm |

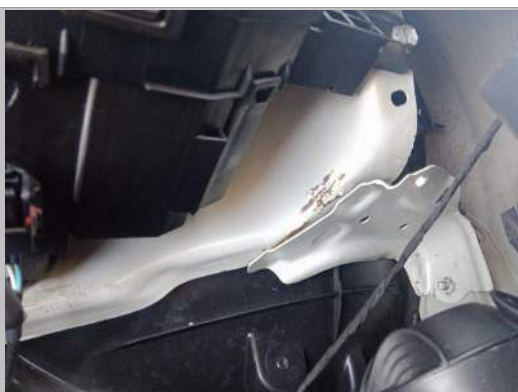
| Front Fender Left / Inner Tray Damaged | Repair |

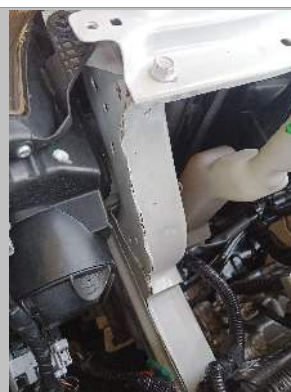
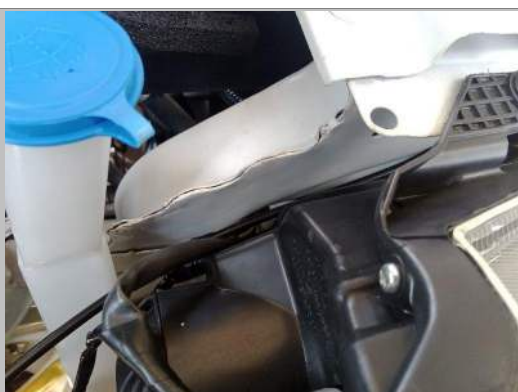
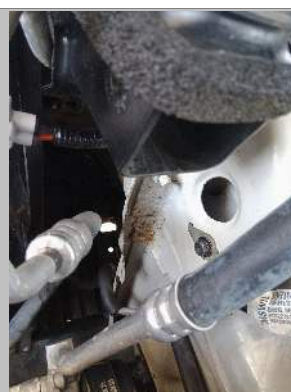
| Radiator Cross Member Damaged | Replace |

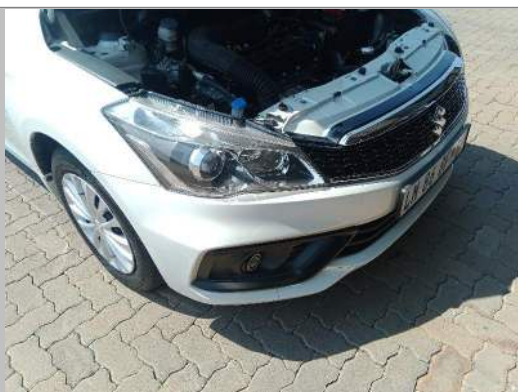
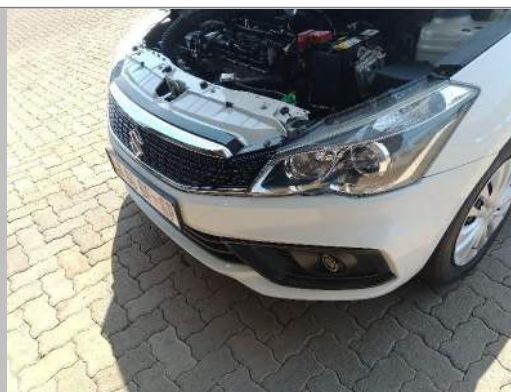
| Front Bumper Damaged | Repair |

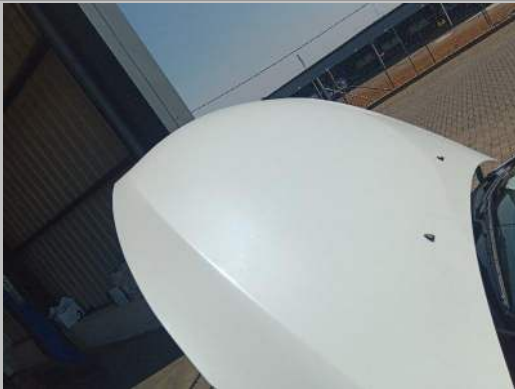
| Bonnet Damaged | Repair |

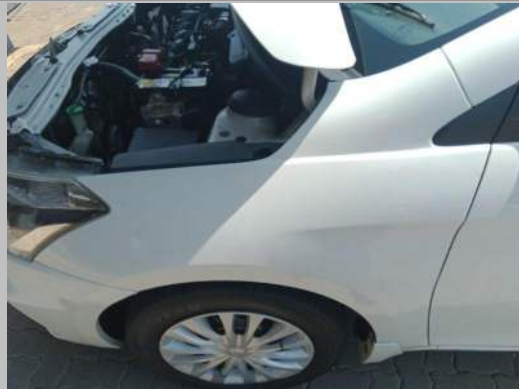
| Front Fender Left Damaged | Repair |

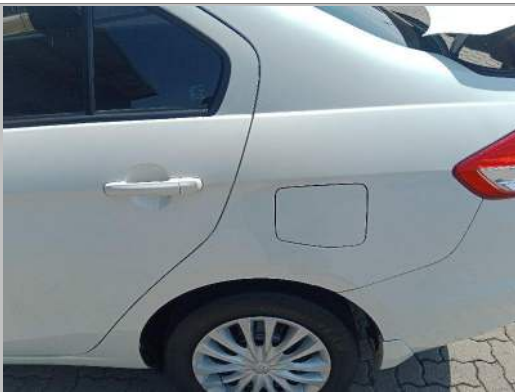
| Rear Fender Left Damaged | Repair |

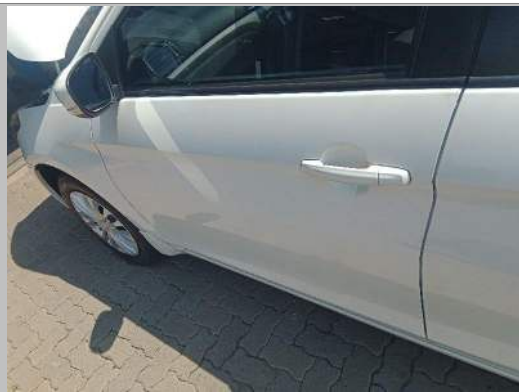
| Door Front Left Damaged | Repair |

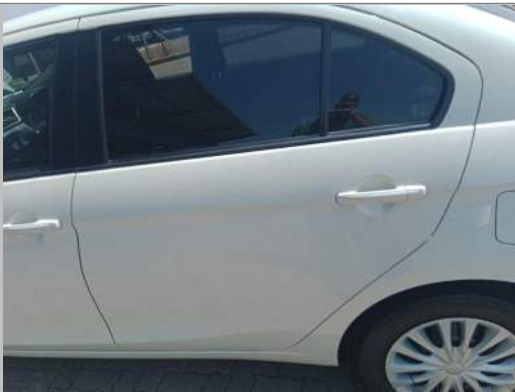
| Door Rear Left Damaged | Repair |

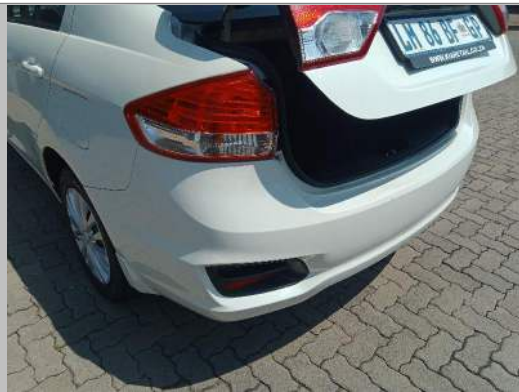
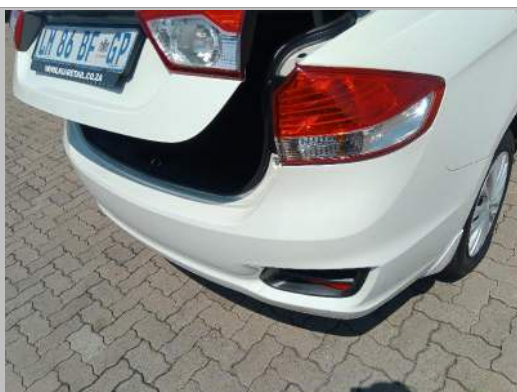
| Rear bumper Damaged | Repair |

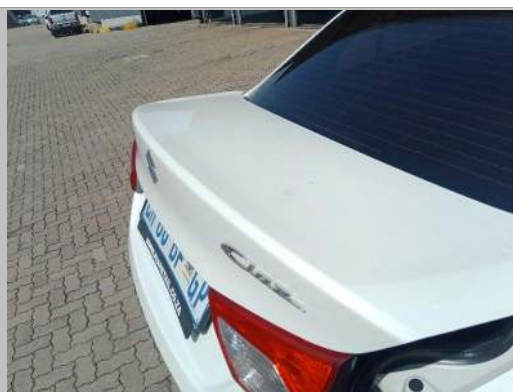
| Boot Lid / Hatch door Damaged | Repair |

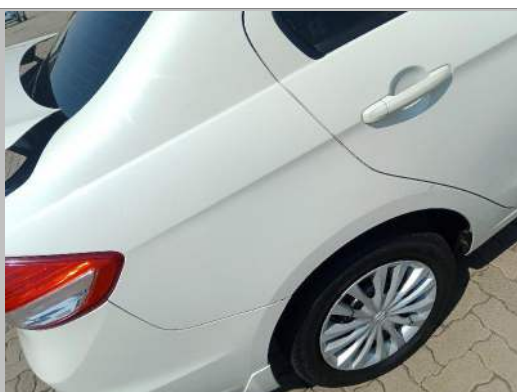
| Rear Fender Right Damaged | Repair |

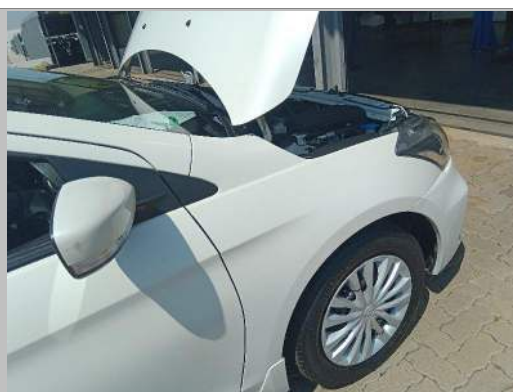
| Front Fender Right Damaged | Repair |

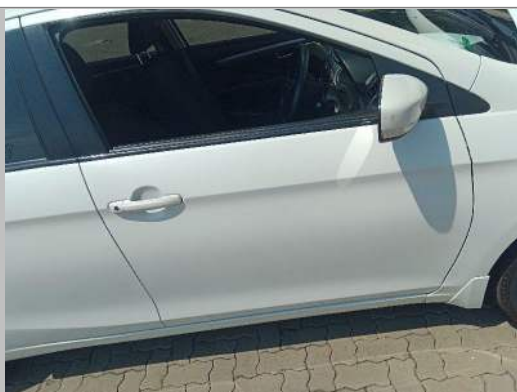
| Door Front Right Damaged | Repair |

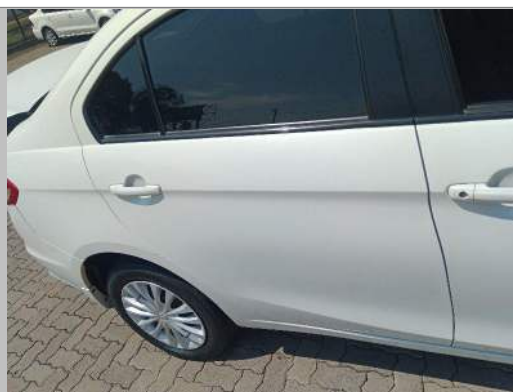
| Door Rear Right Damaged | Repair |

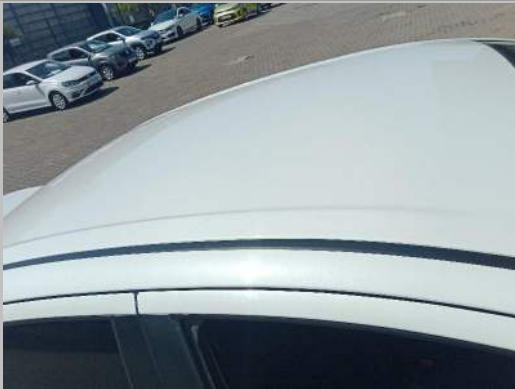
| Roof Damaged | Repair |

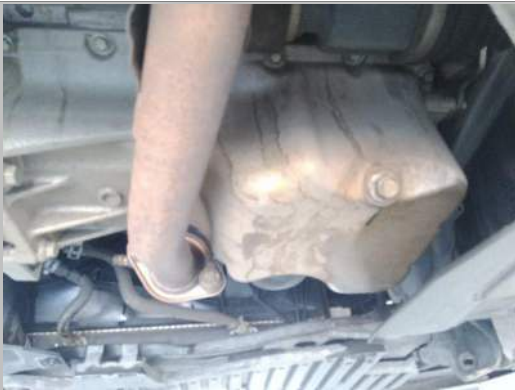
| Engine Oil Leak | Repair |
