CONDITION REPORT

Report No:  
2017305339  
DATE  
30/09/2026

MFC Auction House  
M57 Pretoria Rd, Glenmarais, KEMPTON PARK  
Gauteng

| Model | ERTIGA 1.5 GL MPV AT [2022-2025] | Register Number | |

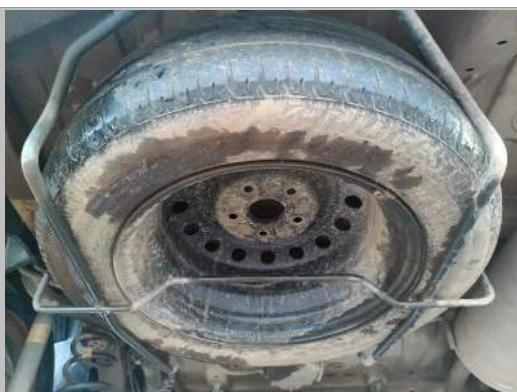
Sparewheel

| | Size | Load/Speed Index | Manufacture | Model | Type* | Production Date | Tread Depth (mm) |
|---|---|---|---|---|---|---|---|
| Spare | 185/65R15 | 88H | Bridgestone | Ecopia | V | 0000 | 1 mm |

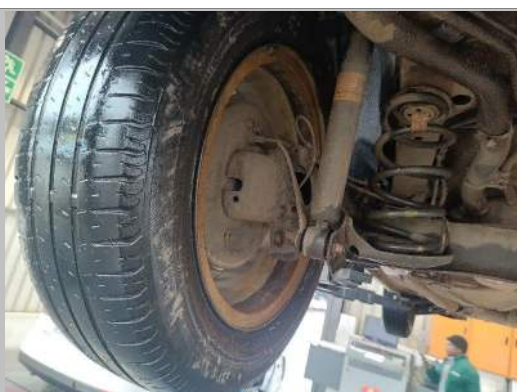
LR TYRE TREAD

| | Size | Load/Speed Index | Manufacture | Model | Type* | Production Date | Tread Depth (mm) |
|---|---|---|---|---|---|---|---|
| Rear Left | 185/65R15 | 88H | Bridgestone | Ecopia | V | 1623 | 1 mm |

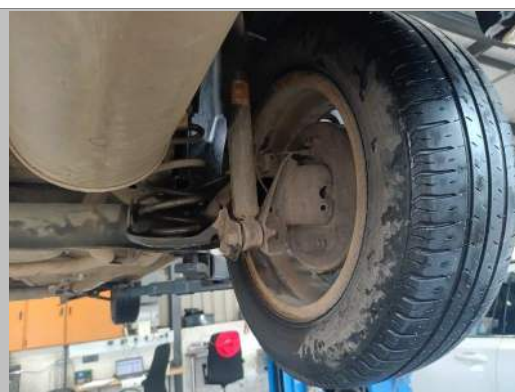
RR TYRE TREAD

| | Size | Load/Speed Index | Manufacture | Model | Type* | Production Date | Tread Depth (mm) |
|---|---|---|---|---|---|---|---|
| Rear Right | 185/65R15 | 88H | Bridgestone | Ecopia | V | 1623 | 3 mm |

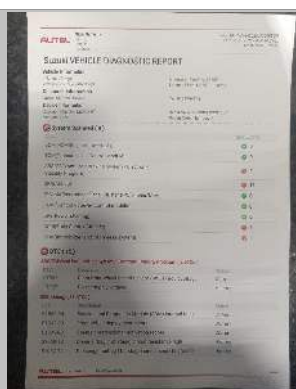
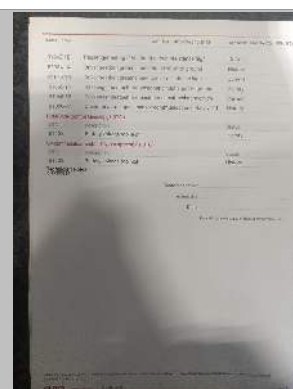
Diagnostic Report page 1

| No | System | Code | Description | Status |
|---|---|---|---|---|
| 1 | AIRBAG | B1032-00 | FRONT AIRBAG DEPLOYMENT RECORD | |

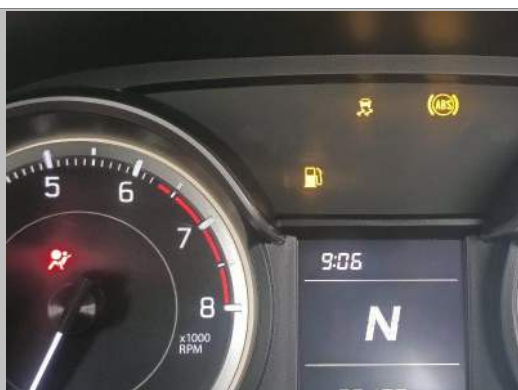
| Warning lights illuminated | Repair |

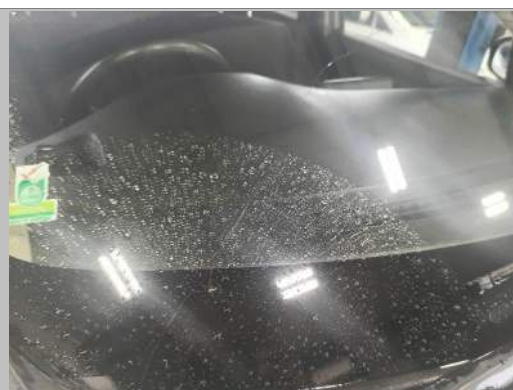
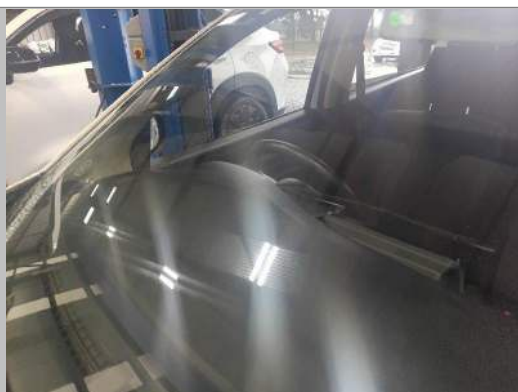
| Windscreen Cracked | Replace |

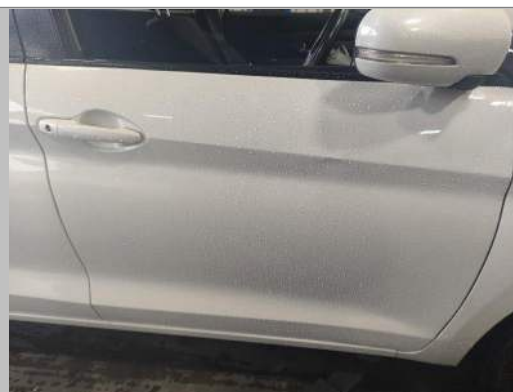
| Door Front Right Dented | Repair |

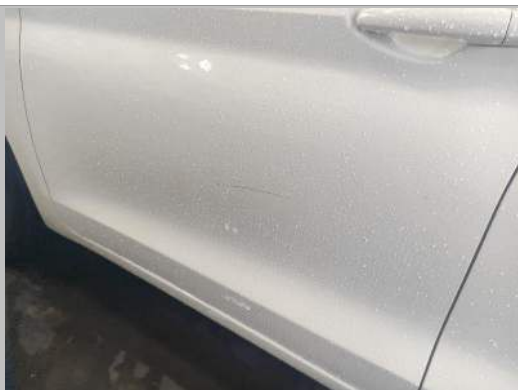
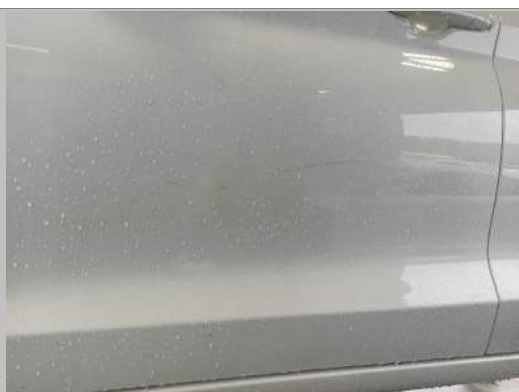
| Door Front Left Paintwork • Scratched | Repair |

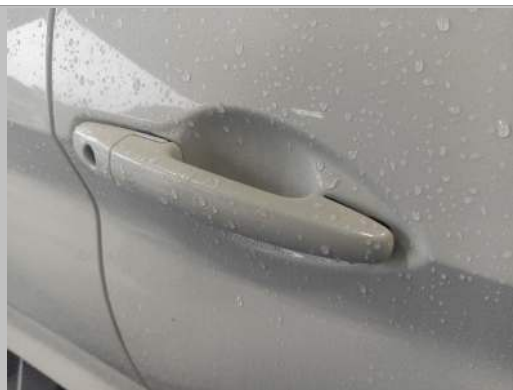
| Door Handle Front Right Damaged | Repair |

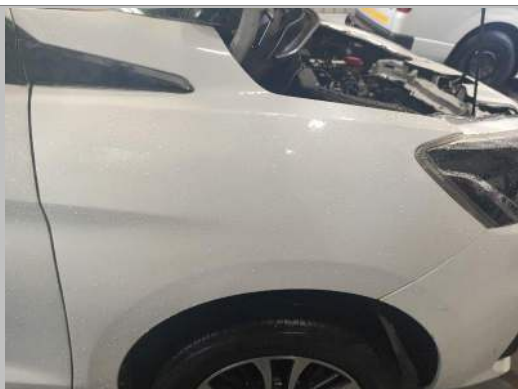
| Front Fender Right Residual Traces of Repair | Repair |

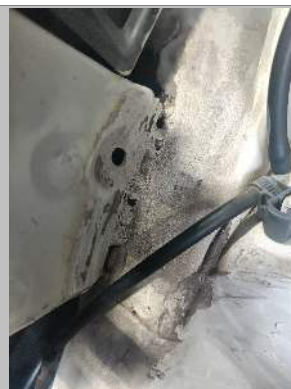
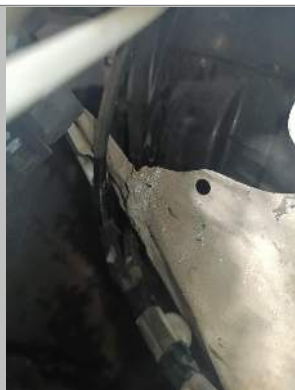
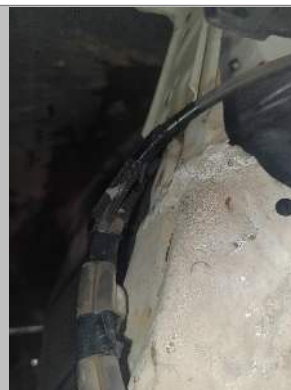
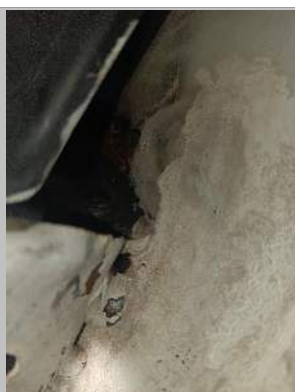
| Front Fender Right / Inner Tray Welded | Repair |

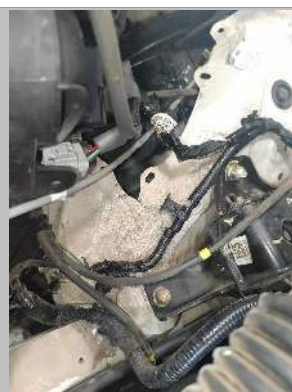
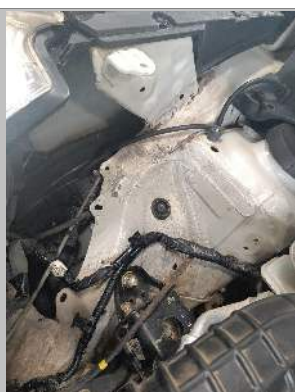
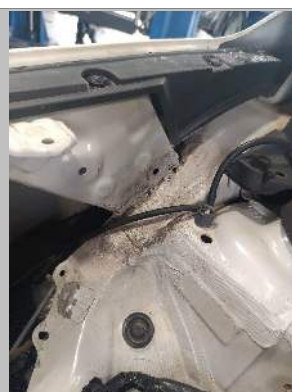
| Bonnet slam plate (Shock tower/ Inner tray) Residual | Repair |
| Traces of Repair | |

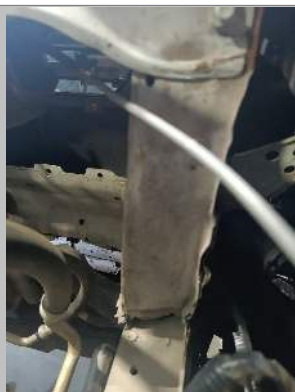
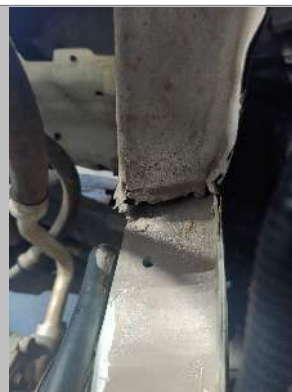
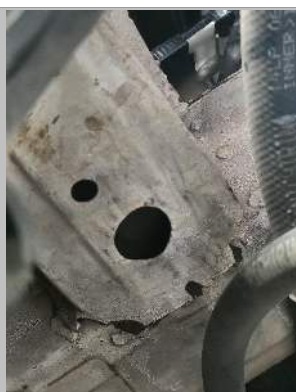
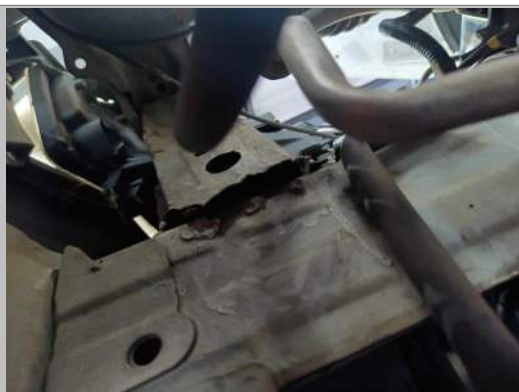
| Radiator Cross Member Residual Traces of Repair | Repair |

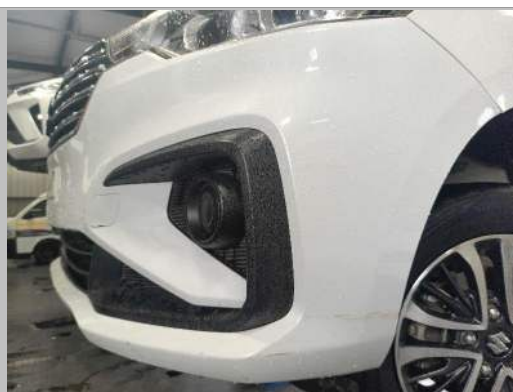
| Front Bumper Paintwork • Scratched | Repair |

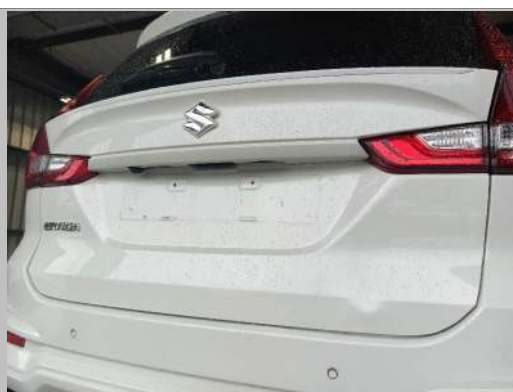
| Boot Lid / Hatch door Dented | Repair |

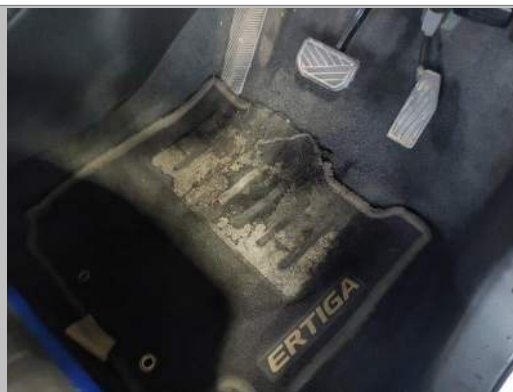
| Carpet Front Torn / Cut | Repair |
