## CONDITION REPORT

Report No:  
2017304546  
DATE  
29/09/2026

| Manufacturer | SUZUKI | Registration Number | MK08CGGP |
| Model | ERTIGA 1.5 GA MPV [2022-2025] | Register Number | |

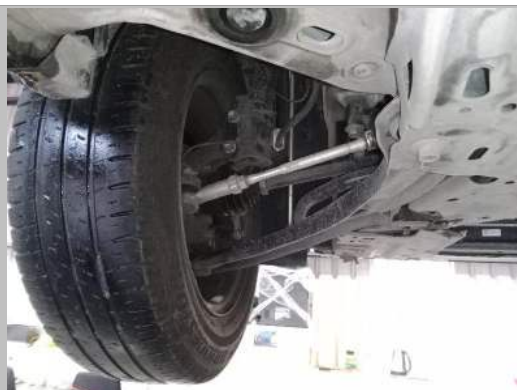
LF TYRE TREAD

| | Size | Load/Speed Index | Manufacture | Model | Type* | Production Date | Tread Depth (mm) |
|---|---|---|---|---|---|---|---|
| Front Left | 185/65 R15 | 88H | Bridgestone | Ecopia | V | 1325 | 2 mm |

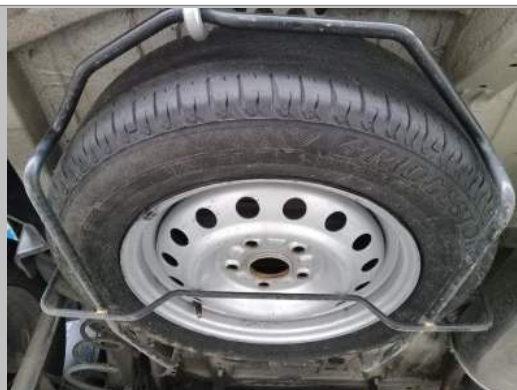
Spare Wheel

| | Size | Load/Speed Index | Manufacture | Model | Type* | Production Date | Tread Depth (mm) |
|---|---|---|---|---|---|---|---|
| Spare | 185/65 R15 | 88H | Bridgestone | Ecopia | V | 1325 | 2 mm |

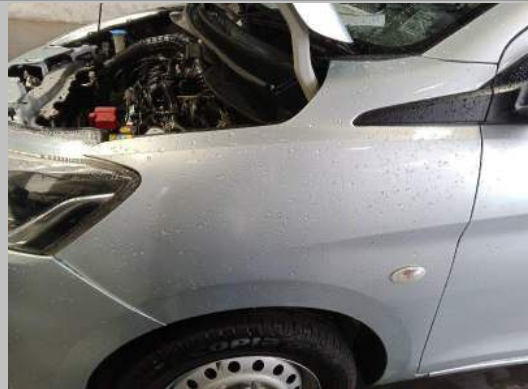
| Front Fender Left Residual Traces of Repair | Repair |

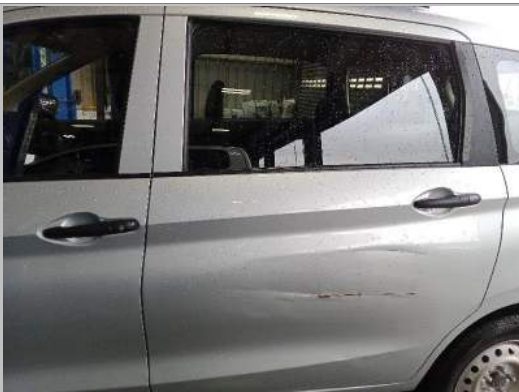
| Door Rear Left Damaged | Repair |

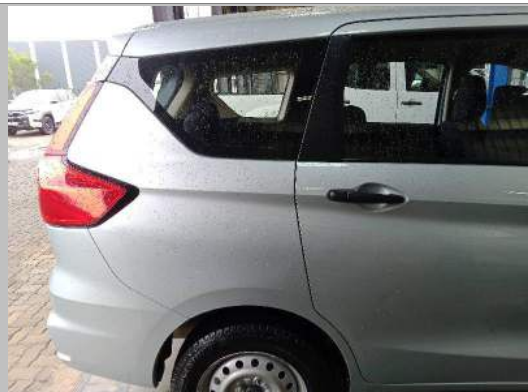
| Rear Fender Right Dented | Repair |

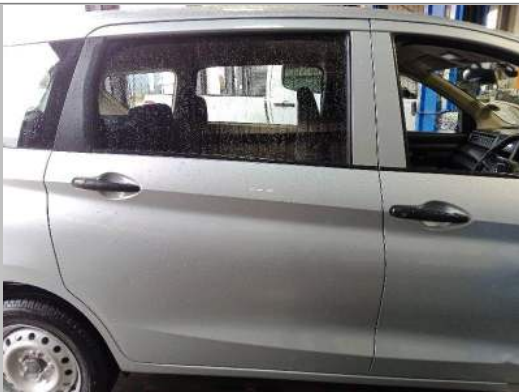
| Door Rear Right Dented | Repair |

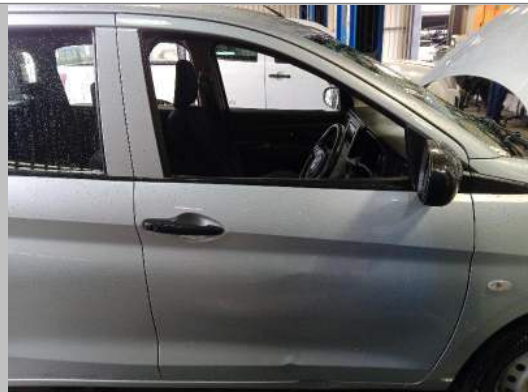
| Door Front Right Damaged | Repair |

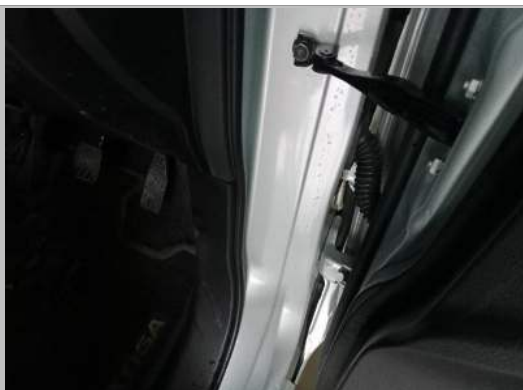
| A • Pillar Right Damaged | Repair |

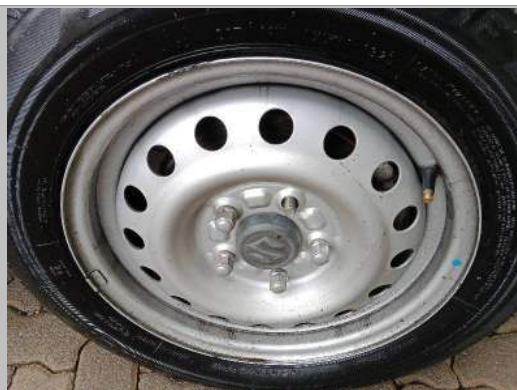
| Bolt(s) / Nut(s) Front Wheel Right Missing | Replace |

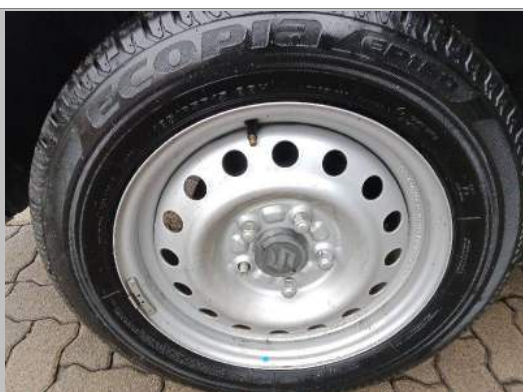
| Bolt(s) / Nut(s) Rear Wheel Right Missing | Replace |

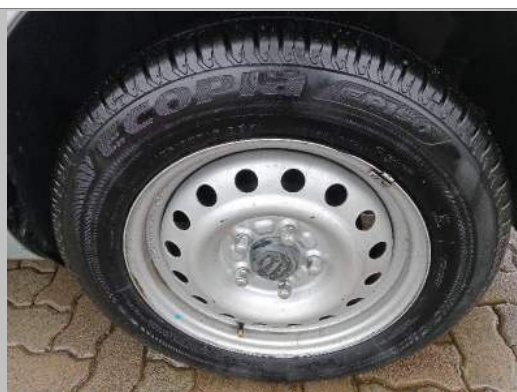
| Rim Rear Left Dented | Repair |

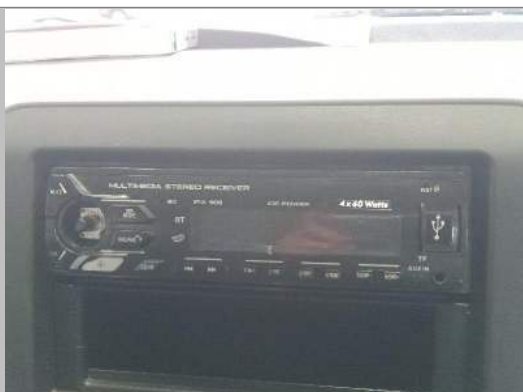
| Radio/CD/USB Defective | Repair |

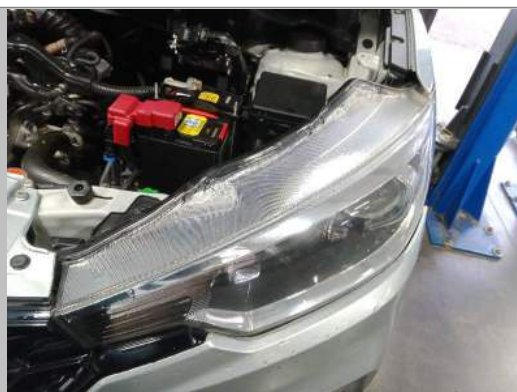
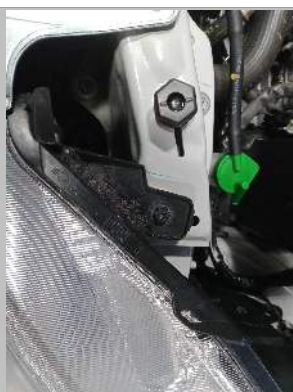
| Headlight Right Damaged | Replace |

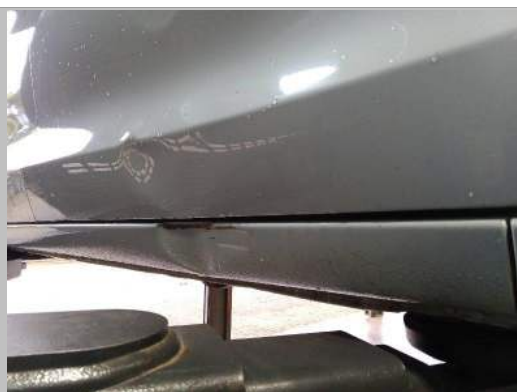
| Sill Panel Right Damaged | Repair |

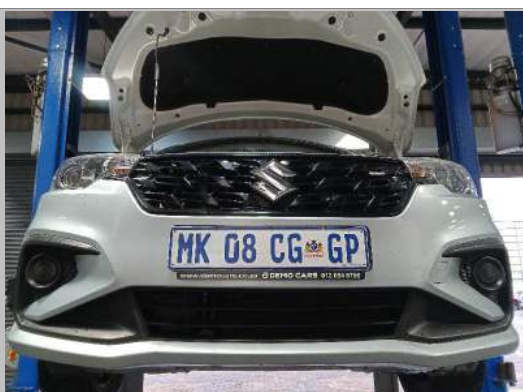
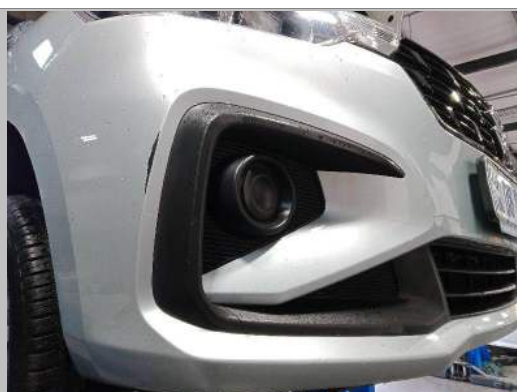
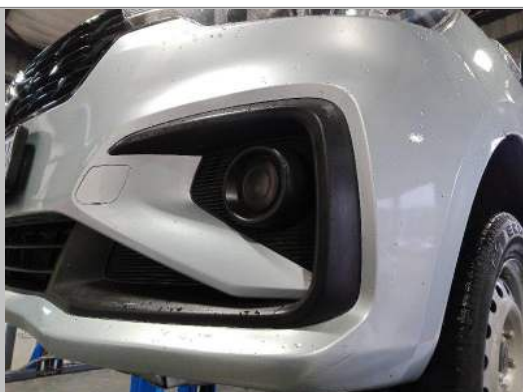
| Front Bumper Paintwork • Scratched | Repair |

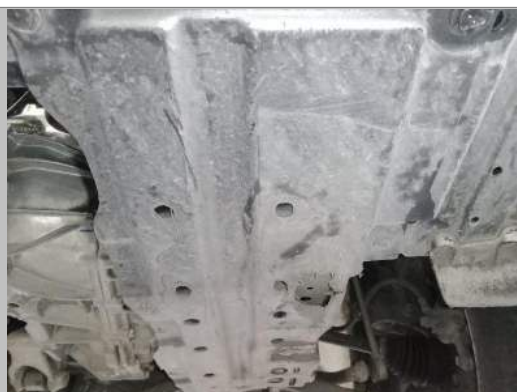
| Belly plates Damaged | Replace |
