## CONDITION REPORT

Report No:  
2017295717  
DATE  
08/09/2026

| Manufacturer | SUZUKI | Registration Number | DD06XDZN |
| Model | ERTIGA 1.5 GA MPV [2022-2025] | Register Number | |

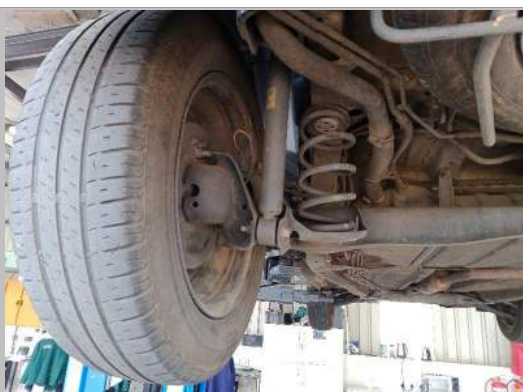
LR TYRE TREAD

| | Size | Load/Speed Index | Manufacture | Model | Type* | Production Date | Tread Depth (mm) |
|---|---|---|---|---|---|---|---|
| Rear Left | 185/65 R15 | 88H | Bridgestone | Ecopia | V | 1225 | 1 mm |

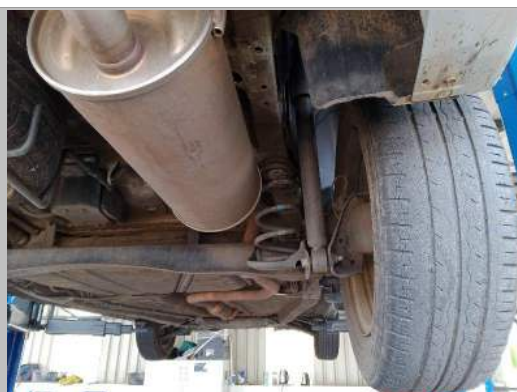
RR TYRE TREAD

| | Size | Load/Speed Index | Manufacture | Model | Type* | Production Date | Tread Depth (mm) |
|---|---|---|---|---|---|---|---|
| Rear Right | 185/65 R15 | 88H | Kumho | Solus | V | 2516 | 1 mm |

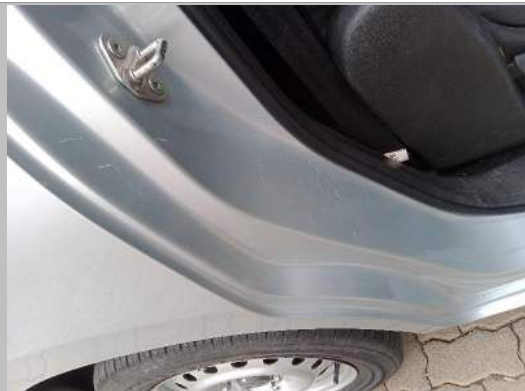
| C • Pillar Right Paintwork • Scratched | Repair |

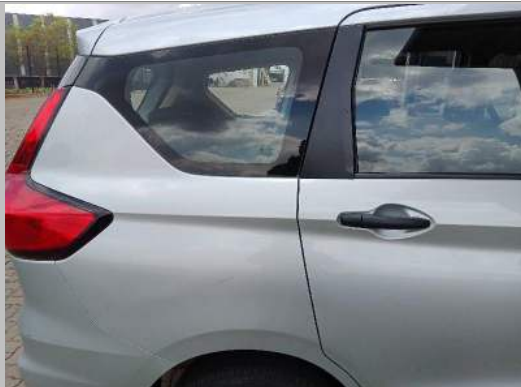
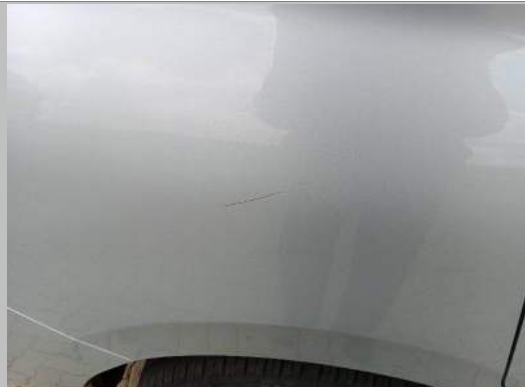
| Rear Fender Right Paintwork • Scratched | Repair |

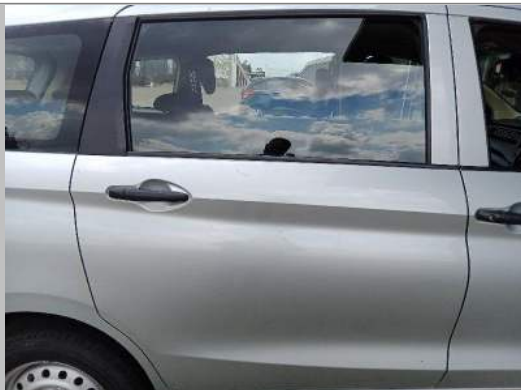
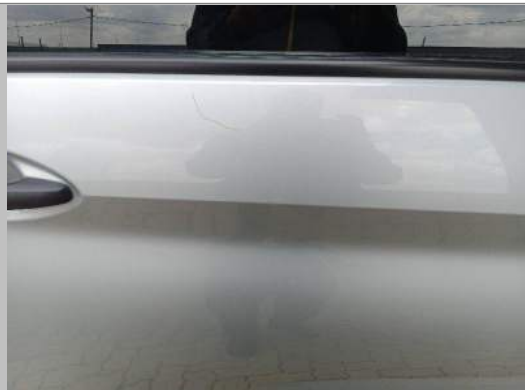
| Door Rear Right Paintwork • Scratched | Repair |

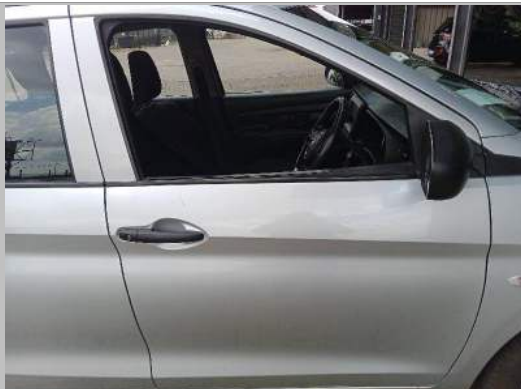
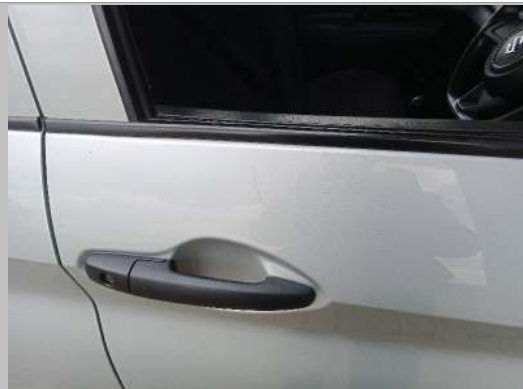
| Door Front Right Paintwork • Scratched | Repair |

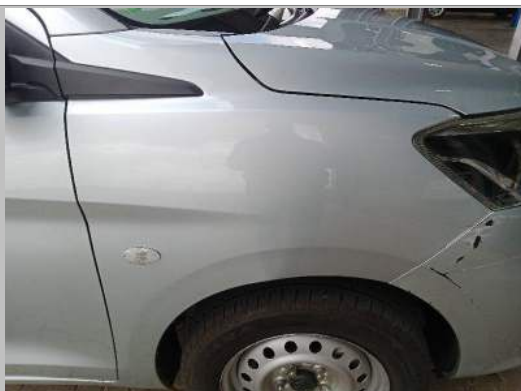
| Front Fender Right Damaged | Repair |

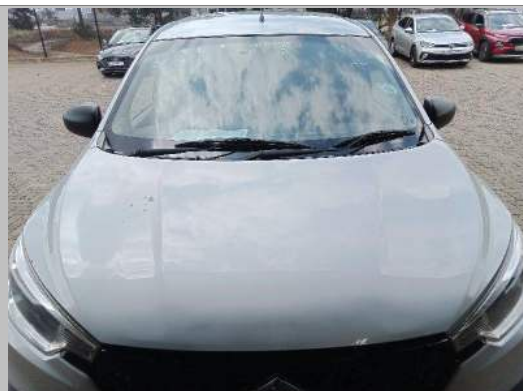
| Bonnet Damaged | Repair |

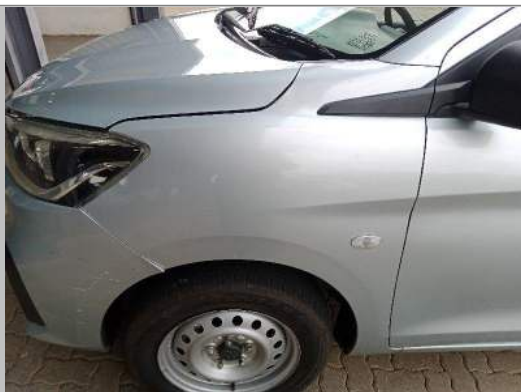
| Front Fender Left Residual Traces of Repair | Repair |

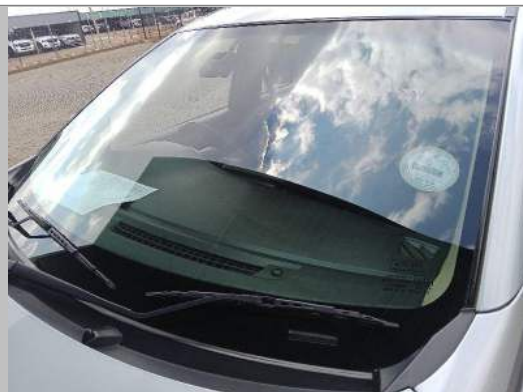
| Windscreen Chipped | Repair |

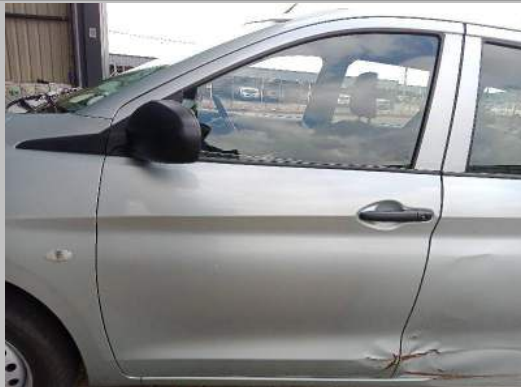
| Door Front Left Damaged | Repair |

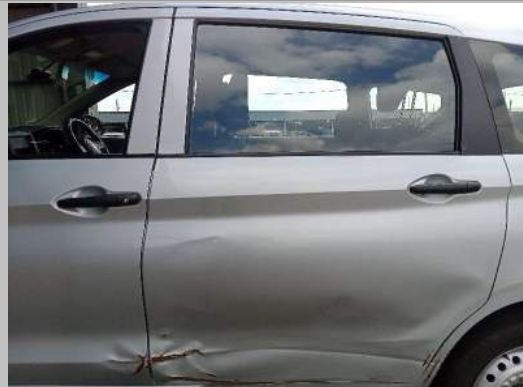
| Door Rear Left Damaged | Repair |

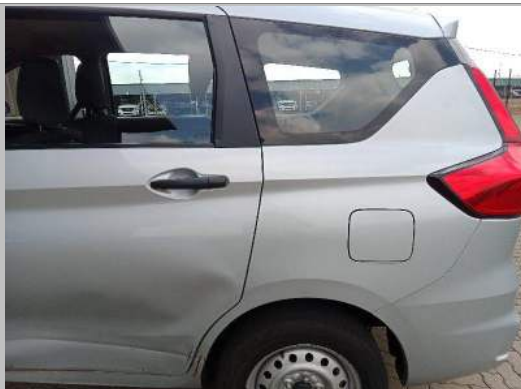
| Rear Fender Left Damaged | Repair |

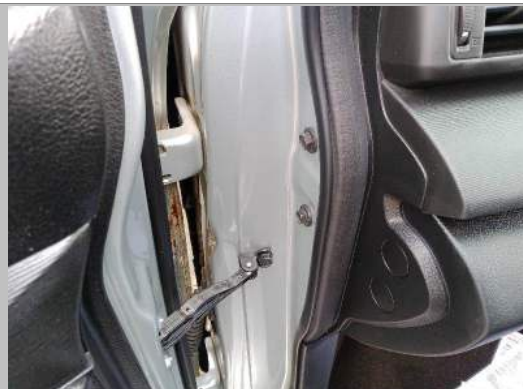
| A • Pillar Left Damaged | Repair |

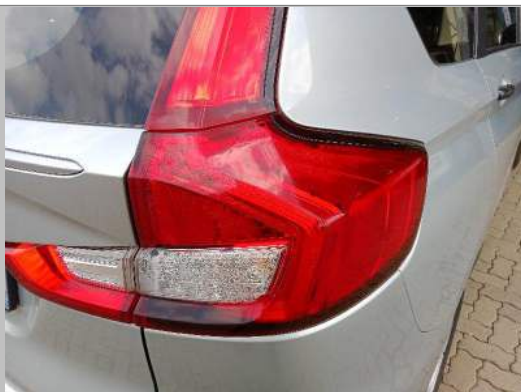
| Tail Light Right Damaged | Replace |

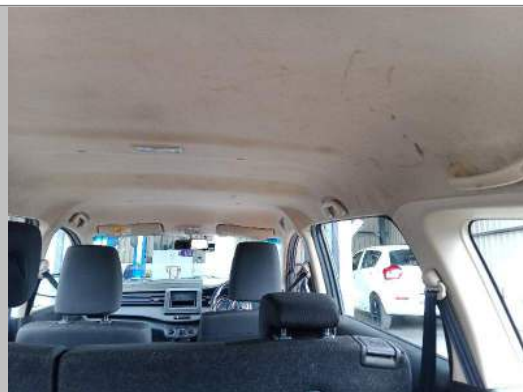
| Hood Lining Dirty | Repair |

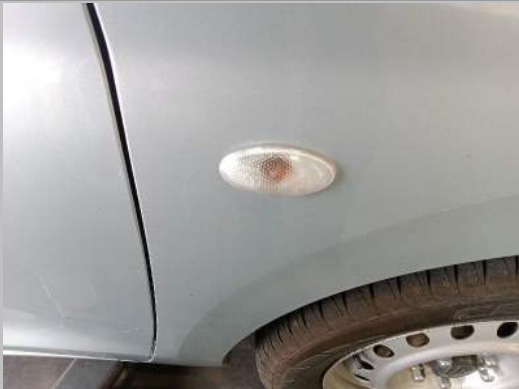
| Indicator Light Front Right Damaged | Replace |

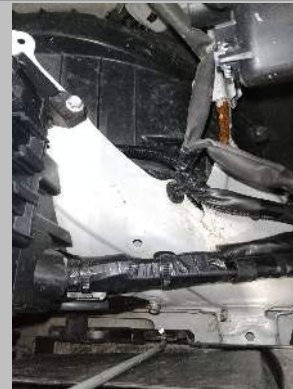
| Front Fender Left / Inner Tray Damaged | Repair |

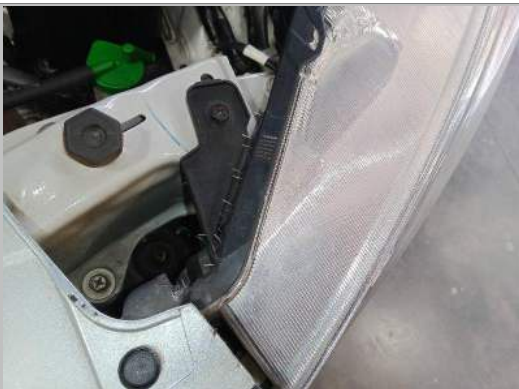
| Headlight Left Damaged | Replace |

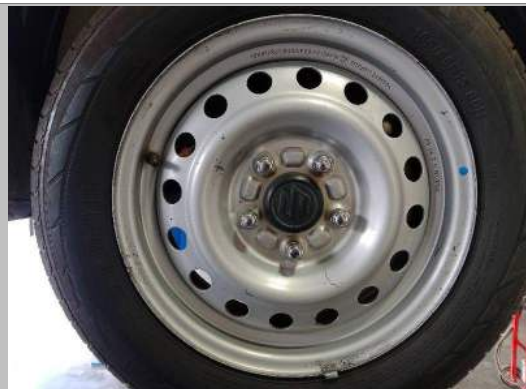
| Rim Front Right Dented | Repair |

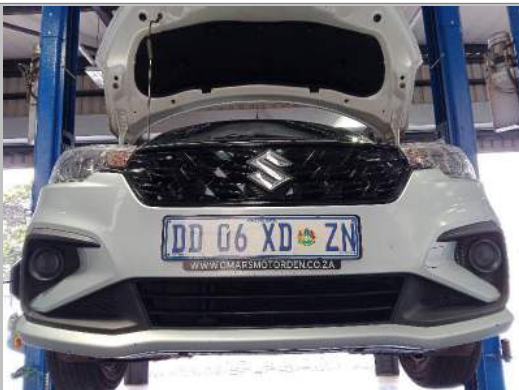
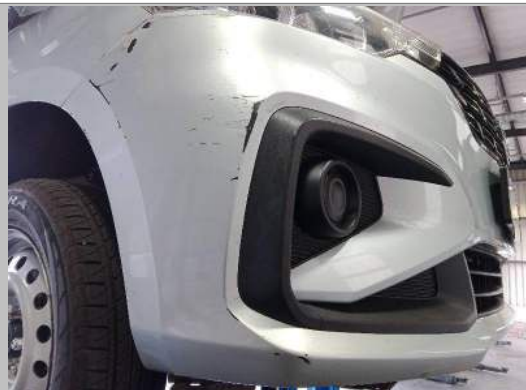
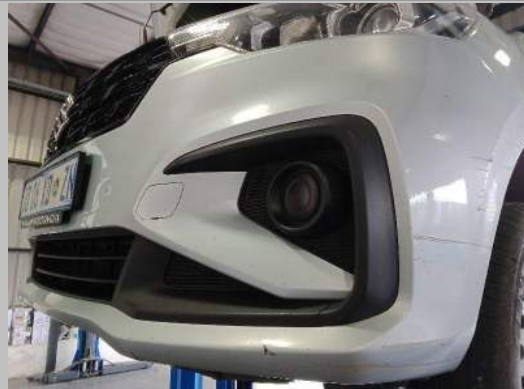
| Front Bumper Paintwork • Scratched | Repair |

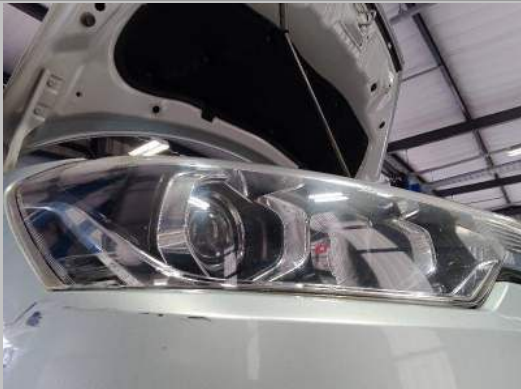
| Headlight Right Scratched | Replace |

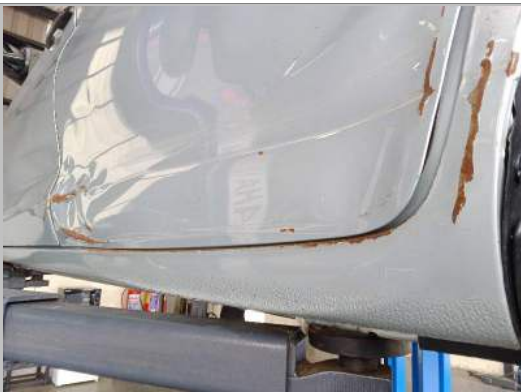
| Sill Panel Left Damaged | Repair |

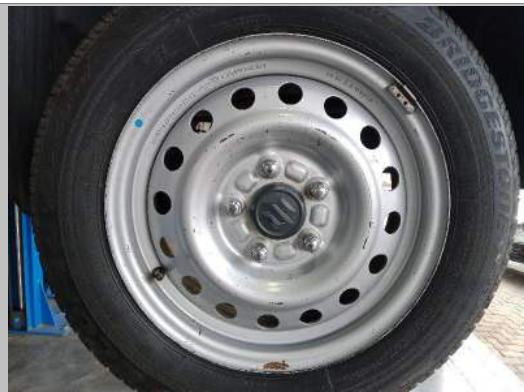
| Rim Rear Left Dented | Repair |

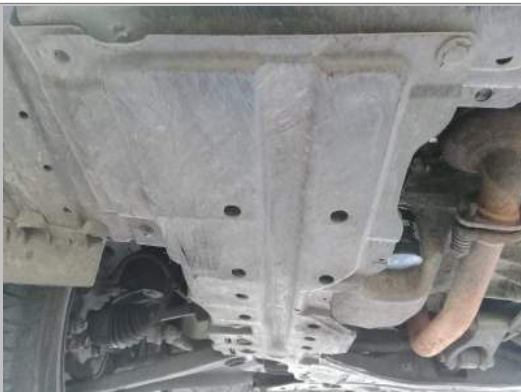
| Belly plates Damaged | Repair |

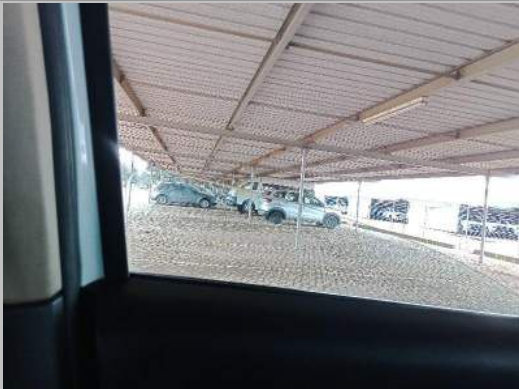
| Window Front Door Left Defective | Repair |
