MFC Auction House
M57 Pretoria Rd, Glenmarais, KEMPTON PARK
Gauteng

DEKRA MFC
M57 Pretoria Rd - 1619
KEMPTON PARK - GT
08610 33572

Vehicle Type	PASSENGER VEHICLE	Registered Owner	
Manufacturer	SUZUKI	Registration Number	NONE
Model	S-PRESSO 1.0 GL+ [2020-2022]	Register Number	
VIN	MA3RFL41S00372834	Date Of First Licensing	
Engine Number		Last COR	
Doors	5	License Expiry Date	
Color	GREY	Power / Displacement	
Year Model	2022	Paint Finish	TWO COAT UNI
Km Reading	144,899 KM	Fuel	PETROL
Cab / Body Type	HATCHBACK	Transmission	MANUAL

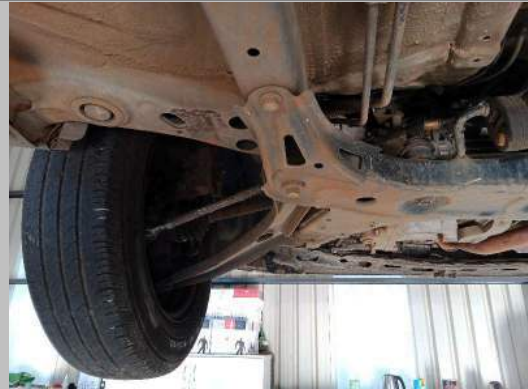
LF TYRE TREAD

Size	Load/Speed Index	Manufacture	Model	Type*	Production Date	Tread Depth (mm)
Front Left	165/70 R14	81S	MRF	ZVTV	V	1722	2 mm
Front Right	165/70 R14	81T	Ceat	Ecodrive	V	2023	5 mm
Rear Left	165/70 R14	81S	MRF	Ecotred	V	1722	5 mm
Rear Right	165/70 R14	81S	MRF	ZVTV	V	1723	4 mm

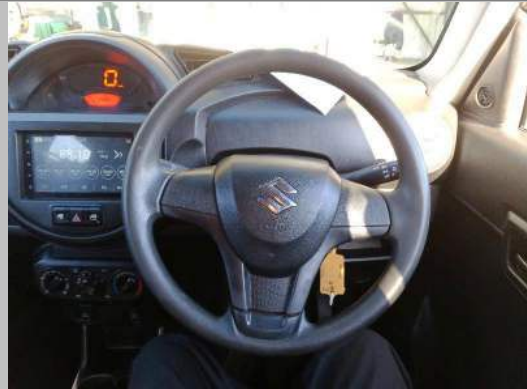
Damage	Repair Way
Engine Oil Leak	Repair
Air Conditioner Insufficient	Replace
Seat Front Left Damaged	Repair
Seat Front Right Damaged	Repair
Seat Rear Damaged	Repair
Door Lock Front Right Damaged	Replace
Boot Carpet Damaged	Repair
Mirror Adjusters Damaged	Replace
Steering Wheel Trim Defective	Repair
Side Mirror Left Paintwork • Scratched	Repair
Side Mirror Right Paintwork • Scratched	Repair
Front Bumper Damaged	Repair
Bonnet Paintwork • Chipmarks	Repair
B • Pillar Right Dented	Repair
Front Fender Left Dented	Repair
Front Fender Right Paintwork • Scratched	Repair
Rear Fender Left Dented	Repair
Rear Fender Right Dented	Repair
Door Front Left Damaged	Repair
Door Front Right Paintwork • Scratched	Repair

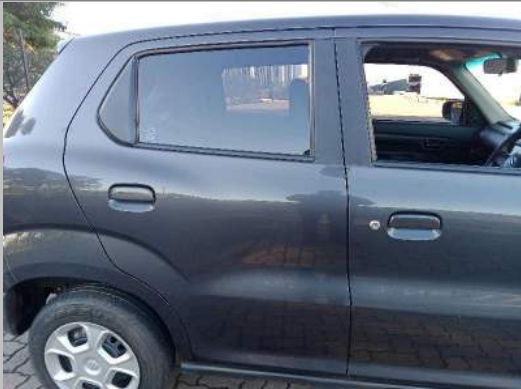
Damage	Repair Way
Door Rear Left Paintwork • Scratched	Repair
Door Rear Right Dented	Repair
Boot Lid / Hatch door Damaged	Repair
Rear bumper Damaged	Repair
Inner Boot Floor Pan and Spare Wheel Well Dented	Repair
Sill Panel Left Dented	Repair
Roof Paintwork • Scratched	Repair
Rear Axle Welded	Replace
Tyre Front Left Damaged	Replace
Tyre Rear Left Damaged	Replace
Main Beam Left Damaged	Repair
Main Beam Right Scratched	Repair
Chassis Dented	Repair
Silencer Welded	Replace
Radiator Cradle Damaged	Replace
Clutch Operation Incorrect	Repair
Body and Exterior	Vehicle license disk missing
Tyres and rims	Spare wheel missing
Engine	Engine bay dirty.
Engine	Fan Cowley damaged
Body and Exterior	Dents and scratches on some body panels
Body and Exterior	Signs of impact damage to front of vehicle
Engine	Foreign substance inside the radiator
Interior	Vehicle interior dirty and some panels scratched
Interior	Steering column cover strapped with cable ties
