CONDITION REPORT

Report No: 2016835778

DATE
09/04/2025

Vehicle Type	PASSENGER VEHICLE	Registered Owner	
Manufacturer	FORD	Registration Number	BG43TWGP
Model	FIGO 1.4 TREND 5-DR [2010-2012]	Register Number	
VIN	MAJ1XXMRJ1BC02552	Date Of First Licensing	
Engine Number		Last COR	
Doors	5	License Expiry Date	31/03/2024
Color	BLUE	Power / Displacement	
Year Model	2011	Paint Finish	C - COMMON
Km Reading	338,171 KM	Fuel	PETROL
Cab / Body Type	HATCHBACK	Transmission	MANUAL

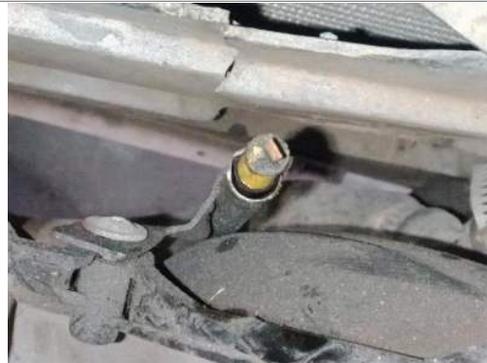
Damage	Repair Way
Door Rear Left Paintwork • Scratched	Repair
Door Rear Right Paintwork • Scratched	Repair
Boot Lid / Hatch door Residual Traces of Repair	Repair
Rear bumper Residual Traces of Repair	Repair
Inner Boot Floor Pan and Spare Wheel Well Residual Traces of Repair	Repair
Sill Panel Left Dented	Repair
Sill Panel Right Dented	Repair
Steering Rack Boot Right Damaged	Replace
Tyre Rear Left Smooth	Replace
Bolt(s) / Nut(s) Front Wheel Left Missing	Replace
Bolt(s) / Nut(s) Front Wheel Right Missing	Replace
CV Joint(s) Boot(s) Front Left (inner/outer) Damaged	Replace
CV Joint(s) Boot(s) Front Right (inner/outer) Loose / Excessive Play	Repair
Gear Selections Insufficient	Repair
Body exterior	Vehicle got some scratches, stone chips and dents
Body exterior	Signs of spray work done on some body panels
Body exterior	Signs of repair work done on some body panels
Dipstick damage	Replace
L/F kick panel loose	Repair

Dipstick damage

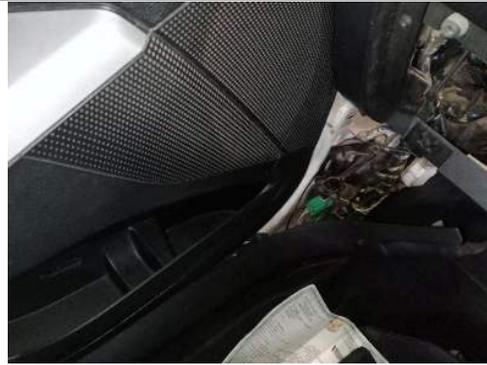
L/F kick panel loose

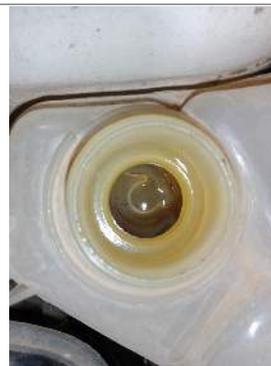
Damage	Repair Way
Engine Oil Leak	Repair
Caps Missing	Repair
Water level Insufficient	Repair
Air conditioner pipes Damaged	Repair
Center Console / Cubbyhole + Lid Damaged	Repair
Indicator Light Front Left Damaged	Replace
Indicator Light Front Right Damaged	Replace
Tail Light Left Damaged	Replace
Tail Light Right Cracked	Repair
Interior Mirror Missing	Replace
Side Mirror Left Paintwork • Scratched	Repair
Rear Upper Valance Welded	Repair
Front Bumper Paintwork • Scratched	Repair
Bonnet Paintwork • Scratched	Repair
Front Fender Left Paintwork • Scratched	Repair
Front Fender Right Paintwork • Scratched	Repair
Rear Fender Left Residual Traces of Repair	Repair
Rear Fender Right Dented	Repair
Door Front Left Dented	Repair
Door Front Right Paintwork • Scratched	Repair

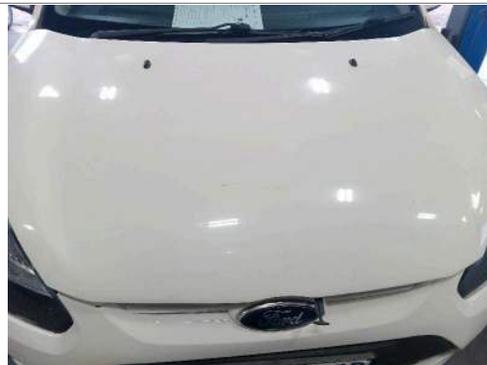
Loose wires in the boot	Repair
L/F fender liner damage	Replace
Water leak	Vehicle got water leak can't pin point water leak
ABS light on	Repair
Bonnet not closing properly	Repair
Both front fog lights malfunction	Repair
Front suspension noisy	Repair
Airbag light on	Repair

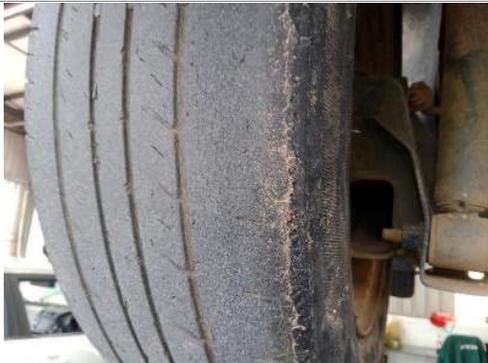
Tyre Rear Left

Size	Load/Speed Index	Manufacture	Model	Type*	Production Date	Tread Depth (mm)
Front Left	175/65R14	86T	Roadshine	Rs906	V	1628	2 mm
Front Right	175/65R14	86T	Roadshine	Rs906	V	1723	3 mm
Rear Left	175/65R14	82H	Rapid	P309	V	1419	0 mm
Rear Right	175/65R14	86T	Roadshine	Rs906	V	1623	4 mm
