## CONDITION REPORT

Report No: 2016337596

MFC Auction House  
M57 Pretoria Rd, Glenmarais, KEMPTON PARK  
Gauteng

Vehicle Type	PASSENGER VEHICLE	Registered Owner	MFC AUCTION HOUSE
Manufacturer	FORD	Registration Number	DW22ZLGP
Model	IKON	Register Number	
VIN	MAJBXXMRTBFE28629	Date Of First Licensing	
Engine Number		Last COR	
Doors	4	License Expiry Date	31/03/2024
Color	WHITE	Power / Displacement	
Year Model		Paint Finish	TWO COAT UNI
Km Reading	291,972 KM	Fuel	PETROL
Cab / Body Type	SEDAN	Transmission	MANUAL

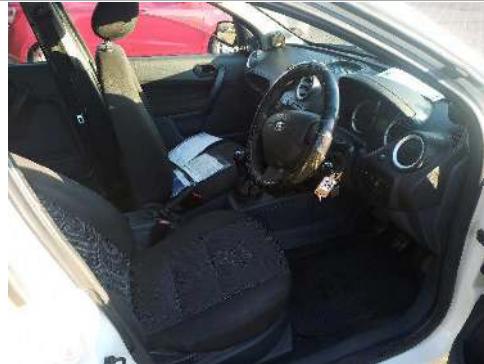
INTERIOR (FRONT DRIVER DOOR)

Damage		Repair Way
Vehicle		Vehicle electronics malfunctioning.
Vehicle		Driver side door does not open from outside
Airbag warning light illuminated		Repair

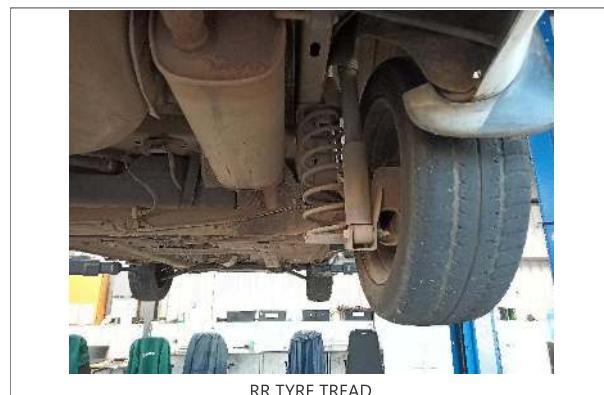
RR TYRE TREAD

Size	Load/Speed Index	Manufacture	Model	Type*	Production Date	Tread Depth (mm)
Front Left	195/55R15	85V	Sumitomo	Radial	V	1321	2 mm
Front Right	195/55R15	85V	Sumitomo	Radial	V	1321	2 mm
Rear Left	195/55R15	82V	Sumitomo	Radial	V	1321	2 mm
Rear Right	195/55R15	85H	Goodyear	Eagle	V	1215	0 mm

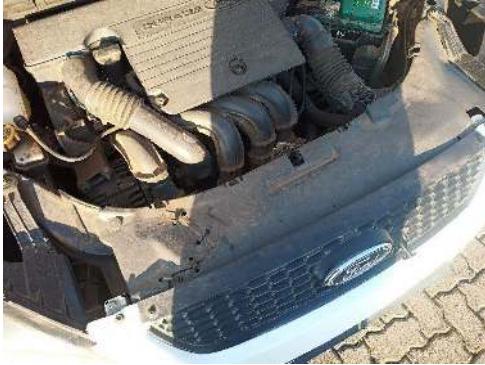
Damage	Repair Way
Engine Management Lights Set	Repair
Tail Light Right Damaged	Replace
Headlight Right Damaged	Replace
Front Bumper Damaged	Repair
Bonnet Damaged	Repair
Bonnet slam plate (Shock tower/ Inner tray) Damaged	Repair
B • Pillar Right Damaged	Repair
C • Pillar Right Damaged	Repair
Front Fender Left Damaged	Repair
Front Fender Right Damaged	Repair
Rear Fender Left Damaged	Repair
Rear Fender Right Damaged	Repair
Door Front Left Damaged	Repair
Door Front Right Damaged	Repair
Door Rear Left Damaged	Repair
Door Rear Right Damaged	Repair
Boot Lid / Hatch door Damaged	Repair
Rear bumper Damaged	Repair
Roof Damaged	Repair
Windscreen Damaged	Repair
Brake disc 1. Axle left Worn	Replace
Brake disc 1. Axle right Worn	Replace
Tyre Rear Right Worn	Replace
Gearbox Oil Leak	Replace
Engine Performance Insufficient	Repair
Engine Noise Excessive	Repair
Body and exterior	Minor dents and scratches and stone chips.
Body and exterior	Signs of repair work done to somebody panels.
