## CONDITION REPORT

Report No:  
2017303398  
DATE  
25/09/2026

| Manufacturer | FORD | Registration Number | KG385MP |
| Model | FIGO 1.5 TREND FREESTYLE 5-DR [2020-2021] | Register Number | |

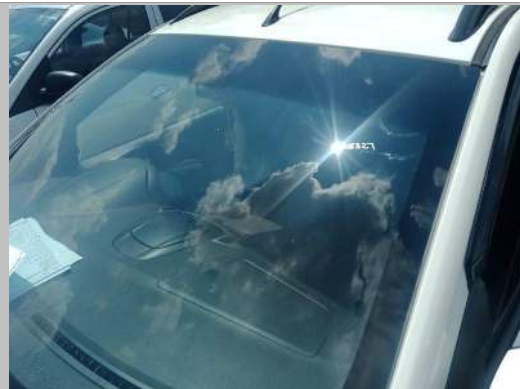
LICENSE DISC MISSING

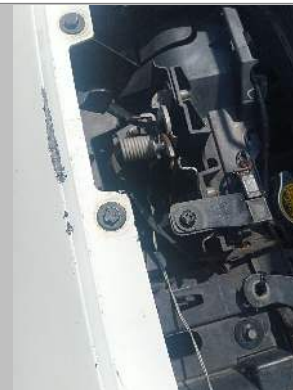
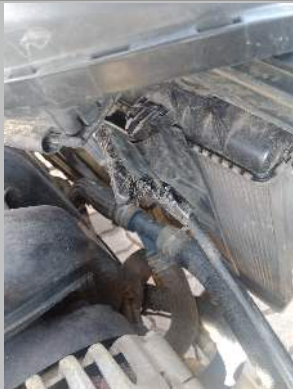
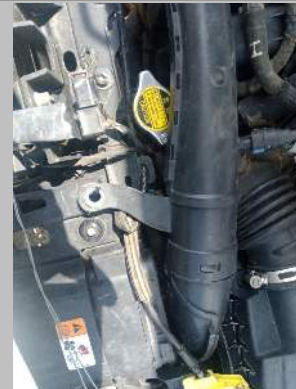
| Damage | Repair Way |
|---|---|
| Bonnet cable Damaged | Replace |

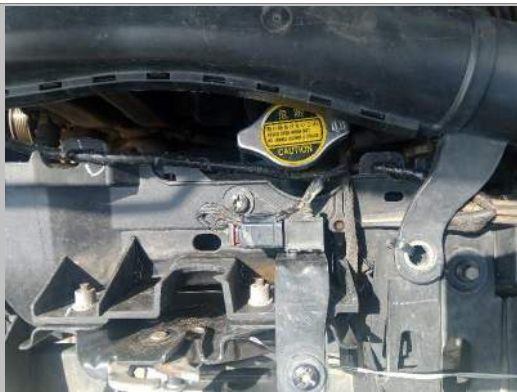
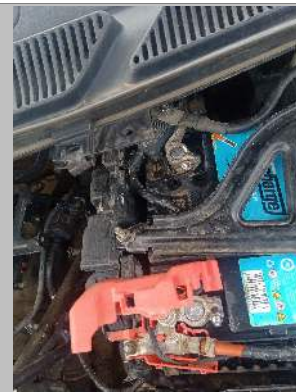
| Damage | Repair Way |
|---|---|
| Engine Wiring Damaged | Repair |

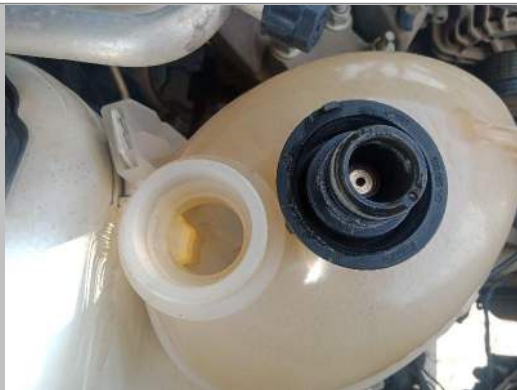
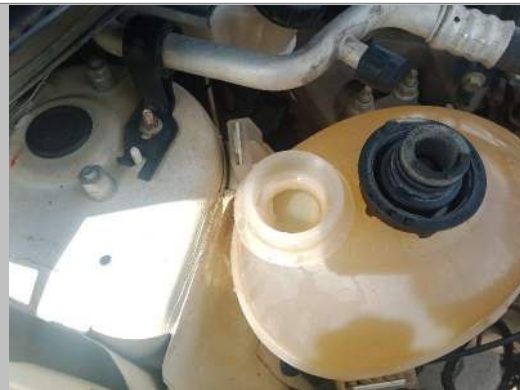
| Damage | Repair Way |
|---|---|
| Water level Insufficient | Replace |

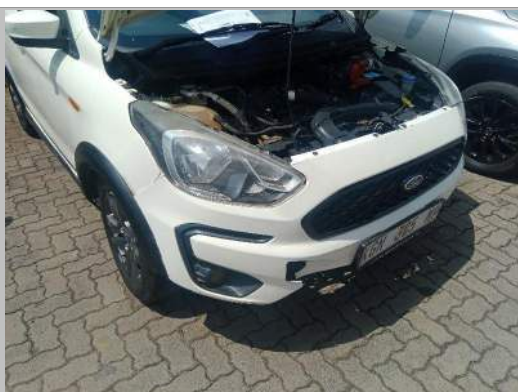
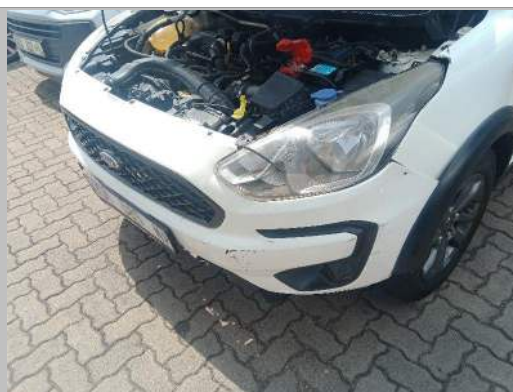
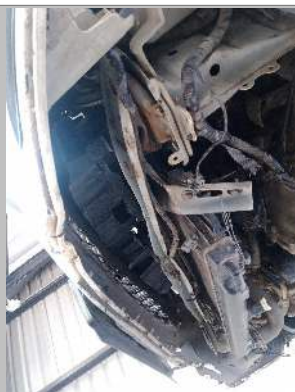
| Damage | Repair Way |
|---|---|
| Front Bumper Damaged | Repair |

Body • Exterior: Minor dents and scratches and stone chips to body panels. Signs of repair work done to body panels. Poor alignment to somebody panels. Repair work done to vehicle below standard. Signs of impact damage to front of vehicle.

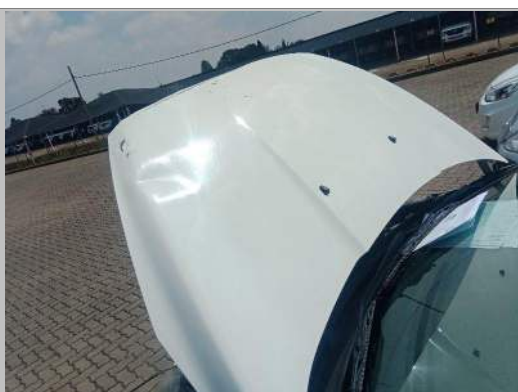
| Damage | Repair Way |
|---|---|
| Bonnet Damaged | Repair |

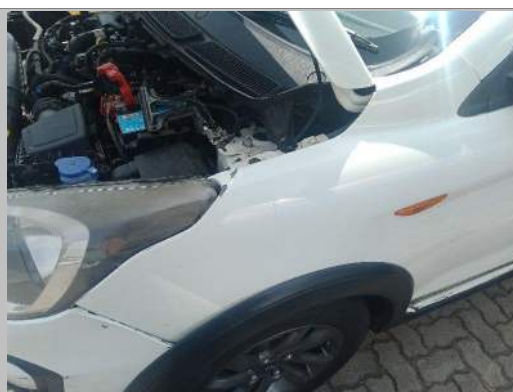
| Damage | Repair Way |
|---|---|
| Front Fender Left Damaged | Repair |

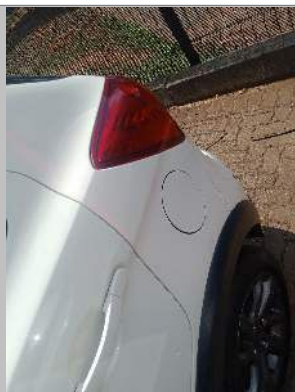
| Damage | Repair Way |
|---|---|
| Rear Fender Left Damaged | Repair |

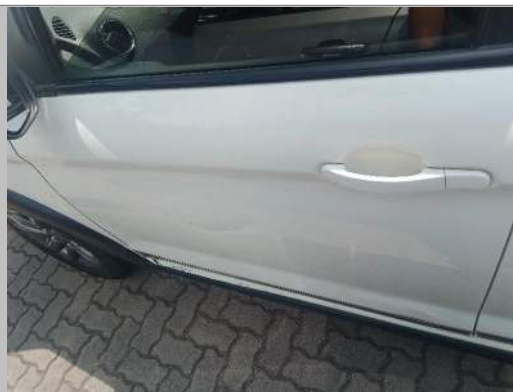
| Damage | Repair Way |
|---|---|
| Door Front Left Damaged | Repair |

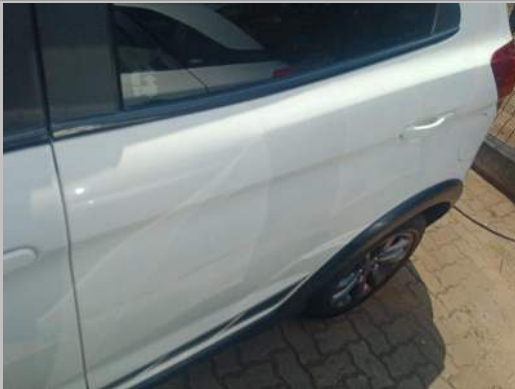
| Damage | Repair Way |
|---|---|
| Door Rear Left Damaged | Repair |

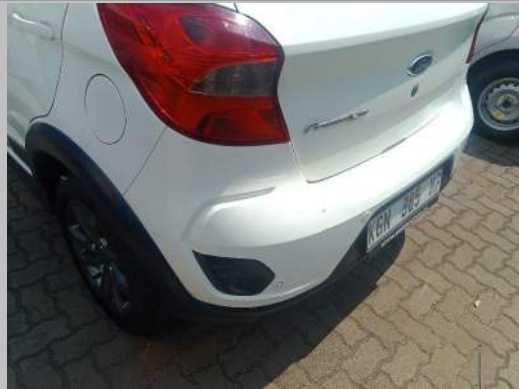
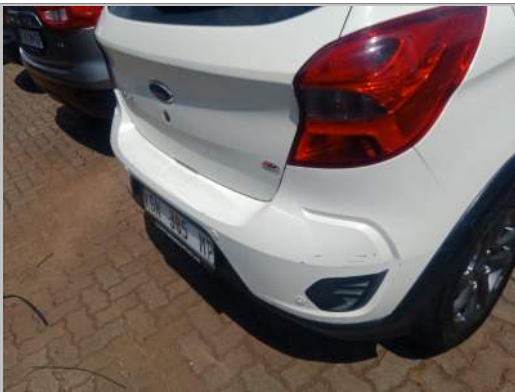
| Damage | Repair Way |
|---|---|
| Rear bumper Damaged | Repair |

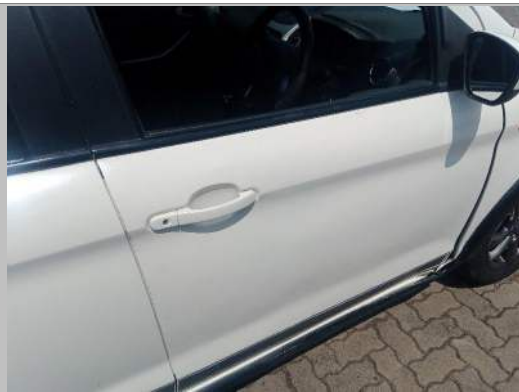
| Damage | Repair Way |
|---|---|
| Door Front Right Damaged | Repair |

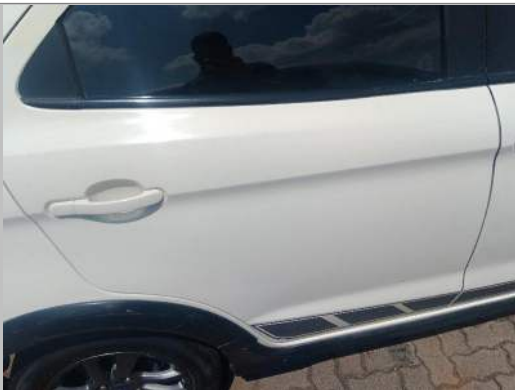
| Damage | Repair Way |
|---|---|
| Door Rear Right Damaged | Repair |

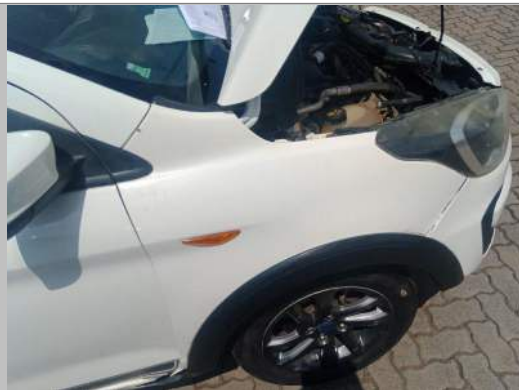
| Damage | Repair Way |
|---|---|
| Front Fender Right Damaged | Repair |

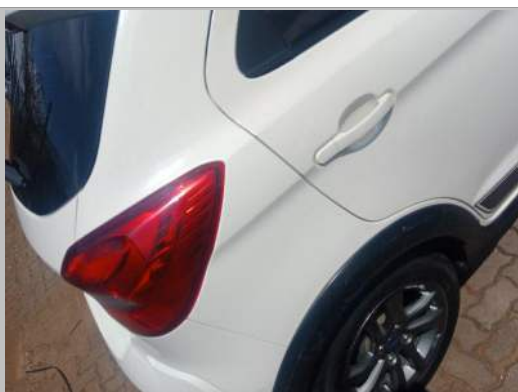
| Damage | Repair Way |
|---|---|
| Rear Fender Right Damaged | Repair |

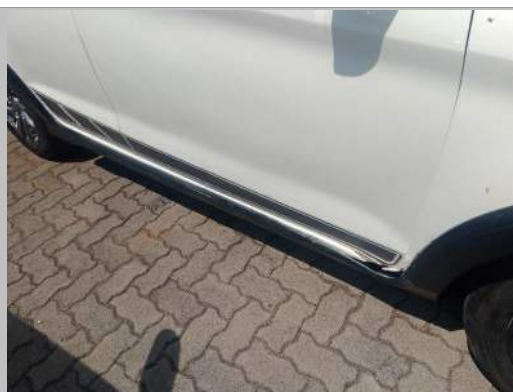
| Damage | Repair Way |
|---|---|
| Sill Panel Right Damaged | Repair |

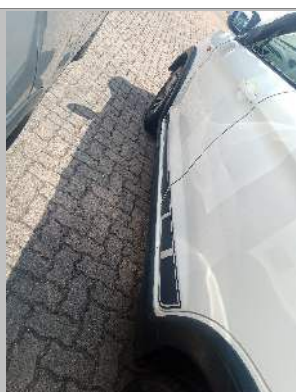
| Damage | Repair Way |
|---|---|
| Sill Panel Left Damaged | Repair |

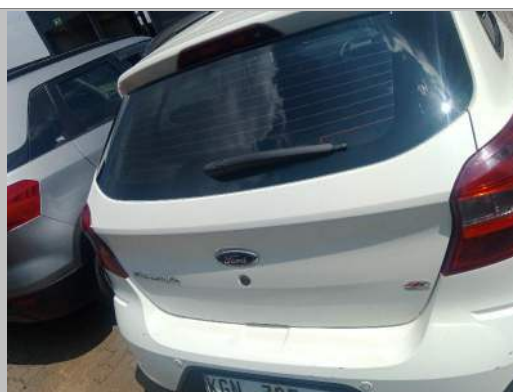
| Damage | Repair Way |
|---|---|
| Boot Lid / Hatch door Damaged | Repair |

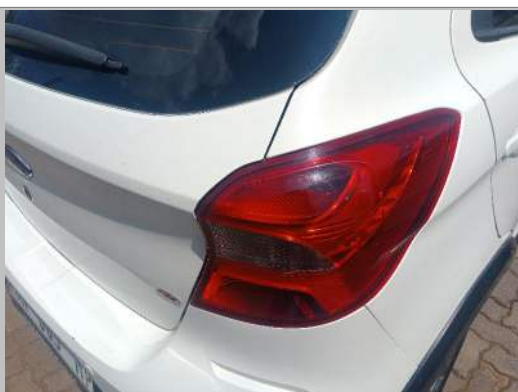
| Damage | Repair Way |
|---|---|
| Tail Light Right Damaged | Replace |

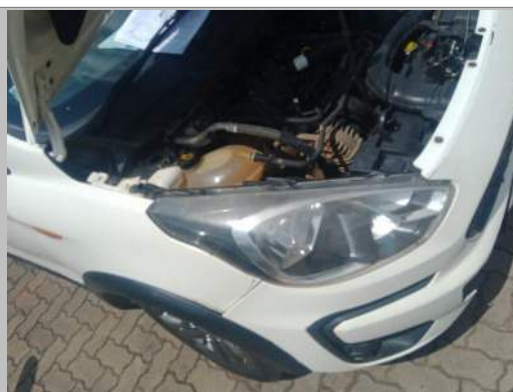
| Damage | Repair Way |
|---|---|
| Headlight Right Damaged | Replace |

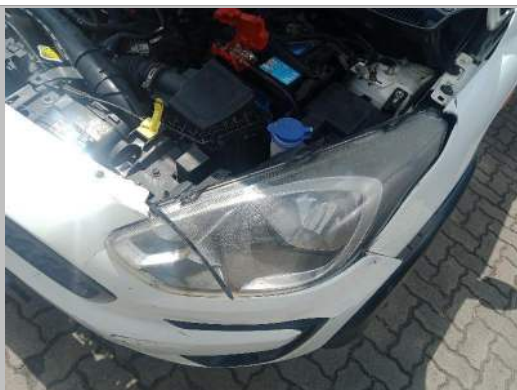
| Damage | Repair Way |
|---|---|
| Headlight Left Damaged | Replace |

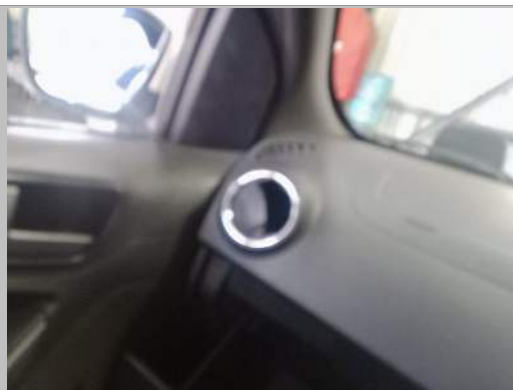
| Damage | Repair Way |
|---|---|
| Central Air Vent Damaged | Replace |

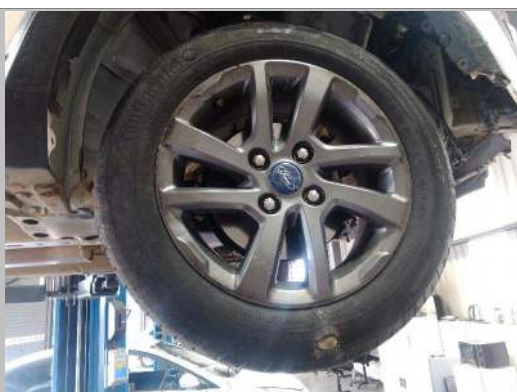
| Damage | Repair Way |
|---|---|
| Tyre Front Right Damaged | Replace |

| | Size | Load/Speed Index | Manufacture | Model | Type* | Production Date | Tread Depth (mm) |
|---|---|---|---|---|---|---|---|
| Front Right | 185/60R15 | 84H | Continental | Contipremiu | V | 0424 | 1 mm |

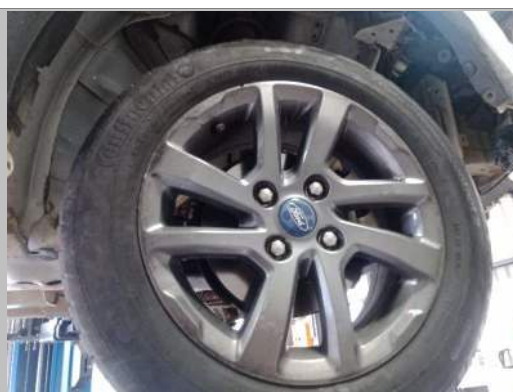
| Damage | Repair Way |
|---|---|
| Rim Front Right Damaged | Replace |

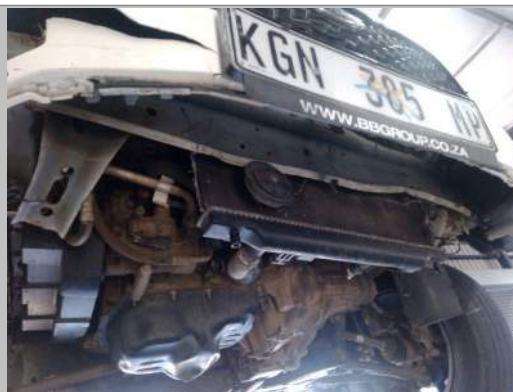
| Damage | Repair Way |
|---|---|
| Radiator Cradle Damaged | Replace |

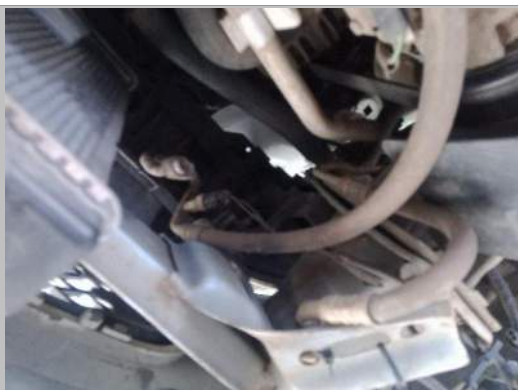
| Damage | Repair Way |
|---|---|
| Air conditioner pipes Damaged | Replace |

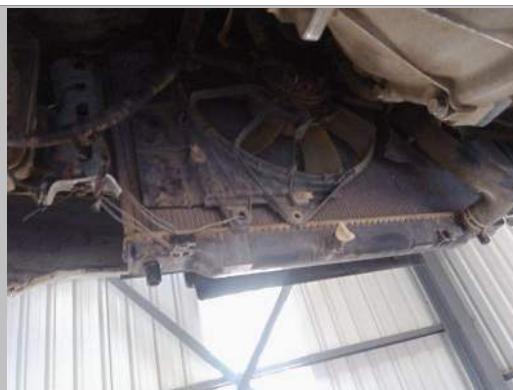
| Damage | Repair Way |
|---|---|
| Radiator Deformed | Replace |

General Comments: 20 DTC'S AT TIME OF TESTING SEE DTC REPORT. VEHICLE STRUGGLES TO SELECT GEARS.ACCORDING TO THE AGE AND MILEAGE OF THE VEHICLE, NORMAL WEAR AND TEAR MARKS ARE VISIBLE ON THE INTERIOR, EXTERIOR, ELECTRICAL AND MECHANICAL PARTS.Engine Compartment: Battery loose. fan cowling damaged. sump damage. signs of water leak cannot pinpoint. non-standard radiator fitted to vehicle.

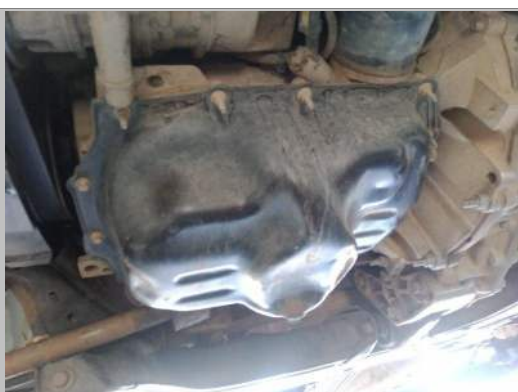
| Damage | Repair Way |
|---|---|
| Engine Damaged | Repair |
| Engine Noise Excessive | Repair |

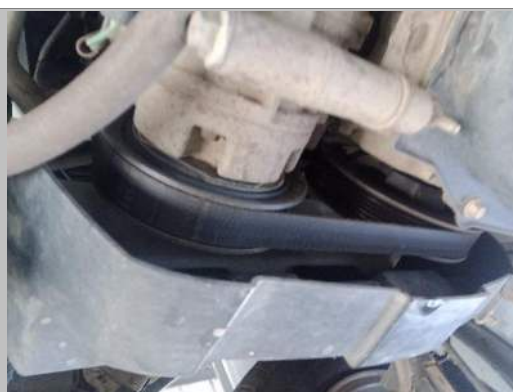
| Damage | Repair Way |
|---|---|
| Fan Belt Worn | Repair |

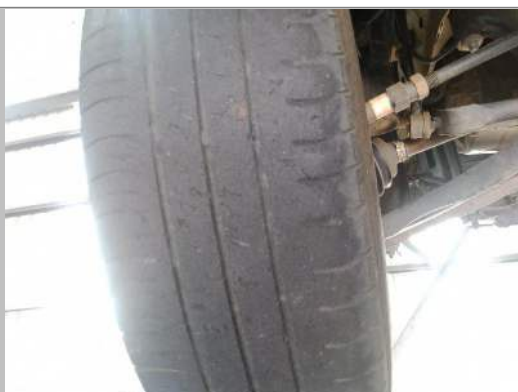
| Damage | Repair Way |
|---|---|
| Tyre Front Left Worn | Replace |

| | Size | Load/Speed Index | Manufacture | Model | Type* | Production Date | Tread Depth (mm) |
|---|---|---|---|---|---|---|---|
| Front Left | 185/60R15 | 92T | Dunlop | Sp | V | 2025 | 0 mm |

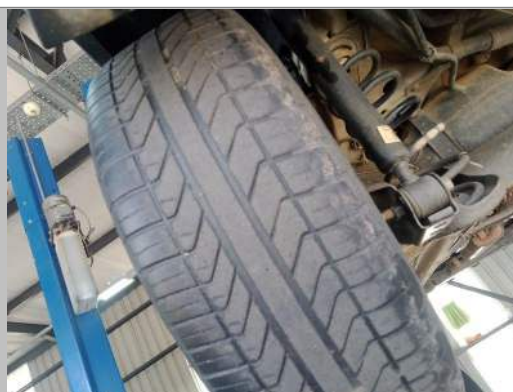
| Damage | Repair Way |
|---|---|
| Tyre Rear Left Worn | Replace |

| | Size | Load/Speed Index | Manufacture | Model | Type* | Production Date | Tread Depth (mm) |
|---|---|---|---|---|---|---|---|
| Rear Left | 185/60R15 | 84H | Sumitomo | Radial | V | 2524 | 0 mm |

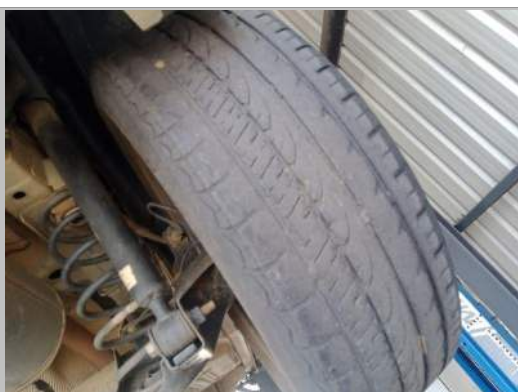
| Damage | Repair Way |
|---|---|
| Tyre Rear Right Worn | Replace |

| | Size | Load/Speed Index | Manufacture | Model | Type* | Production Date | Tread Depth (mm) |
|---|---|---|---|---|---|---|---|
| Rear Right | 185/60R15 | 88H | Autogrip | Radial | V | 3922 | 0 mm |

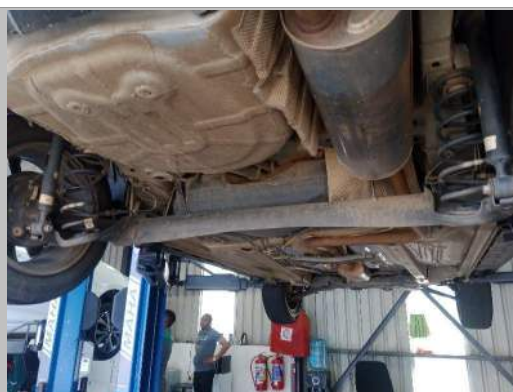
| Damage | Repair Way |
|---|---|
| Rear Axle Poor Alignment | Repair |

Axle and Suspension: signs of vehicle crabbing.

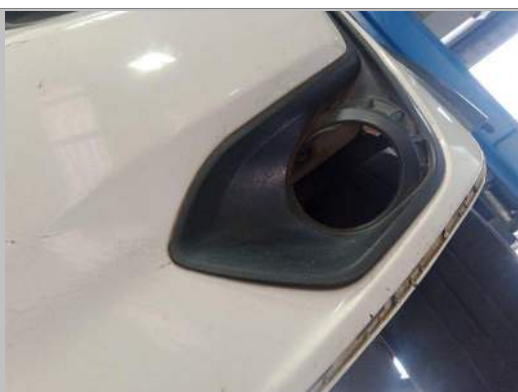
| Damage | Repair Way |
|---|---|
| Fog Light Front Left Damaged | Replace |

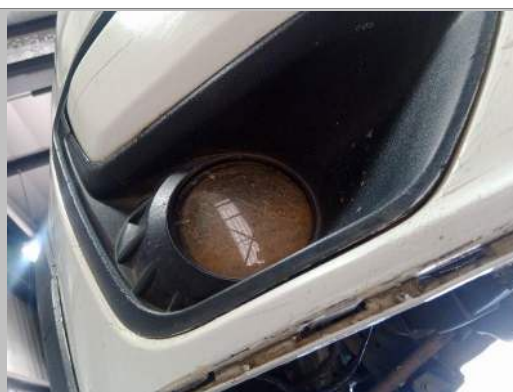
| Damage | Repair Way |
|---|---|
| Fog Light Front Right Damaged | Replace |

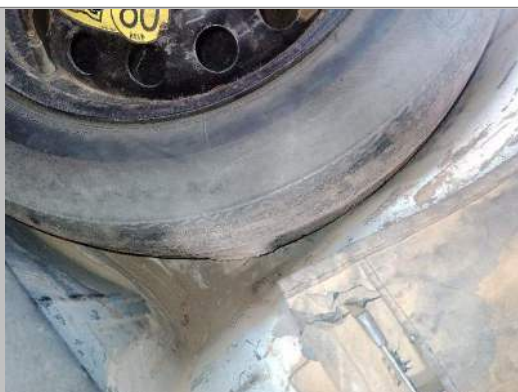
| Damage | Repair Way |
|---|---|
| Spare Tyre Worn | Replace |

| | Size | Load/Speed Index | Manufacture | Model | Type* | Production Date | Tread Depth (mm) |
|---|---|---|---|---|---|---|---|
| Spare | 175/65R14 | 82H | Firestone | Radial | V | 0000 | 0 mm |

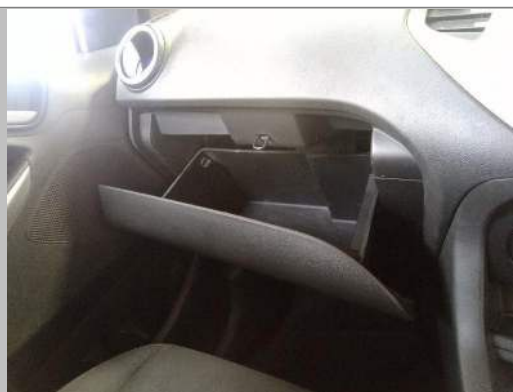
| Damage | Repair Way |
|---|---|
| Center Console / Cubbyhole + Lid Damaged | Replace |

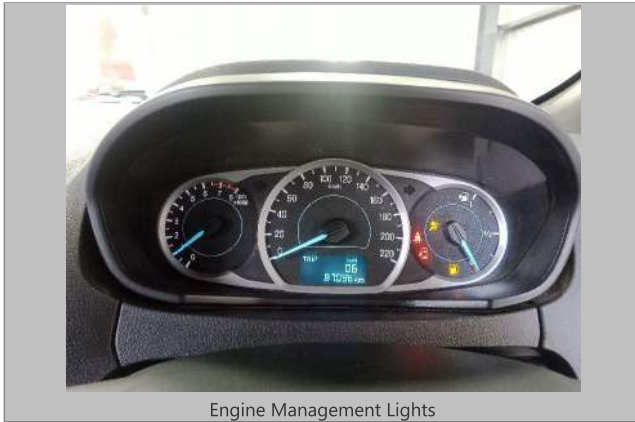
| Damage | Repair Way |
|---|---|
| Engine Management Lights Set | Repair |

| No | System | Code | Description | Status |
|---|---|---|---|---|
| 1 | PCM | P06E9:00-28 | ENGINE STARTER PERFORMANCE | |
