## CONDITION REPORT

Report No:  
2016998456  
DATE  
01/09/2025

| Manufacturer | FORD | Registration Number | KPY501NW |
| VIN | MAJGXXMTKGMA00820 | Date Of First Licensing | |

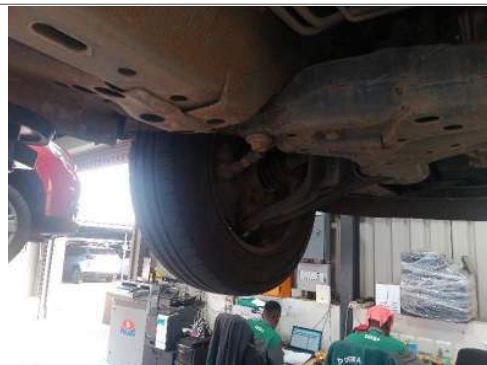
LF TYRE TREAD

| | Size | Load/Speed Index | Manufacture | Model | Type* | Production Date | Tread Depth (mm) |
|---|---|---|---|---|---|---|---|
| Front Left | 175/65R14 | 82T | Apollo | Alnac | V | 4823 | 3 mm |

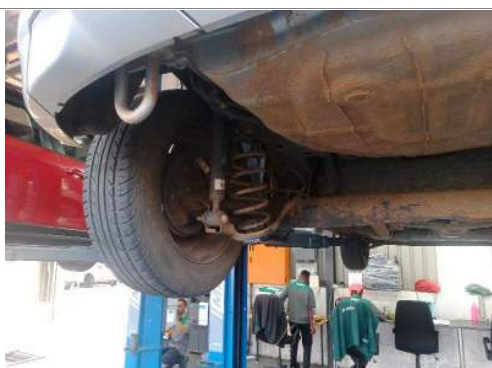
LR TYRE TREAD

| | Size | Load/Speed Index | Manufacture | Model | Type* | Production Date | Tread Depth (mm) |
|---|---|---|---|---|---|---|---|
| Rear Left | 175/65R14 | 82H | Apollo | Alnac | V | 2421 | 4 mm |

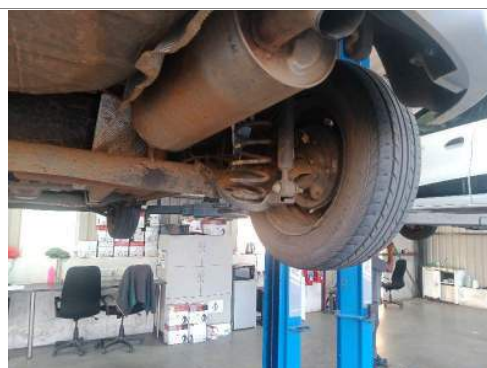
RR TYRE TREAD

| | Size | Load/Speed Index | Manufacture | Model | Type* | Production Date | Tread Depth (mm) |
|---|---|---|---|---|---|---|---|
| Rear Right | 175/65R14 | 82H | Apollo | Alnac | V | 2821 | 3 mm |

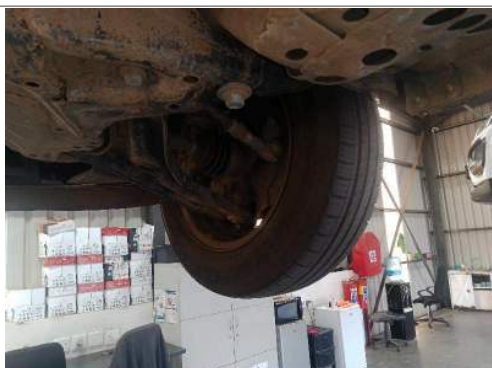
RF TYRE TREAD

| | Size | Load/Speed Index | Manufacture | Model | Type* | Production Date | Tread Depth (mm) |
|---|---|---|---|---|---|---|---|
| Front Right | 175/65R14 | 82T | Apollo | Alnac | V | 4823 | 3 mm |

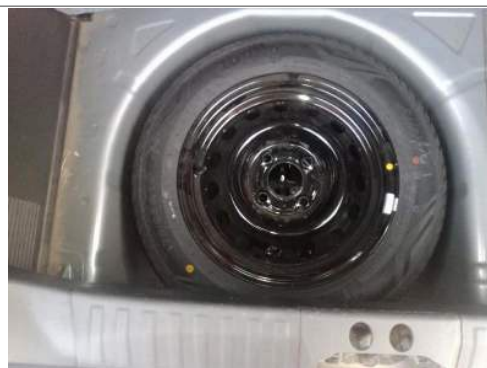
Spare wheel

| | Size | Load/Speed Index | Manufacture | Model | Type* | Production Date | Tread Depth (mm) |
|---|---|---|---|---|---|---|---|
| Spare | 175/65R14 | 82H | Apollo | Alnac | V | 0000 | 5 mm |

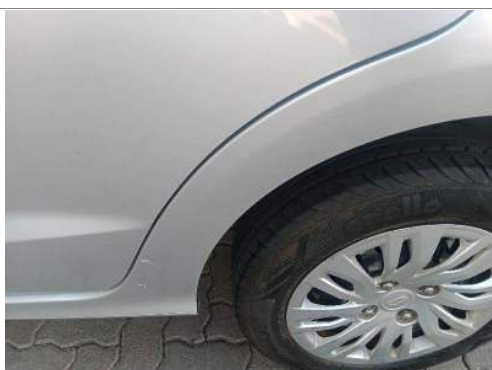
| | Damage | Repair Way |
|---|---|---|
| | Rear Fender Left Paintwork • Scratched | Repair |

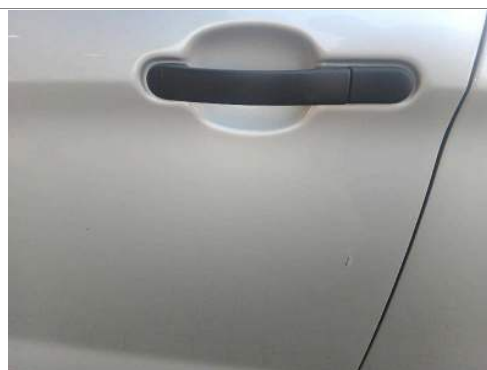
| | Damage | Repair Way |
|---|---|---|
| | Door Front Left Paintwork • Scratched | Repair |

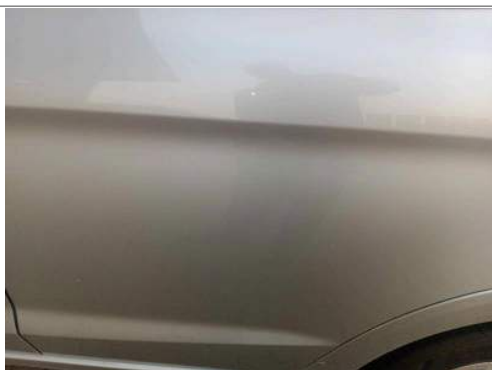
| | Damage | Repair Way |
|---|---|---|
| | Door Rear Left Paintwork • Scratched | Repair |

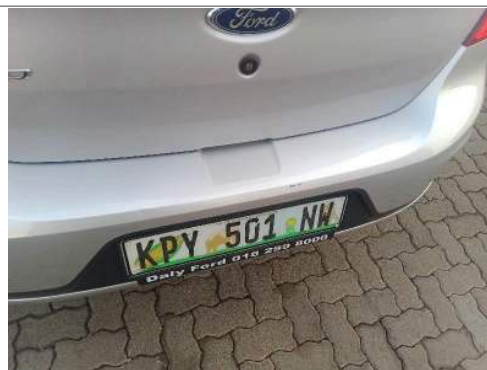
| | Damage | Repair Way |
|---|---|---|
| | Rear bumper Paintwork • Scratched | Repair |
