CONDITION REPORT

Report No: 2016395930

MFC Auction House
M57 Pretoria Rd, Glenmarais, KEMPTON PARK
Gauteng

Vehicle Type	PASSENGER VEHICLE	Registered Owner	MFC AUCTION HOUSE
Manufacturer	HONDA	Registration Number	JK67XNGP
Model	MAZE	Register Number	
VIN	MAKDF5630K4000339	Date Of First Licensing	
Engine Number		Last COR	
Doors	4	License Expiry Date	31/01/2024
Color	WHITE	Power / Displacement	
Year Model		Paint Finish	M - METALLIC
Km Reading	191,533 KM	Fuel	PETROL
Cab / Body Type	SEDAN	Transmission	AUTOMATIC

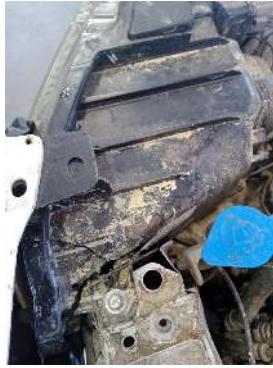
R/F headlight clips broken

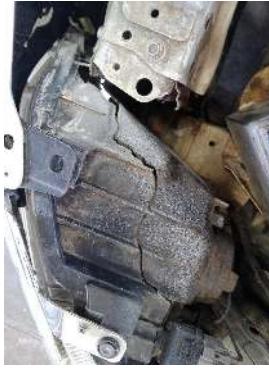
L/F headlight cover broken.

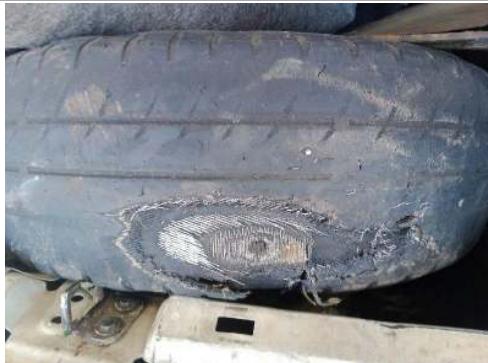
Damage	Repair Way
Sill Panel Left Residual Traces of Repair	Repair
Roof Residual Traces of Repair	Repair
Windscreen Cracked	Replace
Rear Axle Damaged	Replace
Tyre Front Right Excessive Wear & Tear	Replace
Tyre Rear Left Excessive Wear & Tear	Replace
Tyre Rear Right Excessive Wear & Tear	Replace
Spare Tyre Excessive Wear & Tear	Replace
Main Beam Left Welded	Replace
Catalytic converter Welded	Replace
Radiator Cradle Welded	Replace
Body exterior	Sparewheel damage
Body exterior	Signs of spray work done on all body panels
Electronics malfunction	Both front electric mirrors malfunction.
Residual traces of welding on chassis leg extensio	radiator cradle signs of welding.
Axle and suspension	Both front control arm bushes covered
Signs of welding on some body panels	Repair

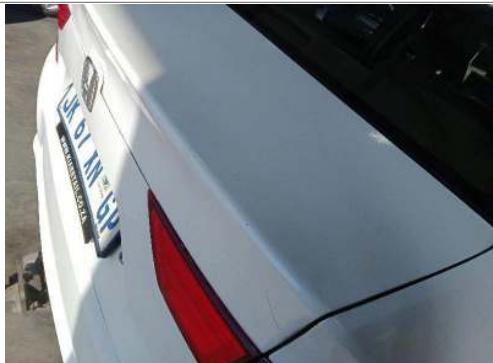
Door Rear Left Residual Traces of Repair	Repair
Door Rear Right Residual Traces of Repair	Repair
Boot Lid / Hatch door Residual Traces of Repair	Repair
Rear bumper Damaged	Repair

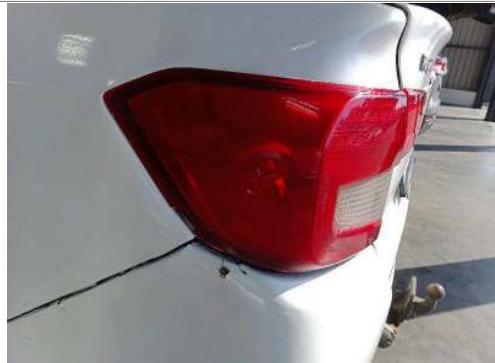
Damage	Repair Way
Engine Wiring Defective	Repair
Battery clamps Defective	Repair
Air conditioner pipes Defective	Repair
Bonnet hinges Damaged	Replace
Windscreen Wiper Worn	Replace
Tail Light Left Cracked	Replace
Headlight Right Chipped	Replace
Seat Front Right Torn / Cut	Repair
Door Sealing Rubber Rear Left Damaged	Replace
Door Sealing Rubber Rear Right Damaged	Replace
Side Mirror Left Damaged	Replace
Side Mirror Right Damaged	Replace
Front Bumper Damaged	Replace
Grill Damaged	Replace
Bonnet Residual Traces of Repair	Repair
Bonnet slam plate (Shock tower/ Inner tray) Residual Traces of Repair	Repair
C • Pillar Left Welded	Replace
Front Fender Left Residual Traces of Repair	Repair
Front Fender Right Residual Traces of Repair	Replace
Rear Fender Left Residual Traces of Repair	Repair
Rear Fender Right Damaged	Repair
Rear Fender Left / Inner Tray Damaged	Repair
Door Front Left Residual Traces of Repair	Repair
Door Front Right Residual Traces of Repair	Repair
