CONDITION REPORT

Report No: 2016363150

MFC Auction House  
M57 Pretoria Rd, Glenmarais, KEMPTON PARK  
Gauteng

| Manufacturer | HYUNDAI | Registration Number | HJ93PPGP |

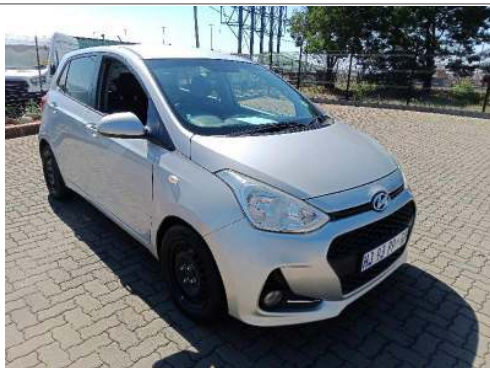
FRONT RIGHT CORNER

| Damage | Repair Way |
|---|---|
| Body and Exterior | Signs of impact damage to front of vehicle |

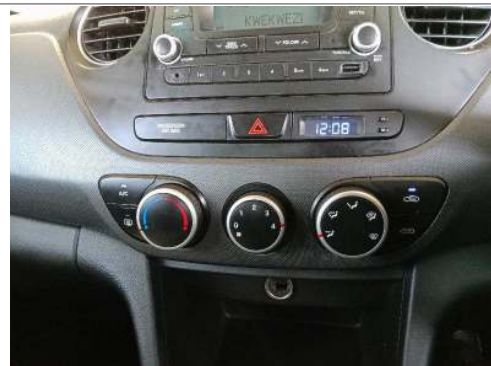
| Damage | Repair Way |
|---|---|
| Air Conditioner Insufficient | Replace |

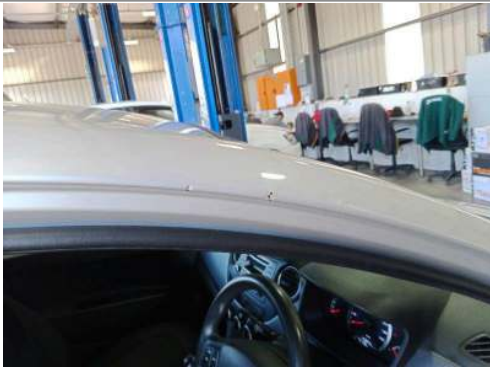
| Damage | Repair Way |
|---|---|
| A • Pillar Right Paintwork • Chipmarks | Repair |

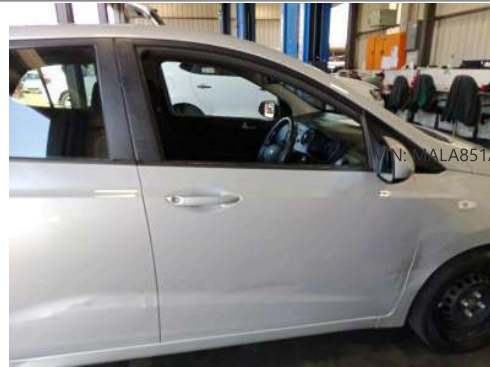
| Damage | Repair Way |
|---|---|
| Door Front Right Damaged | Repair |

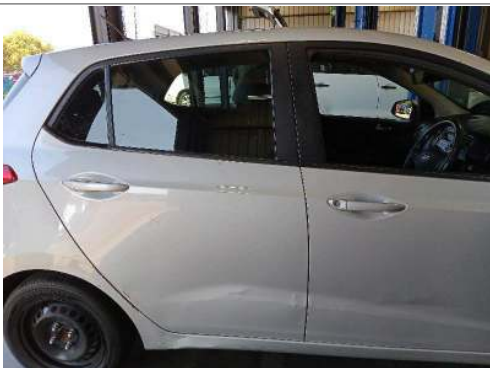
| Damage | Repair Way |
|---|---|
| Door Rear Right Damaged | Repair |

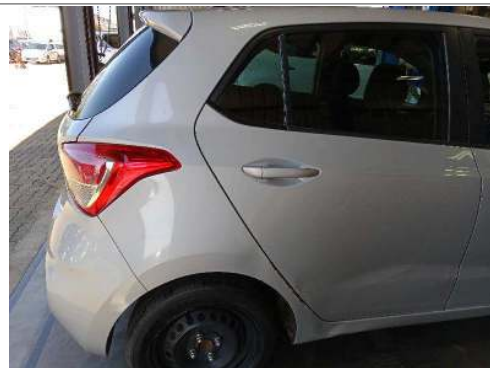
| Damage | Repair Way |
|---|---|
| Rear Fender Right Damaged | Repair |

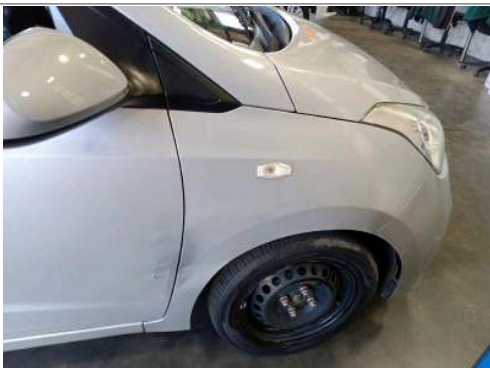
| Damage | Repair Way |
|---|---|
| Front Fender Right Damaged | Repair |

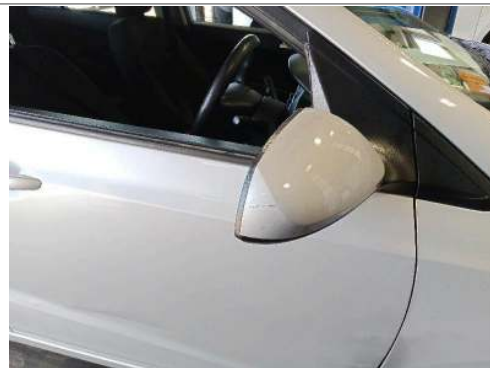
| Damage | Repair Way |
|---|---|
| Side Mirror Right Paintwork • Scratched | Repair |

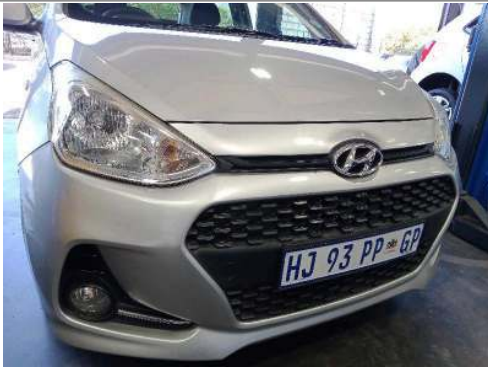
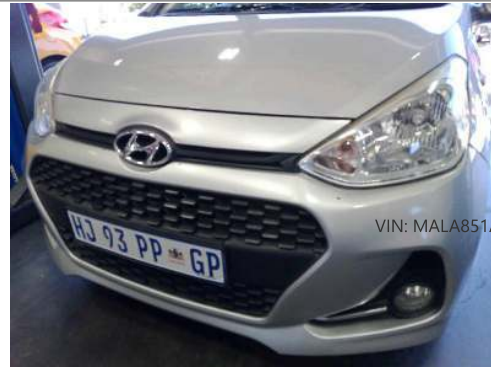
| Damage | Repair Way |
|---|---|
| Front Bumper Residual Traces of Repair | Replace |

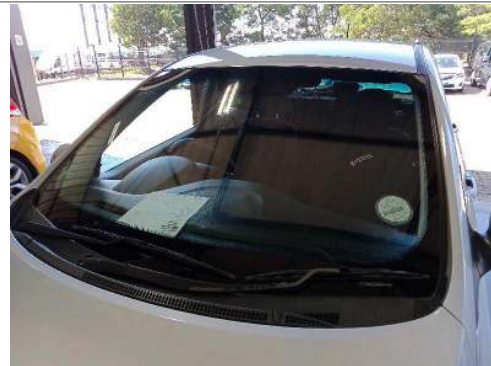
| Damage | Repair Way |
|---|---|
| Windscreen Chipped | Repair |

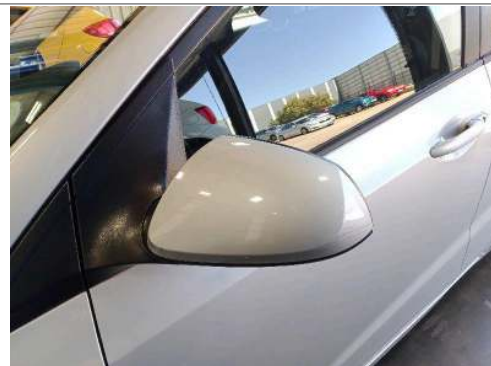
| Damage | Repair Way |
|---|---|
| Side Mirror Left Paintwork • Scratched | Repair |

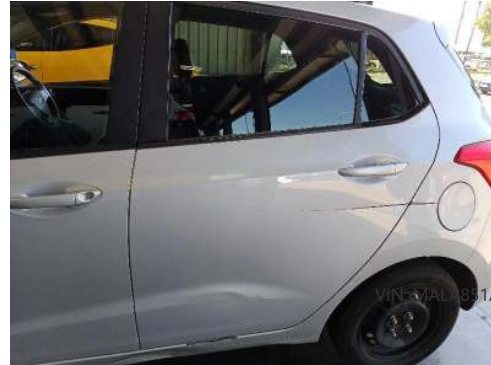
| Damage | Repair Way |
|---|---|
| Door Rear Left Damaged | Repair |

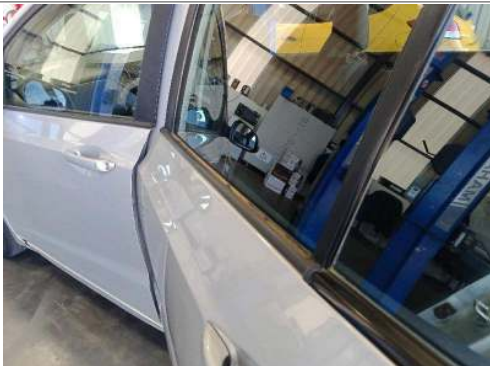
| Damage | Repair Way |
|---|---|
| Weather Strip Door Rear Left Damaged | Replace |

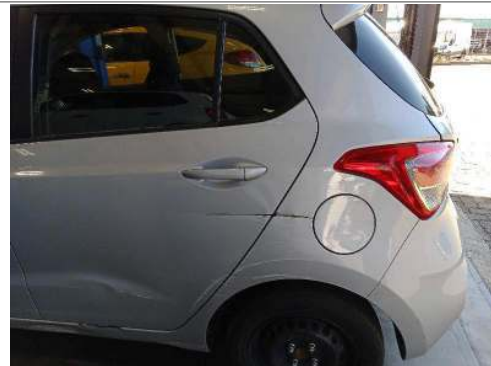
| Damage | Repair Way |
|---|---|
| Rear Fender Left Damaged | Repair |

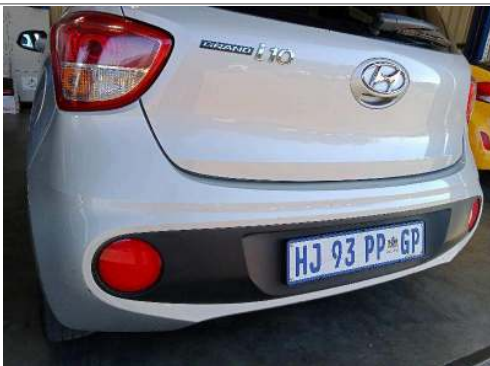
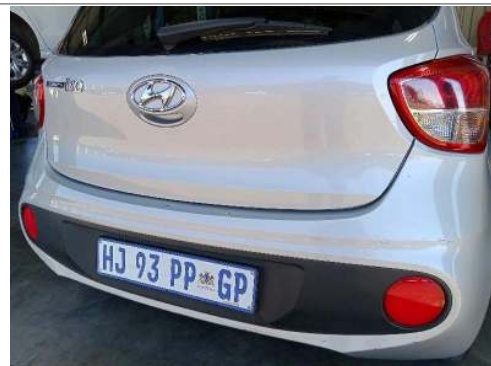
| Damage | Repair Way |
|---|---|
| Rear bumper Damaged | Repair |

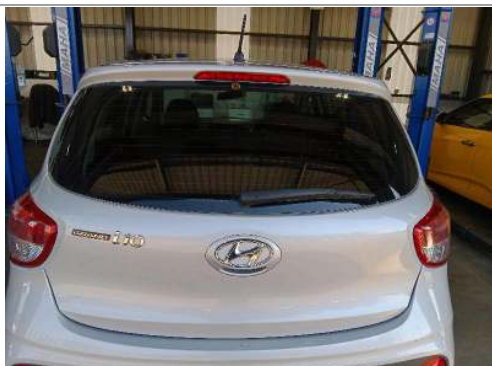
| Damage | Repair Way |
|---|---|
| Boot Lid / Hatch door Paintwork • Scratched | Repair |

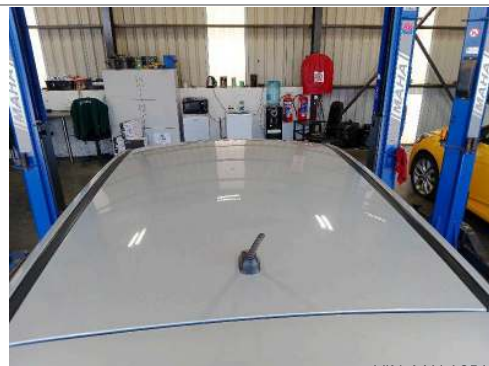
| Damage | Repair Way |
|---|---|
| Roof Dented | Repair |

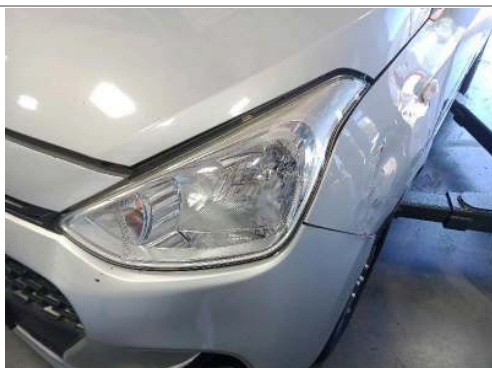
| Damage | Repair Way |
|---|---|
| Headlight Left Scratched | Replace |

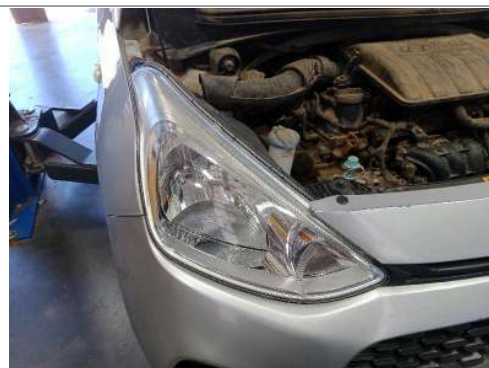
| Damage | Repair Way |
|---|---|
| Headlight Right Defective | Repair |

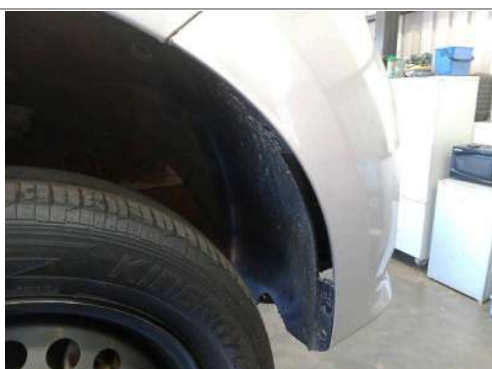
| Damage | Repair Way |
|---|---|
| Front Fender Right / Inner Tray Damaged | Replace |

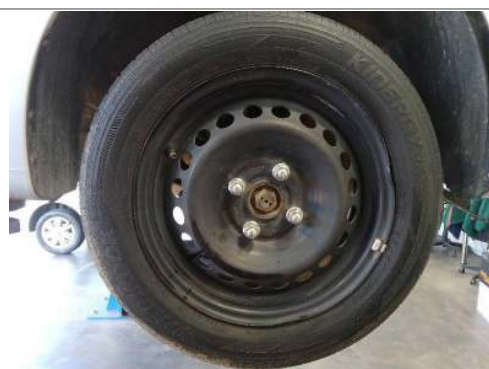
| Damage | Repair Way |
|---|---|
| Rim Front Right Dented | Repair |

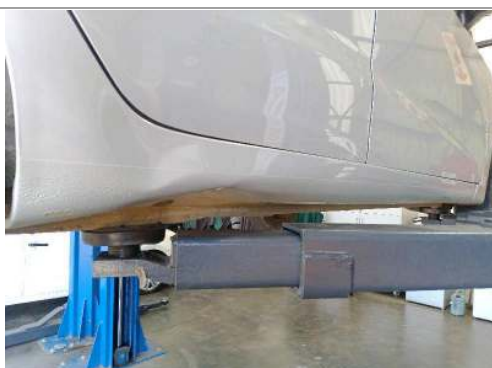
| Damage | Repair Way |
|---|---|
| Rocker Panel Right Damaged | Repair |

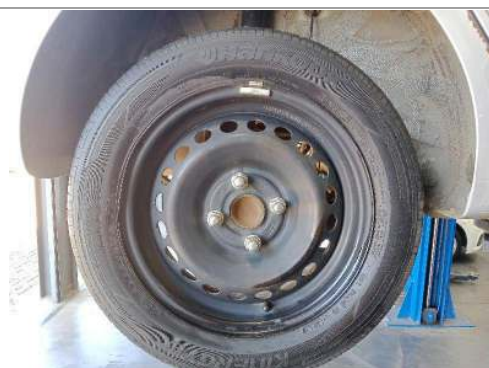
| Damage | Repair Way |
|---|---|
| Rim Rear Right Dented | Repair |

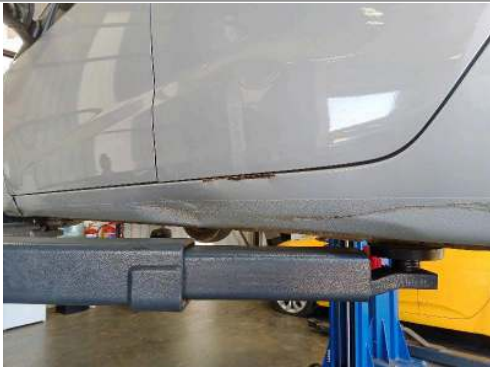
| Damage | Repair Way |
|---|---|
| Rocker Panel Left Damaged | Repair |

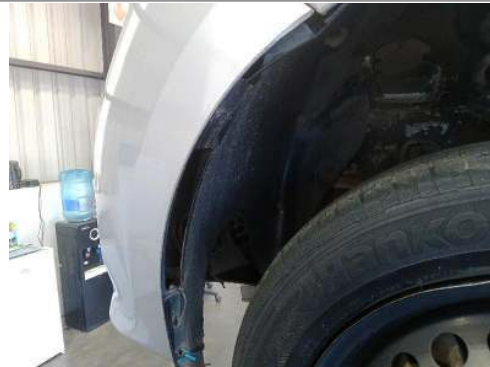
| Damage | Repair Way |
|---|---|
| Front Fender Left / Inner Tray Damaged | Replace |

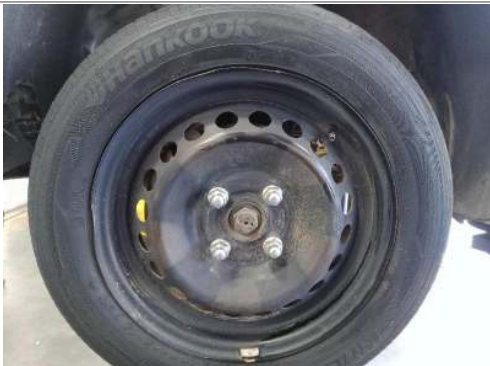
| Damage | Repair Way |
|---|---|
| Rim Front Left Dented | Repair |

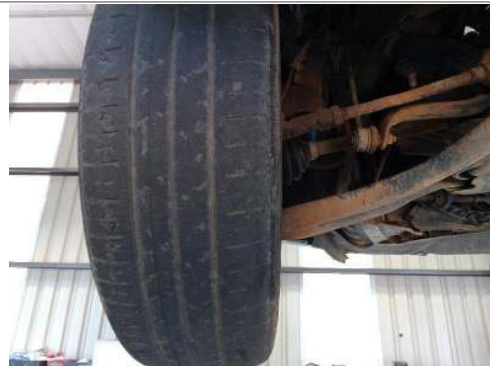
| Damage | Repair Way |
|---|---|
| Tyre Front Left Worn | Replace |

| | Size | Load/Speed Index | Manufacture | Model | Type* | Production Date | Tread Depth (mm) |
|---|---|---|---|---|---|---|---|
| Front Left | 165/65 R14 | 79H | Hankook | Kinergy | V | 4817 | 0 mm |

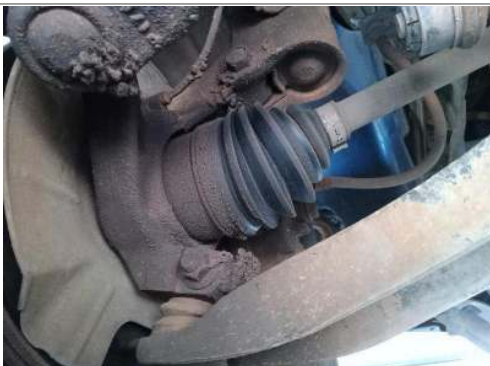
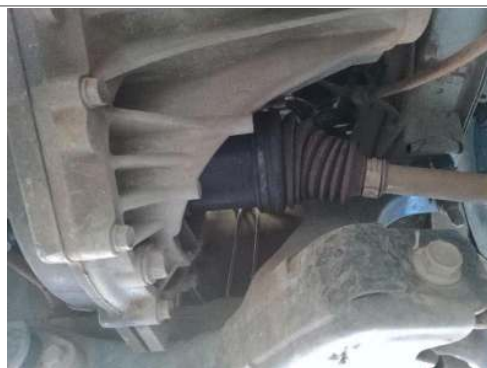
| Damage | Repair Way |
|---|---|
| CV Joint(s) Boot(s) Front Left (inner/outer) Defective | Replace |

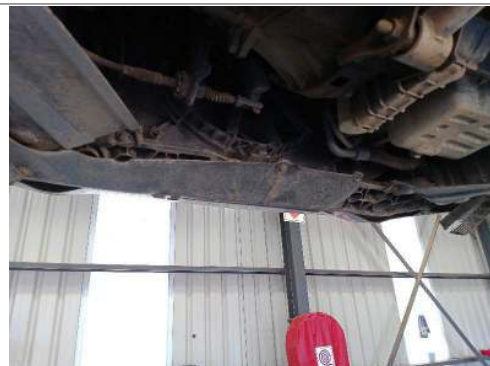
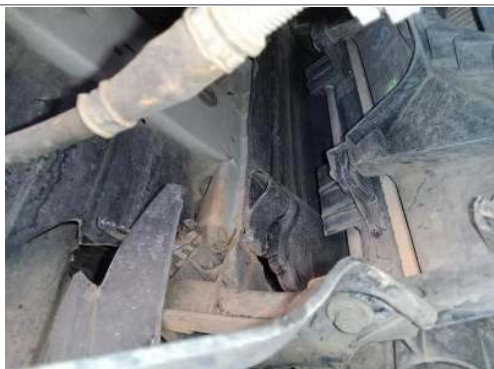
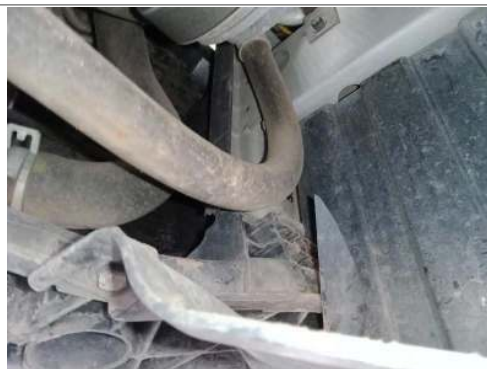
| Damage | Repair Way |
|---|---|
| Radiator Cradle Damaged | Replace |

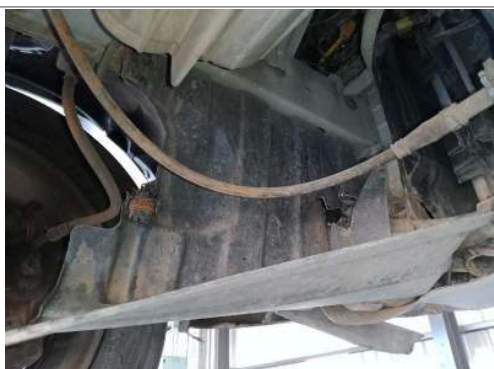
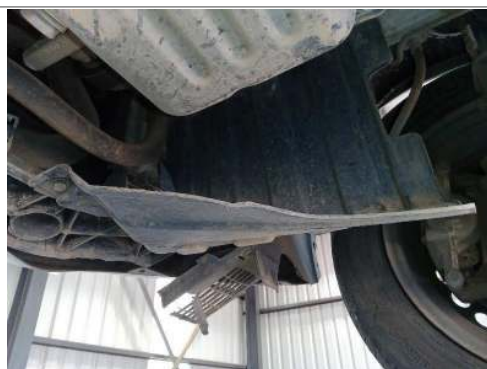
| Damage | Repair Way |
|---|---|
| Belly plates Damaged | Replace |

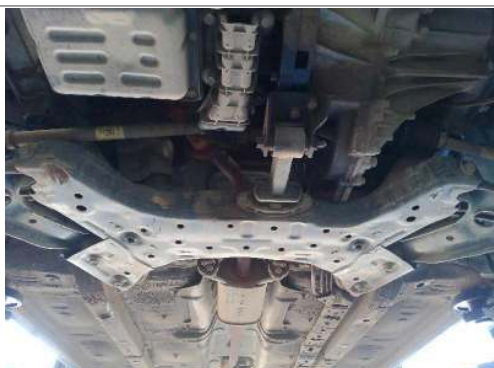
| Damage | Repair Way |
|---|---|
| Sub Frame Dented | Repair |

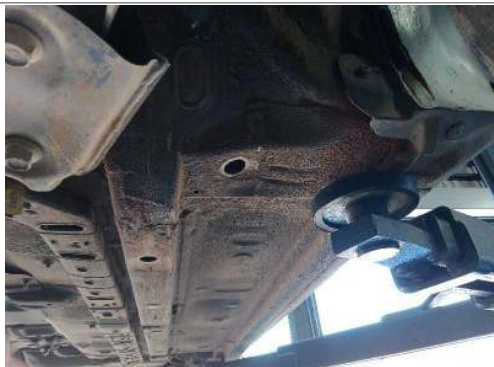
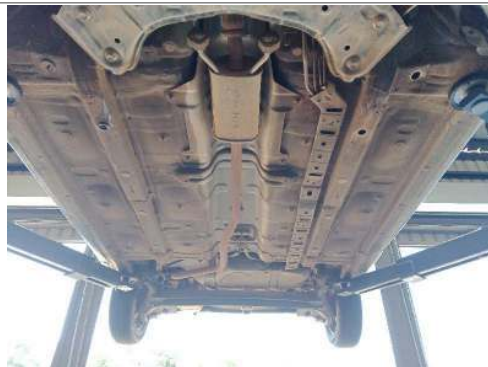
| Damage | Repair Way |
|---|---|
| Chassis Dented | Repair |

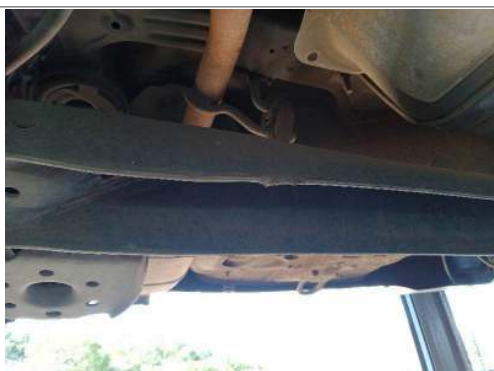
| Damage | Repair Way |
|---|---|
| Rear Axle Defective | Repair |

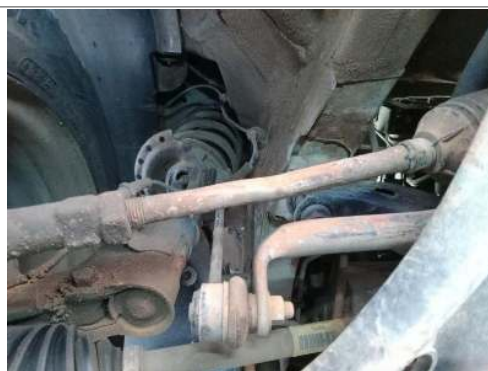
| Damage | Repair Way |
|---|---|
| Tie Rod left Damaged | Replace |

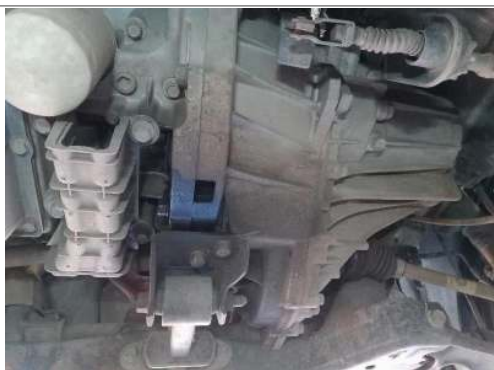
| Damage | Repair Way |
|---|---|
| Gearbox Oil Leak | Repair |

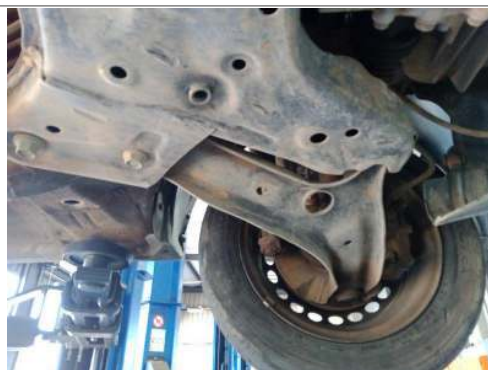
| Damage | Repair Way |
|---|---|
| Control Arm(s) Front Axle Left Damaged | Replace |

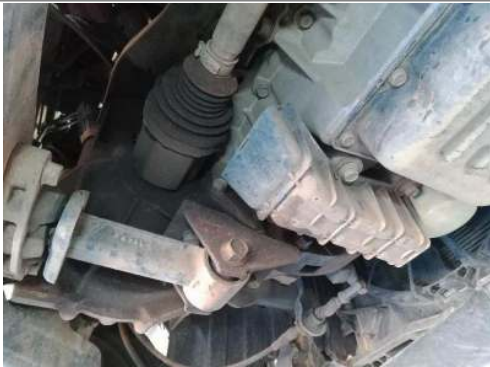
| Damage | Repair Way |
|---|---|
| Engine Oil Sweat | Repair |

| Damage | Repair Way |
|---|---|
| Engine Noise Excessive | Repair |

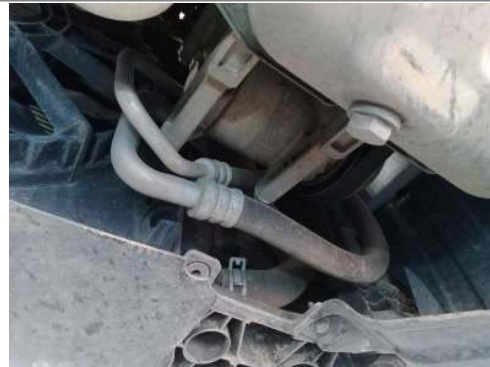
| Damage | Repair Way |
|---|---|
| Air conditioner pipes Defective | Repair |

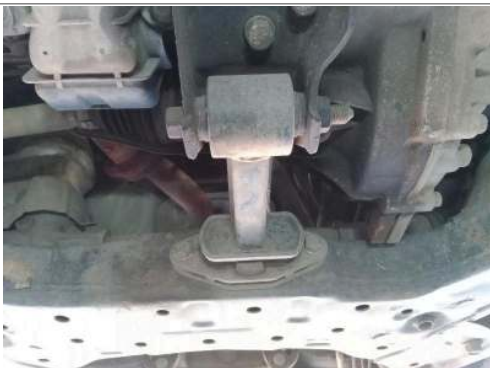
| Damage | Repair Way |
|---|---|
| Gearbox Mountings Defective | Replace |

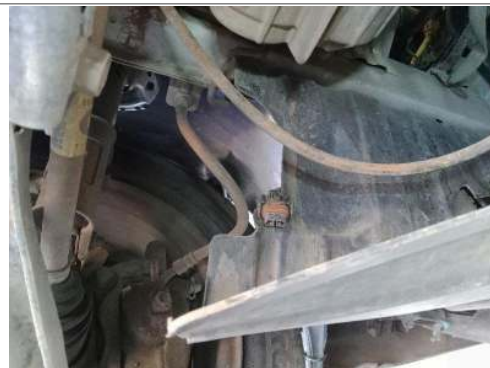
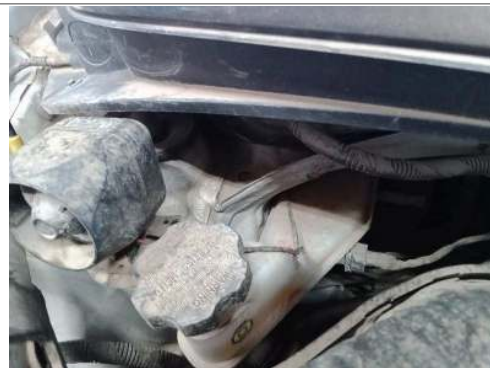
| Damage | Repair Way |
|---|---|
| Engine Wiring Defective | Repair |

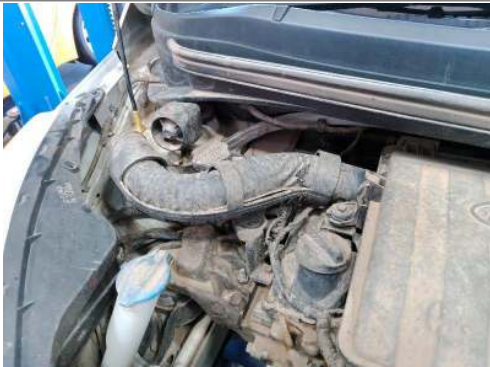
| Damage | Repair Way |
|---|---|
| Air cleaner Defective | Repair |

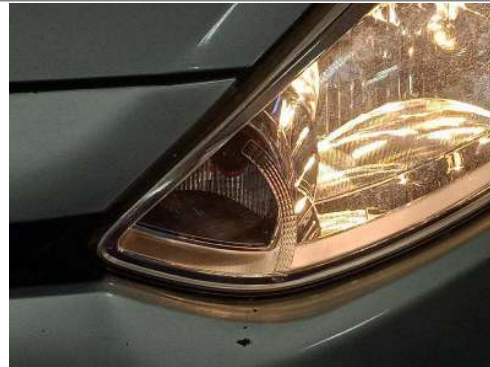
| Damage | Repair Way |
|---|---|
| Indicator Light Front Left Defective | Replace |

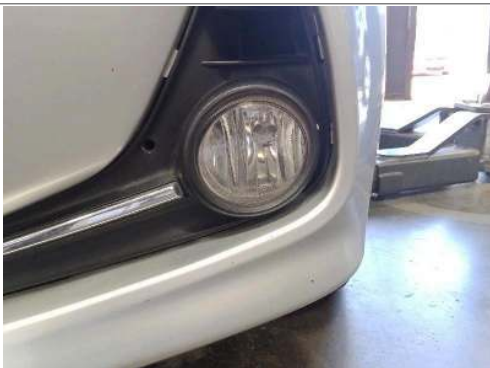
| Damage | Repair Way |
|---|---|
| Fog Light Front Left Defective | Replace |
