CONDITION REPORT

Report No: 2016886481

| Manufacturer | HYUNDAI | Registration Number | JZ61XYGP |
| Model | ATOS 1.1 50KW MOTION 5-DR [2019-2024] | Register Number | |

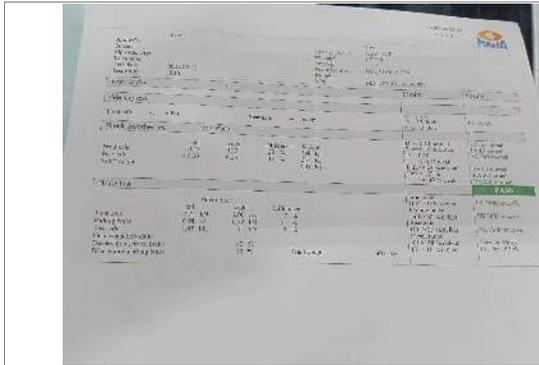
Brake test.

| | Left | Right | Axle Weight [KG] | Deceleration [m/s ²] |
|---|---|---|---|---|
| Front | 2.22 | 2.06 | - | |
| Rear | 1.45 | 1.55 | - | |
| Emergency / Parking | 0.98 | 0.74 | - | |

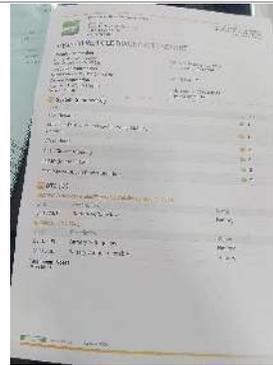
Diagnostic.

| No | System | Code | Description | Status |
|---|---|---|---|---|
| 1 | ABS/ESC | C1102:01 | BATTERY VOLTAGE LOW | |

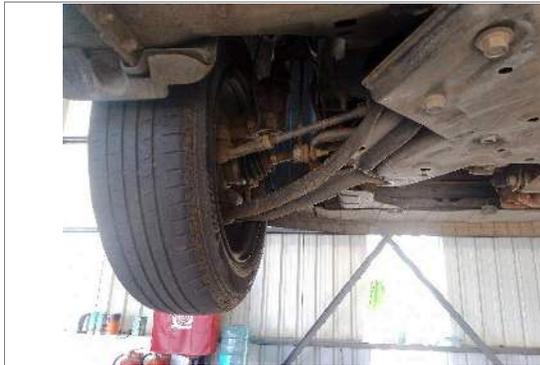
LF TYRE TREAD

| | Size | Load/Speed Index | Manufacture | Model | Type* | Production Date | Tread Depth (mm) |
|---|---|---|---|---|---|---|---|
| Front Left | 165/70R14 | 81T | Duran | Radial | V | 4123 | 2 mm |

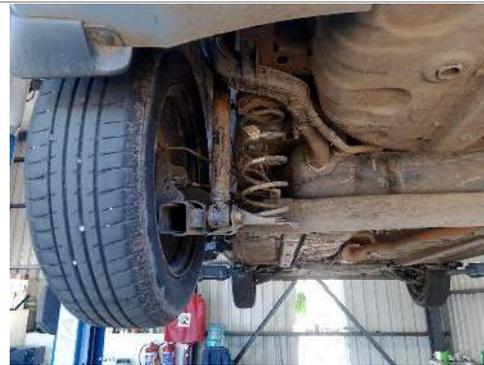
LR TYRE TREAD

| | Size | Load/Speed Index | Manufacture | Model | Type* | Production Date | Tread Depth (mm) |
|---|---|---|---|---|---|---|---|
| Rear Left | 175/65R14 | 82H | Autogrip | Radial | V | 2924 | 0 mm |

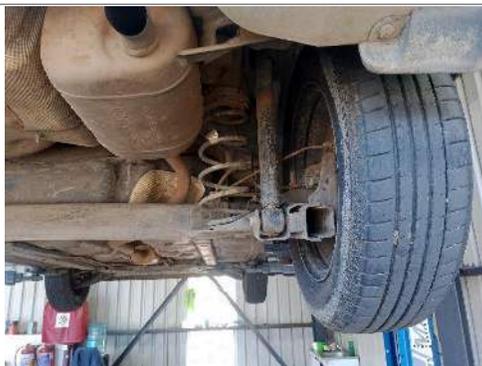
RR TYRE TREAD

| | Size | Load/Speed Index | Manufacture | Model | Type* | Production Date | Tread Depth (mm) |
|---|---|---|---|---|---|---|---|
| Rear Right | 175/65R14 | 82H | Autogrip | Radial | V | 2924 | 0 mm |

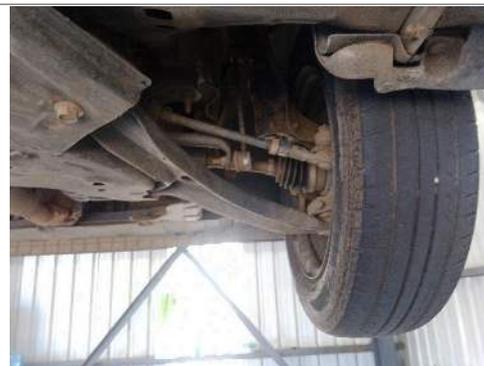
RF TYRE TREAD

| | Size | Load/Speed Index | Manufacture | Model | Type* | Production Date | Tread Depth (mm) |
|---|---|---|---|---|---|---|---|
| Front Right | 165/70R14 | 81T | Hilo | Radial | V | 3623 | 2 mm |

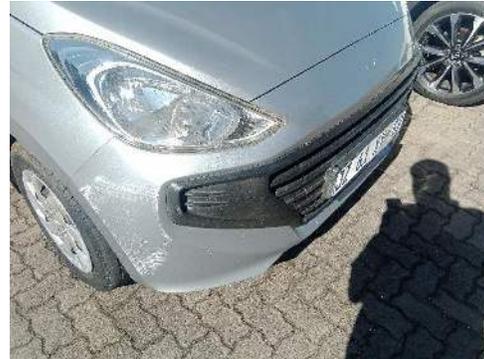
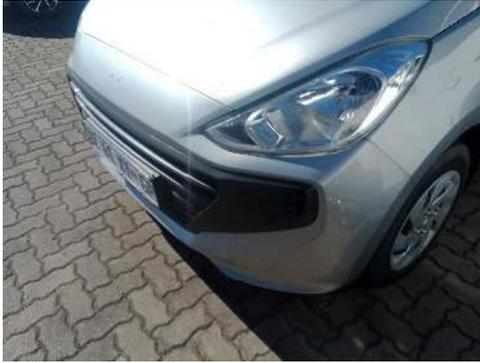
| Damage | Repair Way |
|---|---|
| Front Bumper Damaged | Repair |

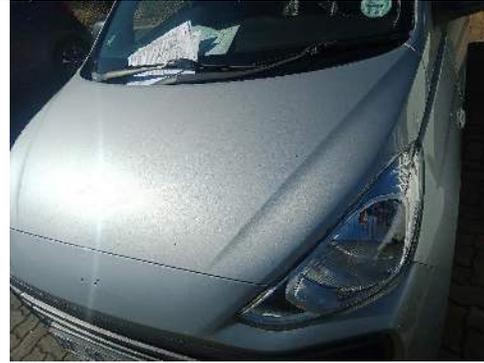
| Damage | Repair Way |
|---|---|
| Bonnet Damaged | Repair |

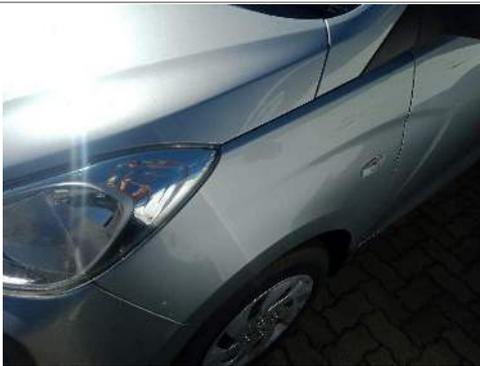
| Damage | Repair Way |
|---|---|
| Front Fender Left Damaged | Repair |

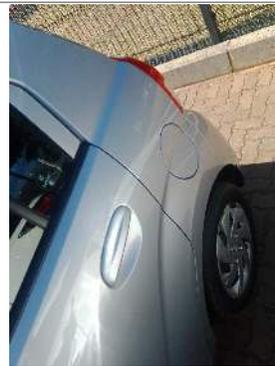
| Damage | Repair Way |
|---|---|
| Rear Fender Left Damaged | Repair |

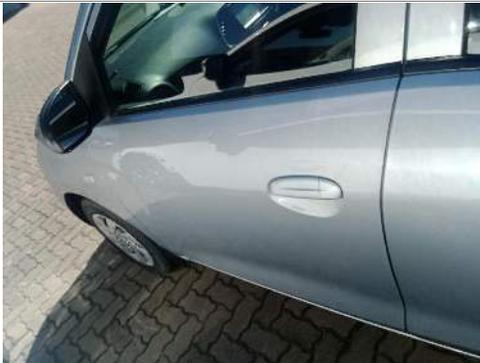
| Damage | Repair Way |
|---|---|
| Door Front Left Damaged | Repair |

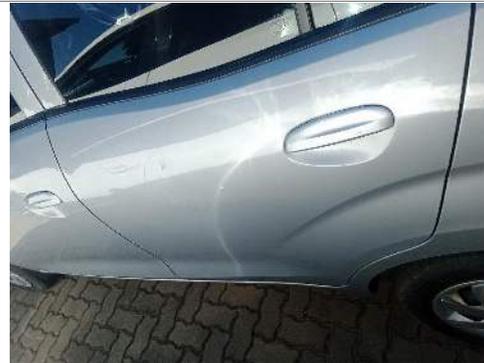
| Damage | Repair Way |
|---|---|
| Door Rear Left Damaged | Repair |

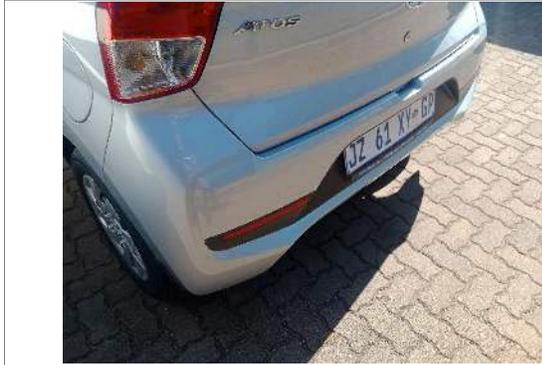
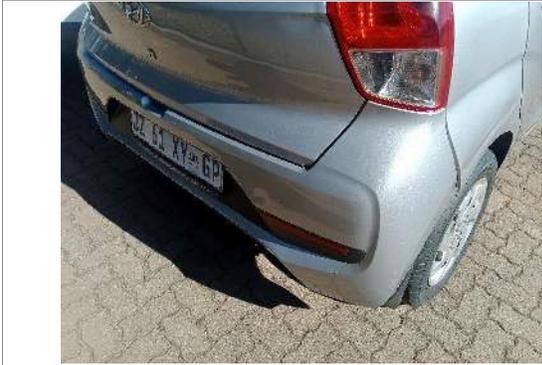
| Damage | Repair Way |
|---|---|
| Rear bumper Damaged | Repair |

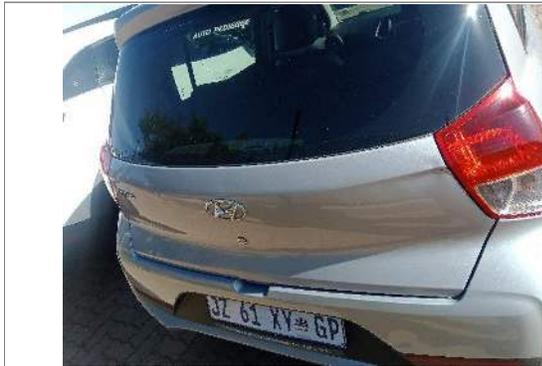
| Damage | Repair Way |
|---|---|
| Boot Lid / Hatch door Damaged | Repair |

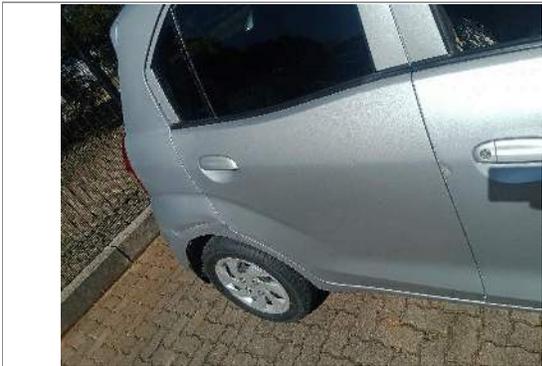
| Damage | Repair Way |
|---|---|
| Door Rear Right Damaged | Repair |

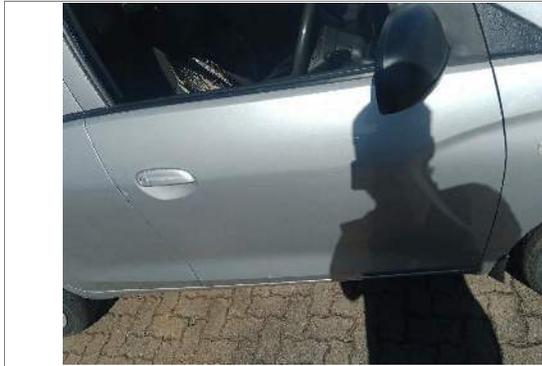
| Damage | Repair Way |
|---|---|
| Door Front Right Damaged | Repair |

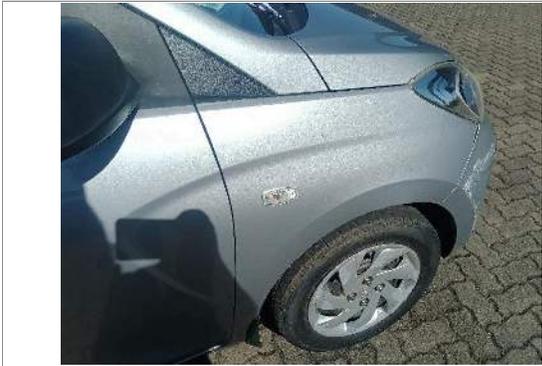
| Damage | Repair Way |
|---|---|
| Front Fender Right Damaged | Repair |

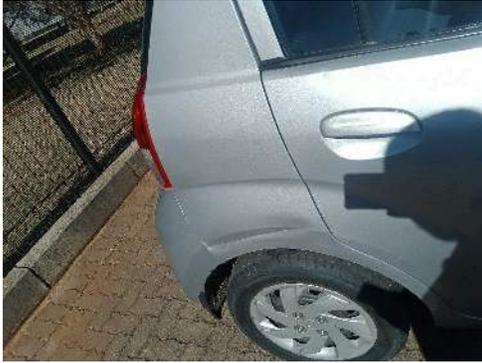
| Damage | Repair Way |
|---|---|
| Rear Fender Right Damaged | Repair |

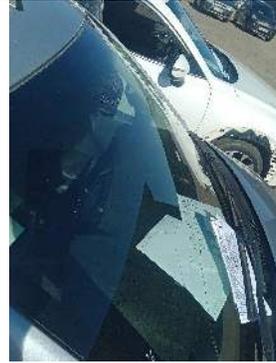
| Damage | Repair Way |
|---|---|
| Windscreen Damaged | Replace |

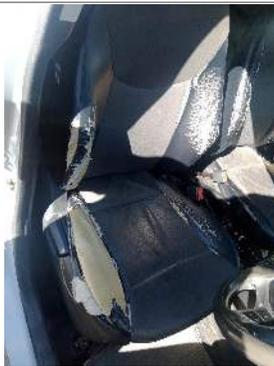
| Damage | Repair Way |
|---|---|
| Seat Front Right Damaged | Repair |

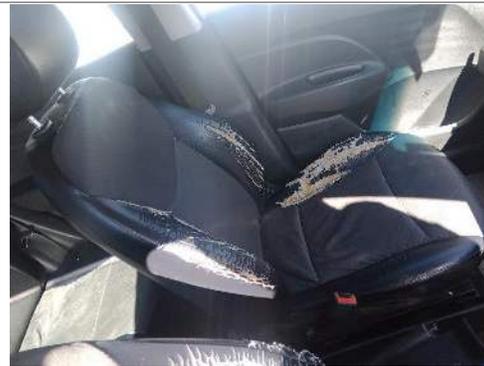
| Damage | Repair Way |
|---|---|
| Seat Front Left Damaged | Repair |

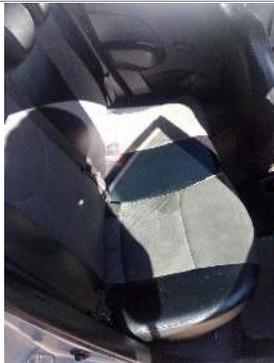
| Damage | Repair Way |
|---|---|
| Seat Rear Damaged | Repair |

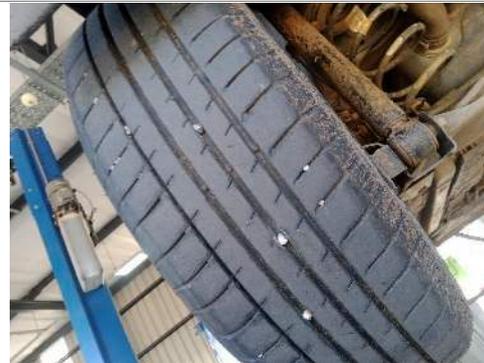
| Damage | Repair Way |
|---|---|
| Tyre Rear Left Worn | Replace |

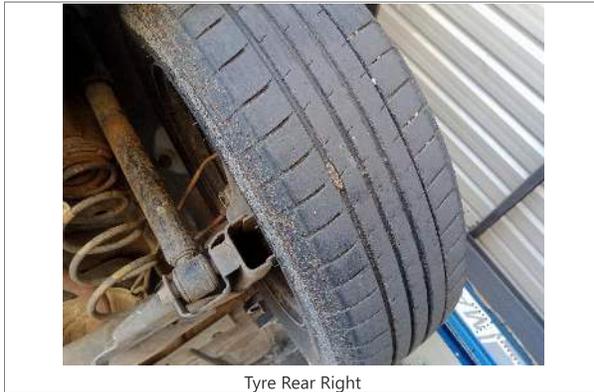
| Damage | Repair Way |
|---|---|
| Tyre Rear Right Worn | Replace |
