MFC Auction House  
M57 Pretoria Rd, Glenmarais, KEMPTON PARK  
Gauteng

Vehicle Type	PASSENGER VEHICLE	Registered Owner	MFC
Manufacturer	HYUNDAI	Registration Number	KD13JNGP
Model	ATOS	Register Number	
VIN	MALAF51CLNM151166	Date Of First Licensing	
Engine Number		Last COR	
Doors	5	License Expiry Date	31/07/2023
Color	SILVER	Power / Displacement	
Year Model		Paint Finish	M - METALLIC
Km Reading	32,959 KM	Fuel	PETROL
Cab / Body Type	HATCHBACK	Transmission	MANUAL

### VEHICLE INSPECTION

Report No: 2016209356

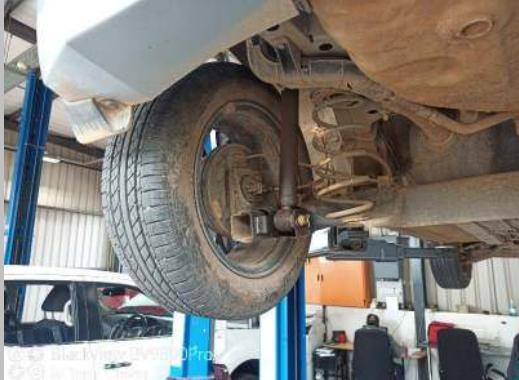
LR TYRE TREAD

Size	Load/Speed Index	Manufacture	Model	Type*	Production Date	Tread Depth (mm)
Front Left	185/60R14	82H	Gt radial	Champro	V	5020	3 mm
Front Right	185/60R14	82H	Gt radial	Champro	V	1020	3 mm
Rear Left	185/60R14	82H	Gt radial	Champro	V	0221	4 mm
Rear Right	185/60R14	82H	Gt radial	Champro	V	1020	4 mm
Spare	175/70R13	82T	Dunlop	Sp sport	V	///	0 mm

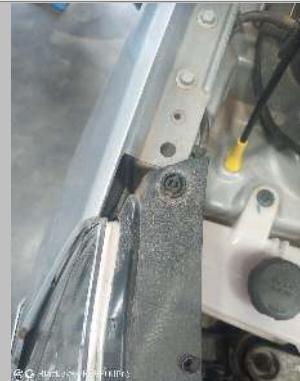
Damage	Repair Way
Indicator Light Front Left Missing	Replace
Headlight Right Damaged	Repair
Seat Front Right Torn / Cut	Repair
Front Bumper Paintwork • Scratched	Repair
Bonnet slam plate (Shock tower/ Inner tray) Corrosion	Repair
A • Pillar Right Dented	Repair
Front Fender Left Residual Traces of Repair	Replace
Front Fender Right Residual Traces of Repair	Replace
Rear Fender Right Paintwork • Scratched	Repair
Door Front Left Dented	Repair
Boot Lid / Hatch door Dented	Repair
Rear bumper Paintwork • Scratched	Repair
Fuel Flap Damaged	Replace
Sill Panel Left Dented	Repair
Windscreen Chipped	Repair
Window Rear Door Right Damaged	Replace
Shock Absorber Rear Left Leak	Replace
Spare Tyre Damaged	Replace
Radiator Cradle Damaged	Repair
Battery loose	Repair
R/F fender line missing	Replace
