CONDITION REPORT

Report No: 2016467642

MFC Auction House
M57 Pretoria Rd, Glenmarais, KEMPTON PARK
Gauteng

Vehicle Type	PASSENGER VEHICLE	Registered Owner	
Manufacturer	HYUNDAI	Registration Number	KR24RKGP
Model	ATOS	Register Number	
VIN	MALAF51CLNM181544	Date Of First Licensing	
Engine Number		Last COR	
Doors	5	License Expiry Date	30/06/2023
Color	SILVER	Power / Displacement	
Year Model		Paint Finish	M - METALLIC
Km Reading	27,251 KM	Fuel	PETROL
Cab / Body Type	HATCHBACK	Transmission	MANUAL

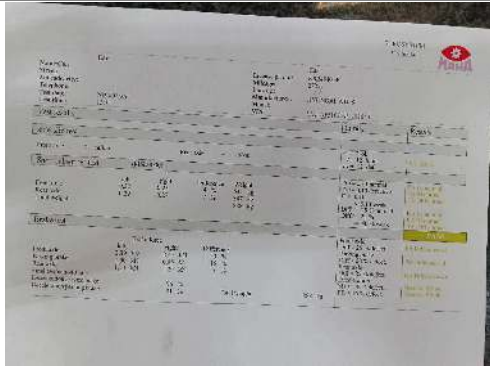
Shock and brake report

Left	Right	Axle Weight [KG]	Deceleration [m/s ²]
	Braking Force [KN]	Braking Force [KN]		
Front	2.3	2.4	-	
Rear	1.7	1.7	-	
Emergency / Parking	1	0.8	-

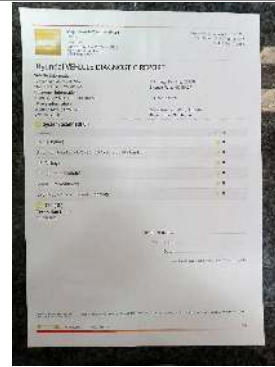
Diagnostic test

During the diagnostic no active error messages were detected. (See also attached Diagnostic Report. For more information regarding the Fault Codes (DTC) and the recommended rectifications please contact the workshops of the vehicle manufacture).

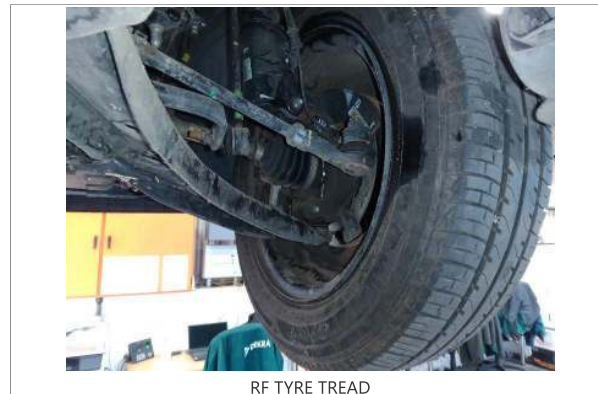
RF TYRE TREAD

Size	Load/Speed Index	Manufacture	Model	Type*	Production Date	Tread Depth (mm)
Front Left	165/70R14	81T	MRF	ZVTV	V	0000	5 mm
Front Right	165/70R14	81T	MRF	ZVTV	V	0000	3 mm
Rear Left	175/70R14	81T	MRF	ZVTV	V	0000	5 mm
Rear Right	165/70R14	81T	MRF	ZVTV	V	0000	5 mm
Spare	155/80R13	79T	MRF	ZVTV	V	0000	6 mm

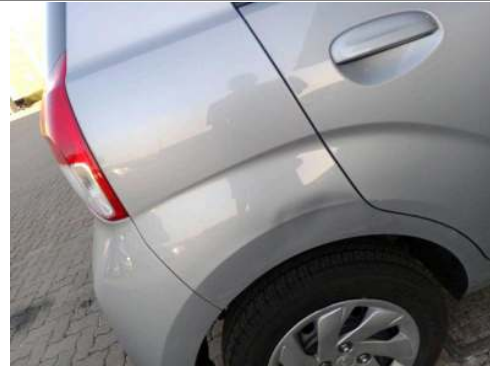
Damage	Repair Way
Front Bumper Paintwork • Scratched	Repair
Front Fender Left Dented	Repair
Rear Fender Right Dented	Repair
