MFC Auction House  
M57 Pretoria Rd, Glenmarais, KEMPTON PARK  
Gauteng

DEKRA MFC  
M57 Pretoria Rd - 1619  
KEMPTON PARK - GT  
08610 33572

## Assignment

| Manufacturer | HYUNDAI | Registration Number | CY34JNGP |

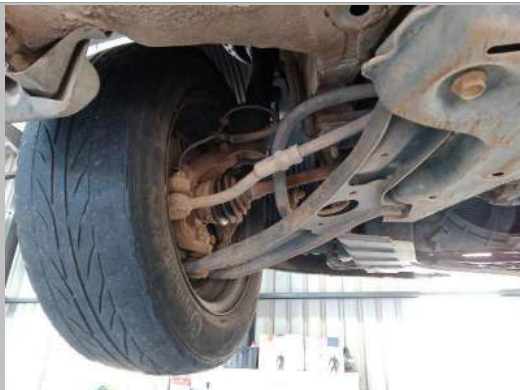
LF TYRE TREAD

| Damage | Repair Way |
|---|---|
| Tyre Front Left Worn | Replace |

| | Size | Load/Speed Index | Manufacture | Model | Type* | Production Date | Tread Depth (mm) |
|---|---|---|---|---|---|---|---|
| Front Left | 185/60 R14 | 82H | Symmetry | SY201 | V | 4417 | 0 mm |

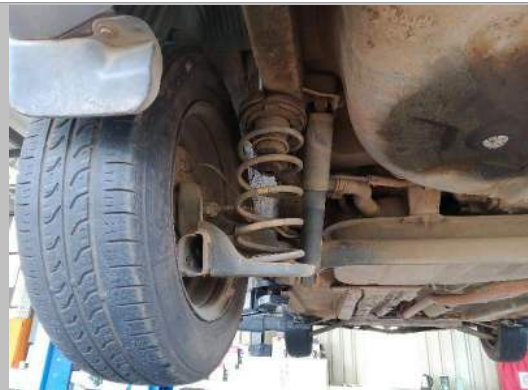
LR TYRE TREAD

| Damage | Repair Way |
|---|---|
| Tyre Rear Left Damaged | Replace |

| | Size | Load/Speed Index | Manufacture | Model | Type* | Production Date | Tread Depth (mm) |
|---|---|---|---|---|---|---|---|
| Rear Left | 185/65 R14 | 86H | Kumho | Sense | V | 4119 | 0 mm |

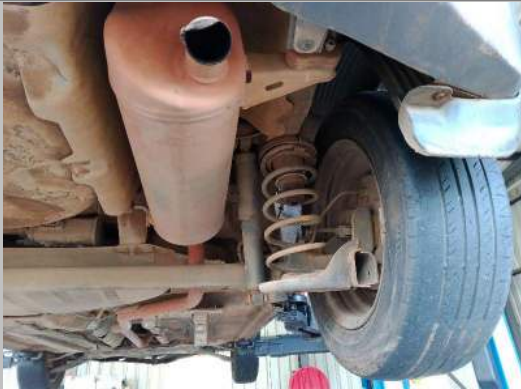
RR TYRE TREAD

| Damage | Repair Way |
|---|---|
| Tyre Rear Right Damaged | Replace |

| | Size | Load/Speed Index | Manufacture | Model | Type* | Production Date | Tread Depth (mm) |
|---|---|---|---|---|---|---|---|
| Rear Right | 185/65 R14 | 86H | Fullway | Radial | V | 2815 | 0 mm |

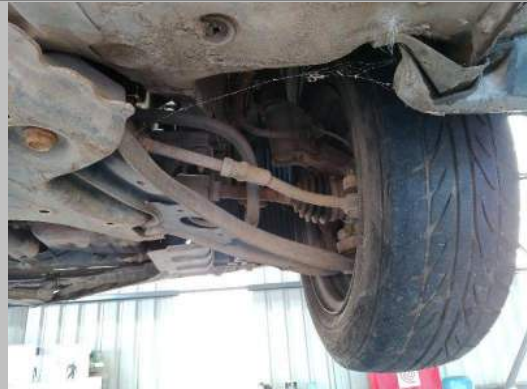
RF TYRE TREAD

| Damage | Repair Way |
|---|---|
| Tyre Front Right Worn | Replace |

| | Size | Load/Speed Index | Manufacture | Model | Type* | Production Date | Tread Depth (mm) |
|---|---|---|---|---|---|---|---|
| Front Right | 185/60 R14 | 82H | Symmetry | SY201 | V | 1919 | 0 mm |

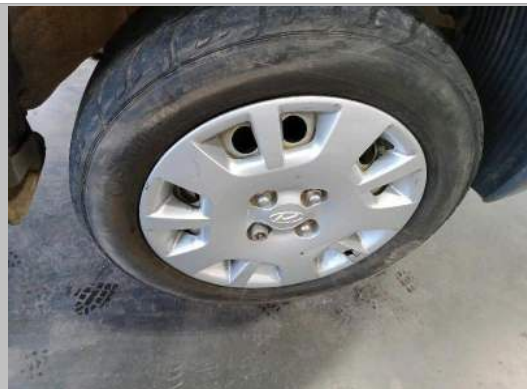
Front right hubcap

| Damage | Repair Way |
|---|---|
| Tyres and rims | Front left and right hubcaps damaged |

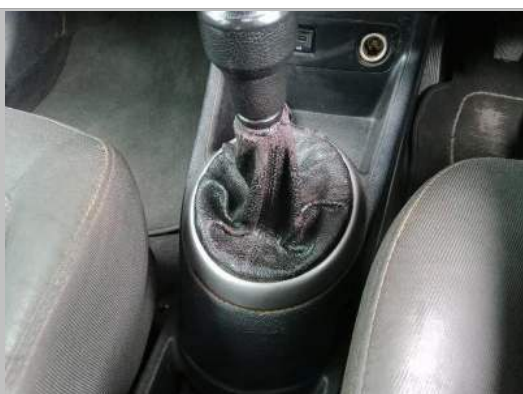
### Gear Lever Dust Boot

| Damage | Repair Way |
|---|---|
| Gear Lever Dust Boot Worn | Repair |

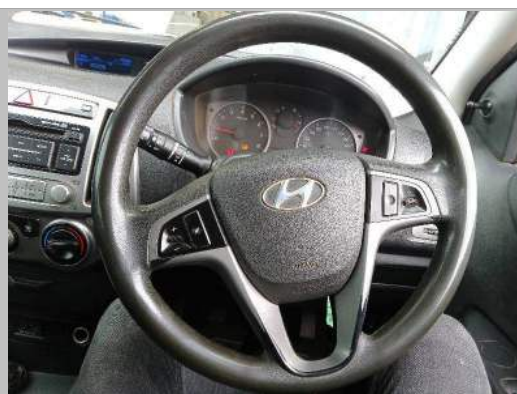
## Steering Wheel Trim

| Damage | Repair Way |
|---|---|
| Steering Wheel Trim Defective | Repair |

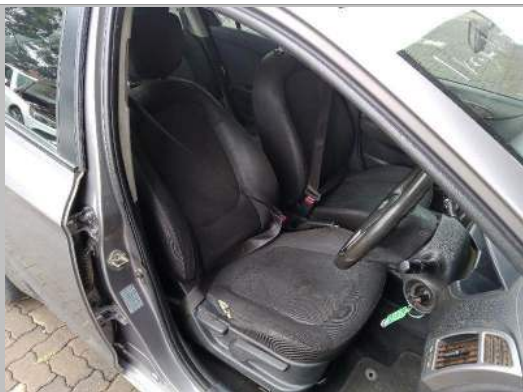
| Damage | Repair Way |
|---|---|
| Seat Front Right Damaged | Repair |

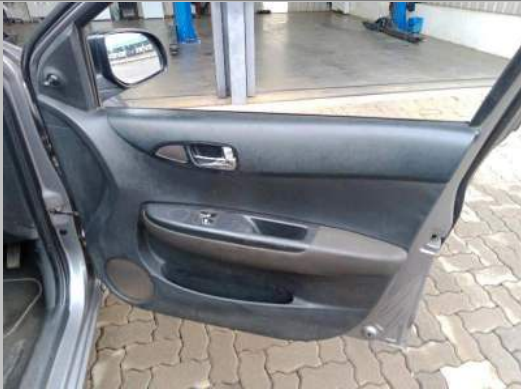
| Damage | Repair Way |
|---|---|
| Door Panel Front Right Defective | Repair |

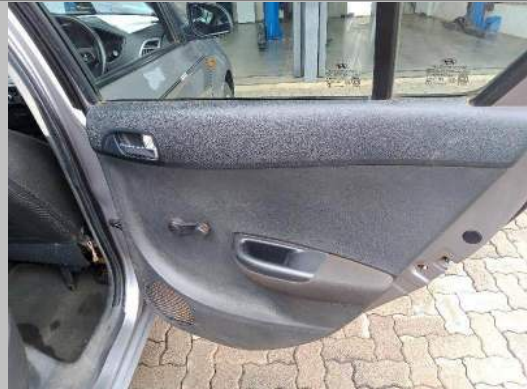
| Damage | Repair Way |
|---|---|
| Door Panel Rear Right Defective | Repair |

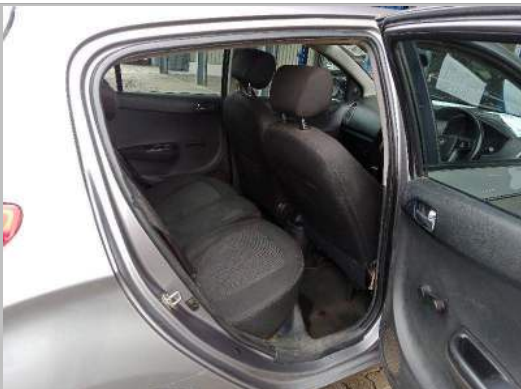
| Damage | Repair Way |
|---|---|
| Door Sealing Rubber Rear Right Damaged | Replace |

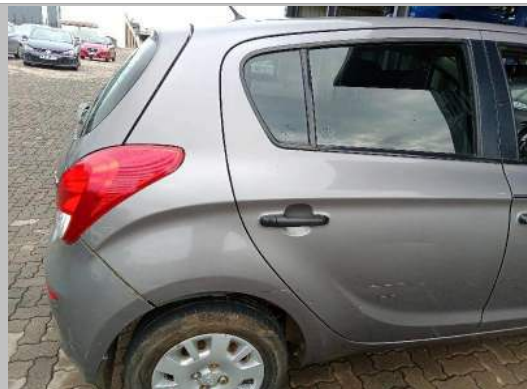
| Damage | Repair Way |
|---|---|
| Rear Fender Right Damaged | Repair |

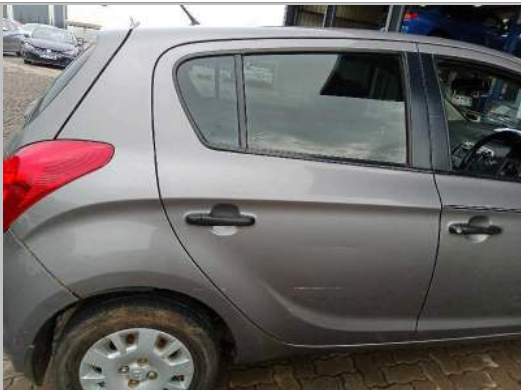
| Damage | Repair Way |
|---|---|
| Door Rear Right Damaged | Repair |

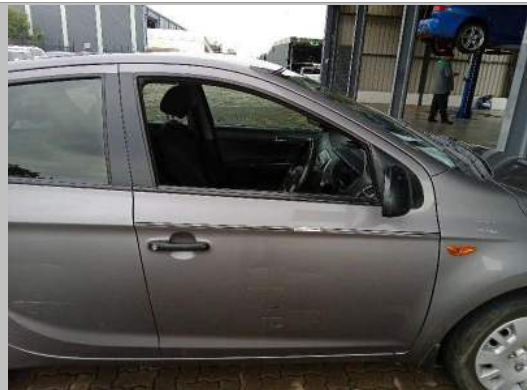
| Damage | Repair Way |
|---|---|
| Door Front Right Damaged | Repair |

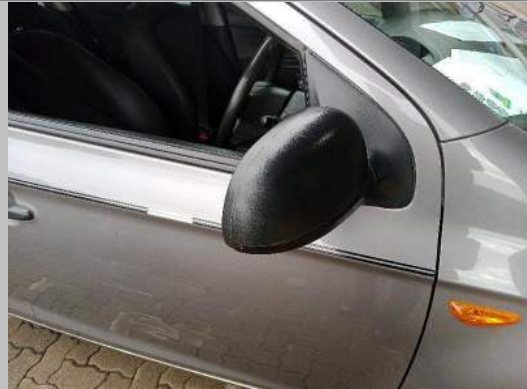
| Damage | Repair Way |
|---|---|
| Side Mirror Right Paintwork • Scratched | Repair |

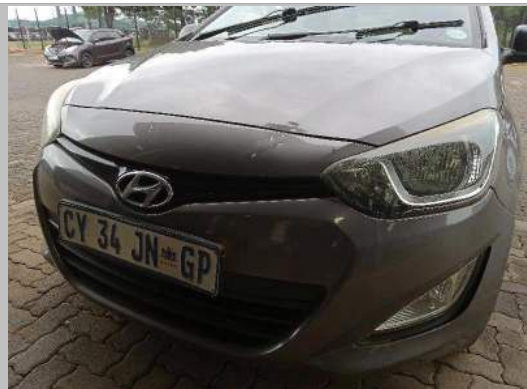
| Damage | Repair Way |
|---|---|
| Front Bumper Damaged | Repair |

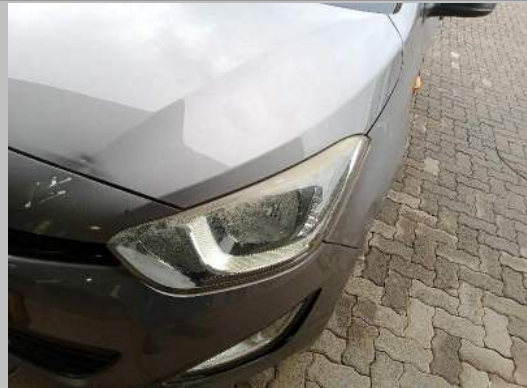
| Damage | Repair Way |
|---|---|
| Headlight Left Defective | Repair |

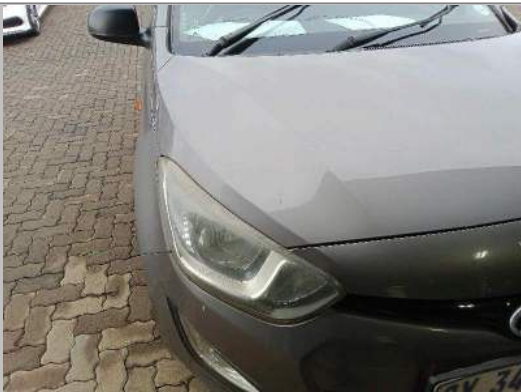
| Damage | Repair Way |
|---|---|
| Headlight Right Defective | Repair |

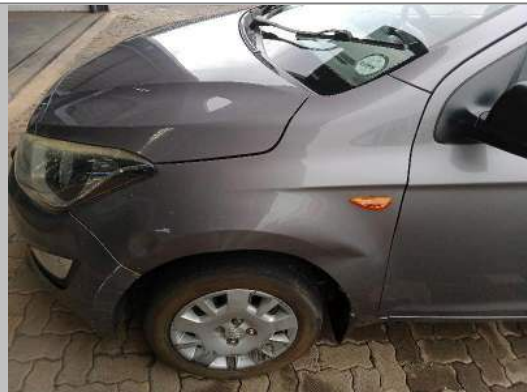
| Damage | Repair Way |
|---|---|
| Front Fender Left Damaged | Repair |

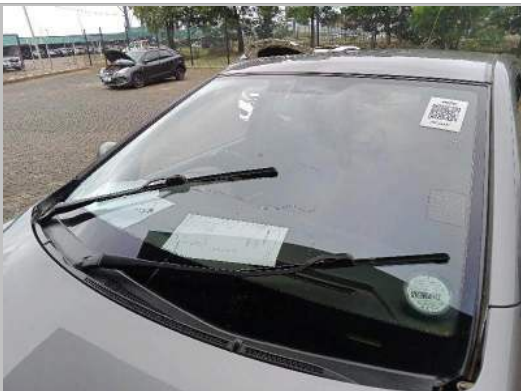
| Damage | Repair Way |
|---|---|
| Windscreen Cracked | Replace |

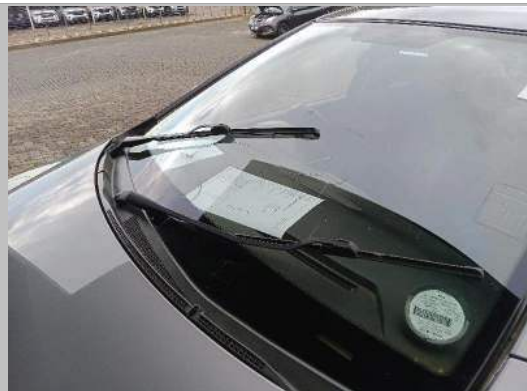
| Damage | Repair Way |
|---|---|
| Windscreen Wiper Malfunction | Repair |

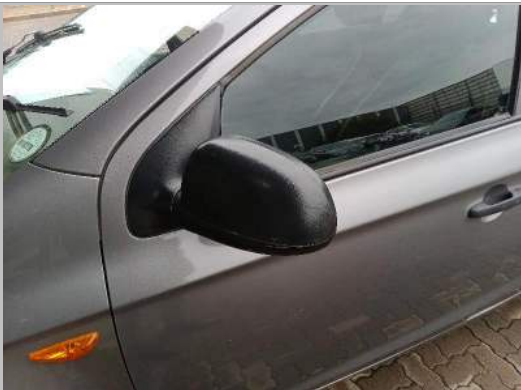
| Damage | Repair Way |
|---|---|
| Side Mirror Left Paintwork • Scratched | Repair |

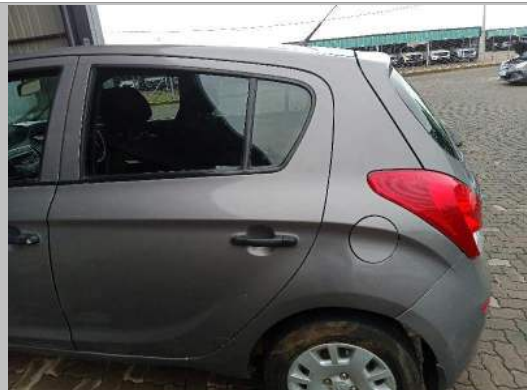
| Damage | Repair Way |
|---|---|
| Rear Fender Left Residual Traces of Repair | Repair |

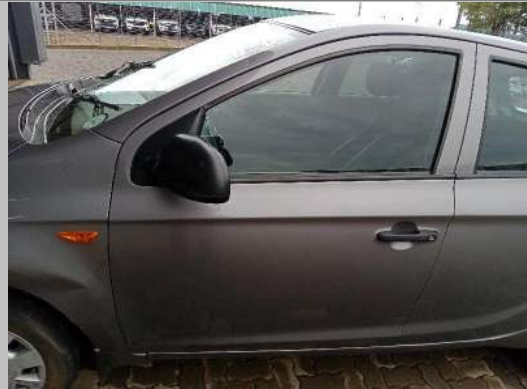
| Damage | Repair Way |
|---|---|
| Door Front Left Damaged | Repair |

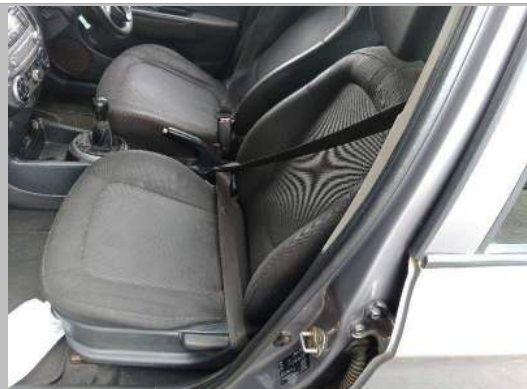
| Damage | Repair Way |
|---|---|
| Seat Front Left Dirty | Repair |

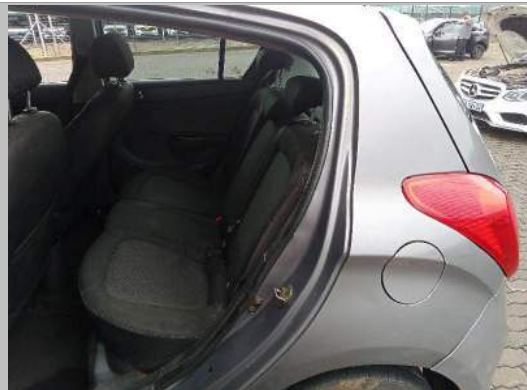
| Damage | Repair Way |
|---|---|
| C • Pillar Left Residual Traces of Repair | Repair |

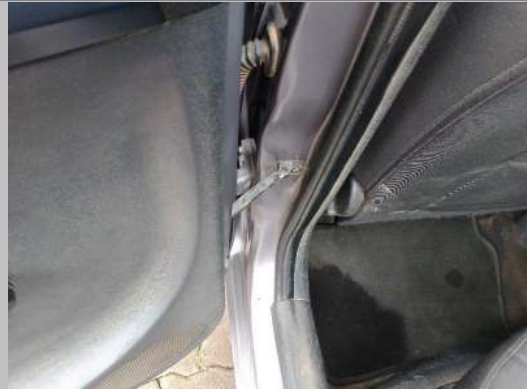
| Damage | Repair Way |
|---|---|
| Doorstopper Rear Left Damaged | Replace |

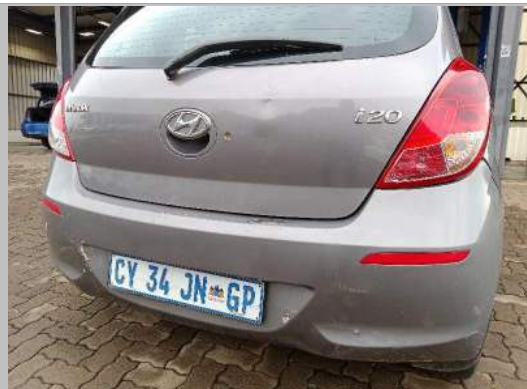
| Damage | Repair Way |
|---|---|
| Rear bumper Damaged | Repair |

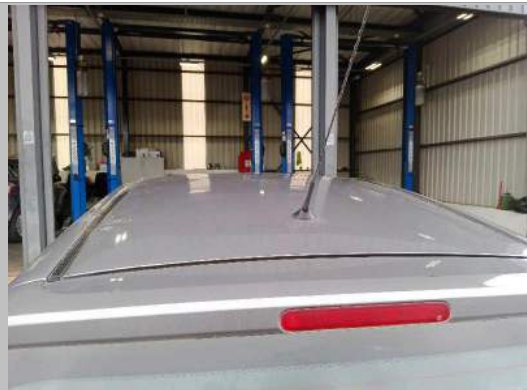
| Damage | Repair Way |
|---|---|
| Roof Dented | Repair |

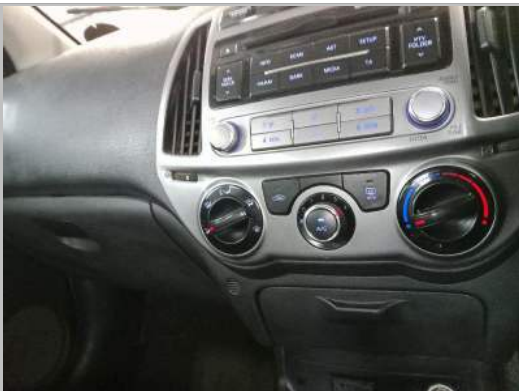
| Damage | Repair Way |
|---|---|
| Air Conditioner Insufficient | Replace |

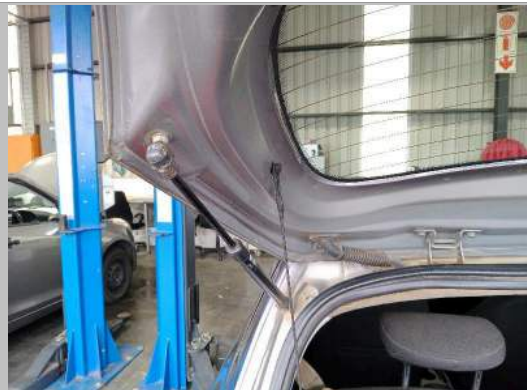
| Damage | Repair Way |
|---|---|
| Boot Lid / Hatch Door Shock Left Damaged | Replace |

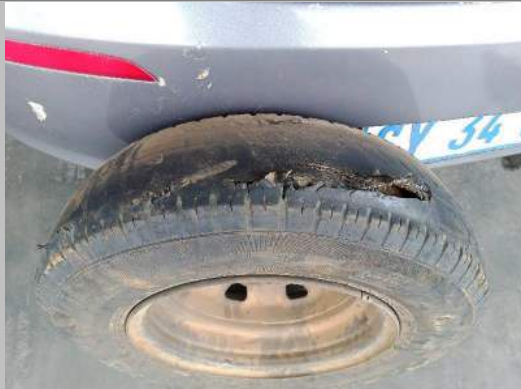
| Damage | Repair Way |
|---|---|
| Spare Tyre Damaged | Replace |

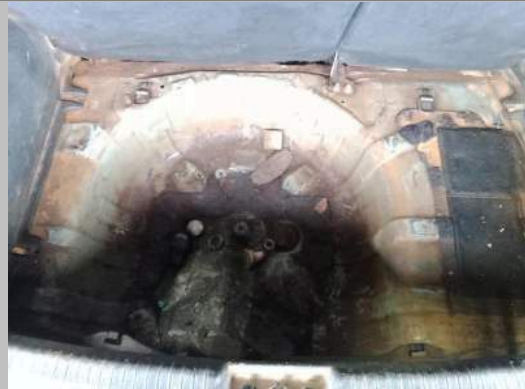
| Damage | Repair Way |
|---|---|
| Inner Boot Floor Pan and Spare Wheel Well Dented | Repair |

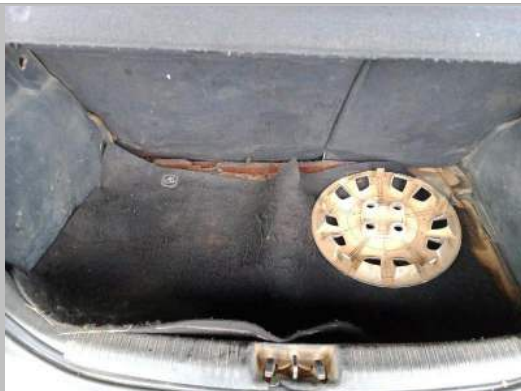
| Damage | Repair Way |
|---|---|
| Boot Carpet Damaged | Repair |

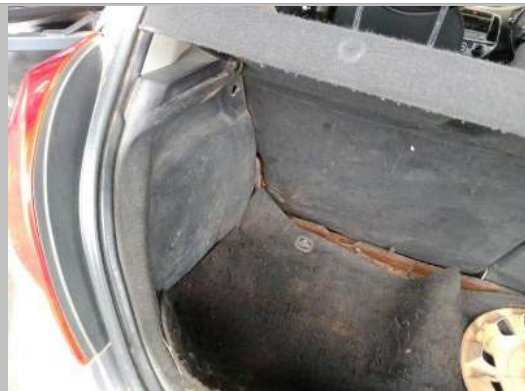
| Damage | Repair Way |
|---|---|
| Boot Panel Left Defective | Repair |

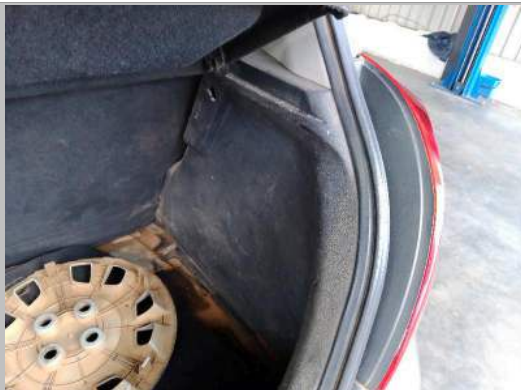
| Damage | Repair Way |
|---|---|
| Boot Panel Right Defective | Repair |

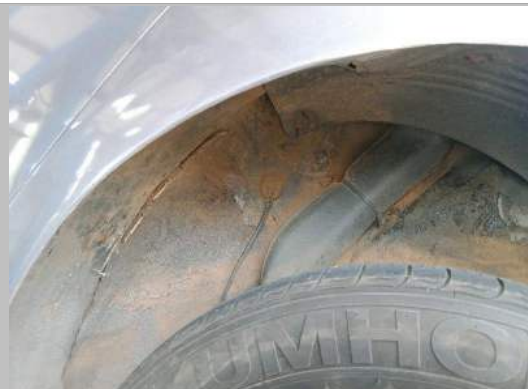
| Damage | Repair Way |
|---|---|
| Rear Fender Left / Inner Tray Damaged | Repair |

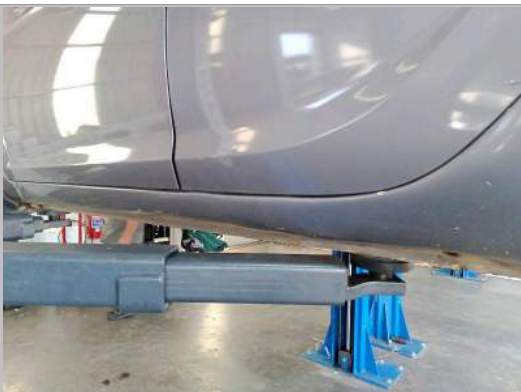
| Damage | Repair Way |
|---|---|
| Sill Panel Left Residual Traces of Repair | Repair |

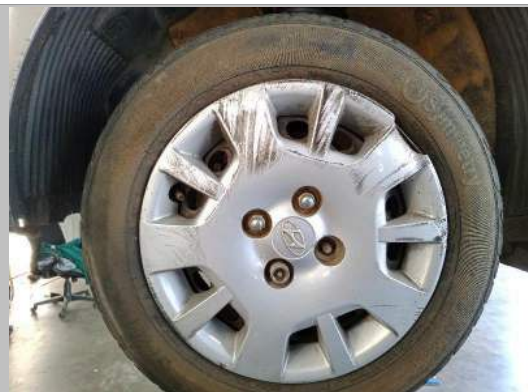
| Damage | Repair Way |
|---|---|
| Bolt(s) / Nut(s) Front Wheel Left Missing | Replace |

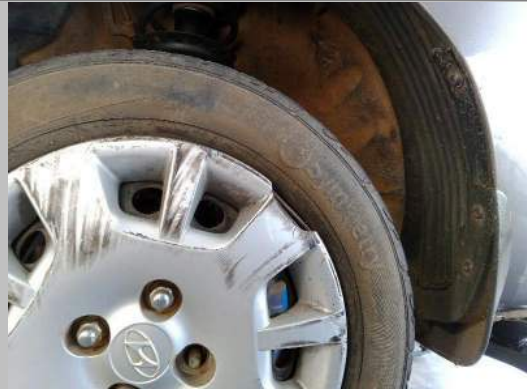
| Damage | Repair Way |
|---|---|
| Rim Front Left Dented | Repair |

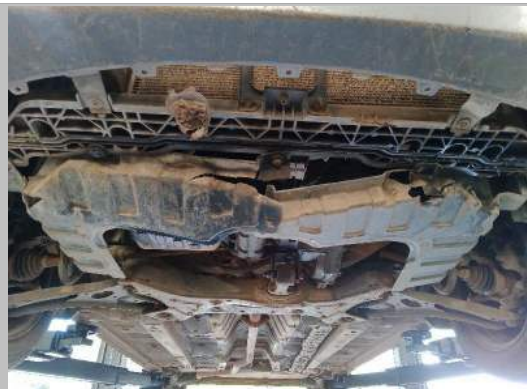
| Damage | Repair Way |
|---|---|
| Belly plates Damaged | Replace |

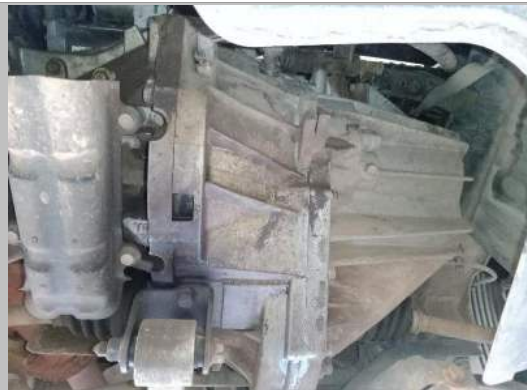
| Damage | Repair Way |
|---|---|
| Gearbox Oil Sweat | Repair |

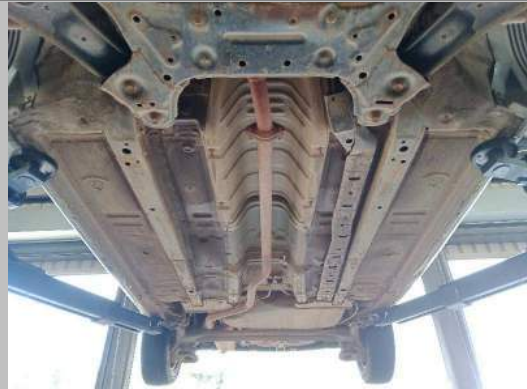
| Damage | Repair Way |
|---|---|
| Chassis Damaged | Repair |

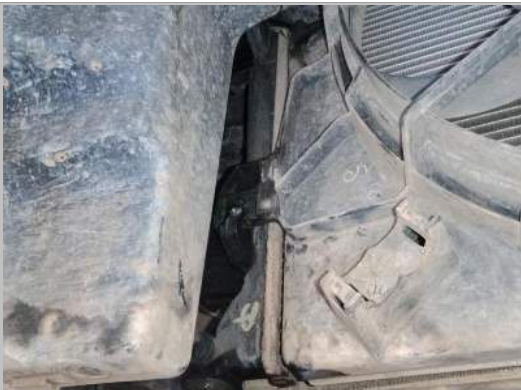
| Damage | Repair Way |
|---|---|
| Radiator Water Leak | Replace |

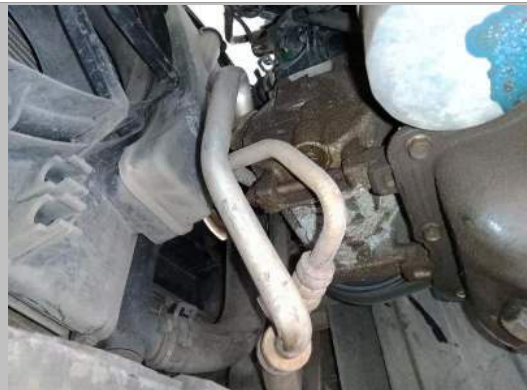
| Damage | Repair Way |
|---|---|
| Air conditioner pipes Defective | Repair |

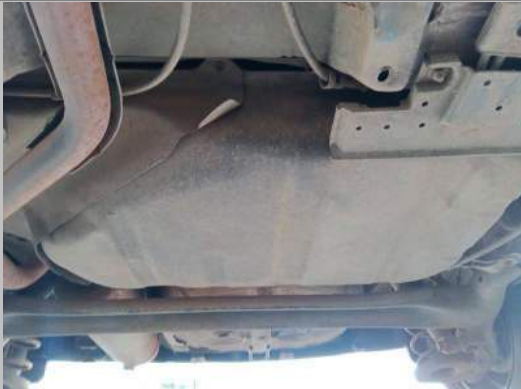
| Damage | Repair Way |
|---|---|
| Fuel Tank Dented | Repair |

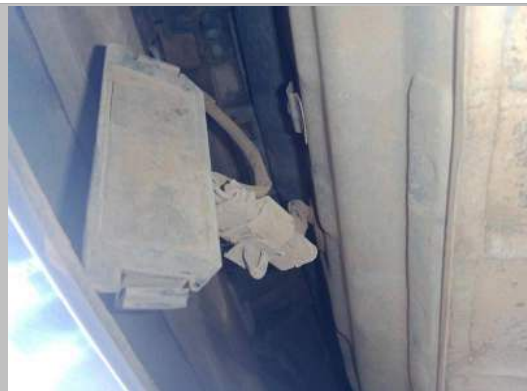
| Damage | Repair Way |
|---|---|
| Number Plate Light Left Defective | Repair |

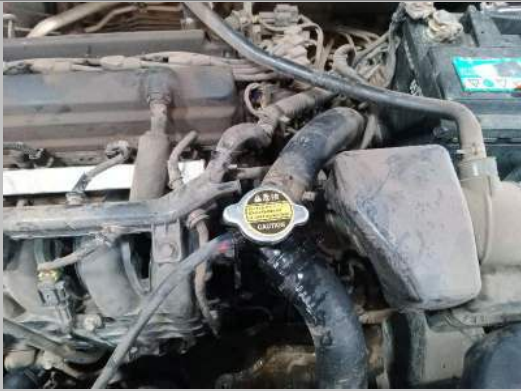
| Damage | Repair Way |
|---|---|
| Caps Damaged | Replace |

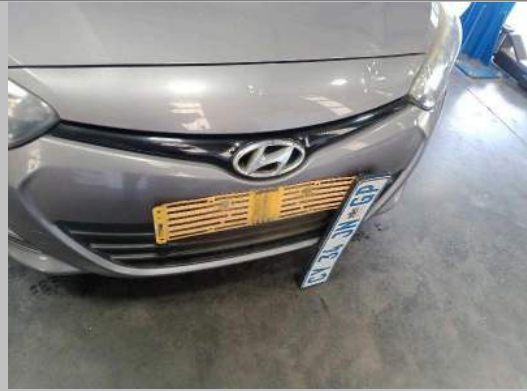
| Damage | Repair Way |
|---|---|
| Number Plate Front Damaged | Repair |

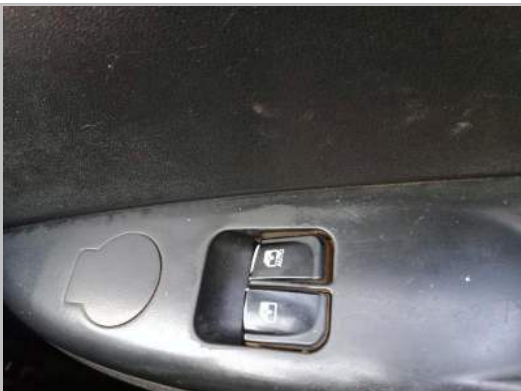
| Damage | Repair Way |
|---|---|
| Switch Electrical Window Winder front right Damaged | Replace |
