## CONDITION REPORT

Report No:  
2016962855  
DATE  
30/07/2025

| Manufacturer | HYUNDAI | Registration Number | BT89BSGP |
| Model | I20 1.4 GL 5-DR [2009-2013] | Register Number | |

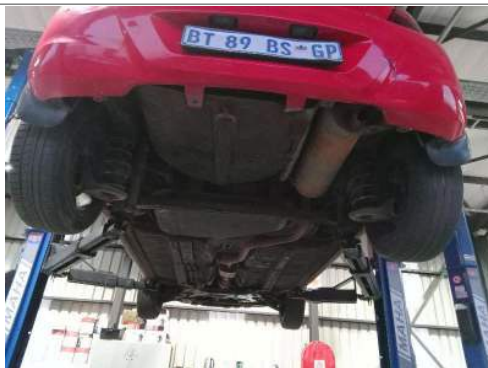
Rear chassis

| Damage | Repair Way |
|---|---|
| Chassis Damaged | Repair |

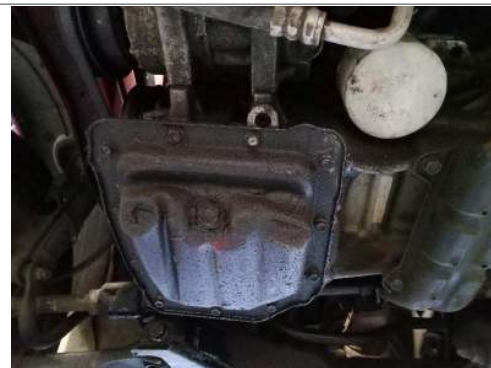
| Damage | Repair Way |
|---|---|
| Engine | Engine oil sump damaged |

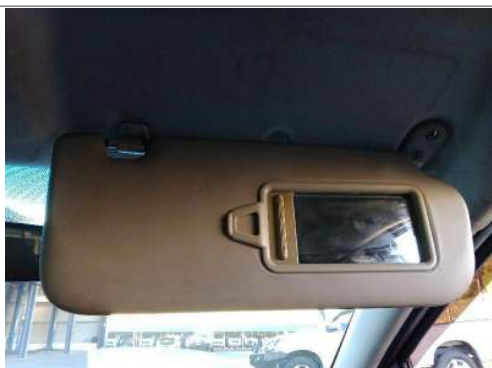
| Damage | Repair Way |
|---|---|
| Sun Visor Left Defective | Repair |

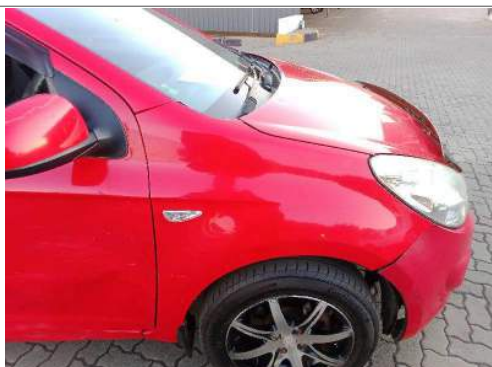
| Damage | Repair Way |
|---|---|
| Front Fender Right Damaged | Repair |

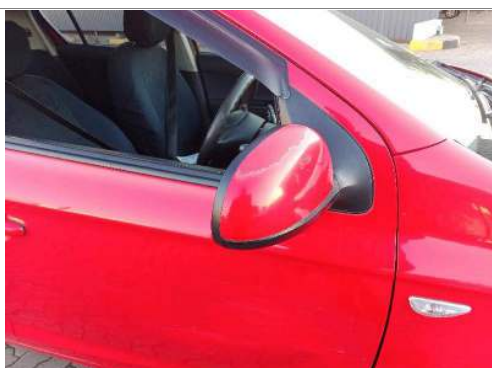
| Damage | Repair Way |
|---|---|
| Side Mirror Right Paintwork • Scratched | Repair |

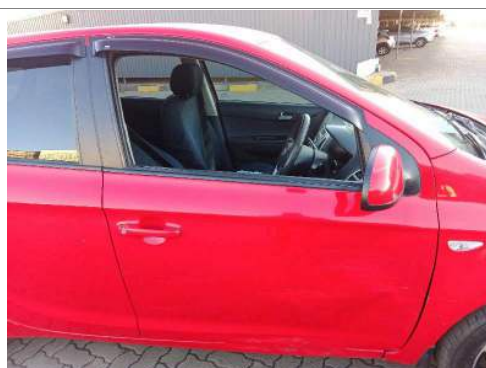
| Damage | Repair Way |
|---|---|
| Door Front Right Damaged | Repair |

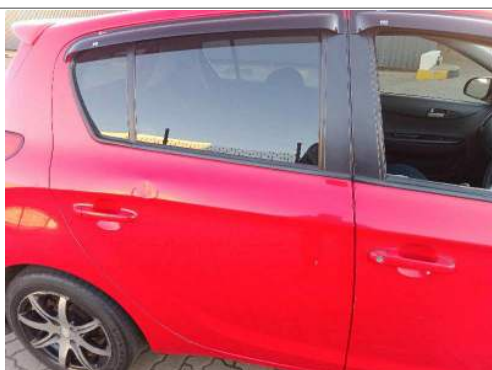
| Damage | Repair Way |
|---|---|
| Door Rear Right Damaged | Repair |

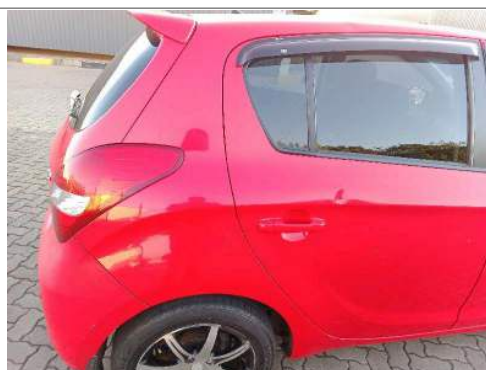
| Damage | Repair Way |
|---|---|
| Rear Fender Right Dented | Repair |

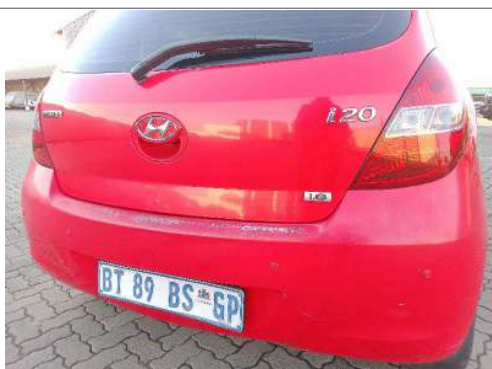
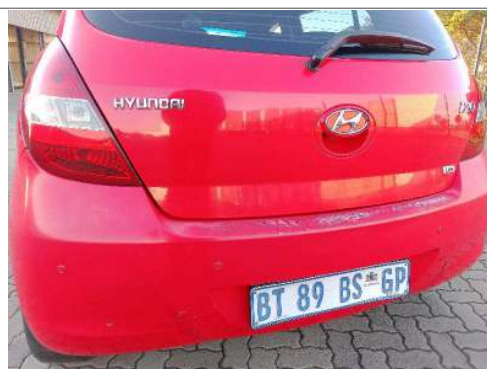
| Damage | Repair Way |
|---|---|
| Rear bumper Damaged | Repair |

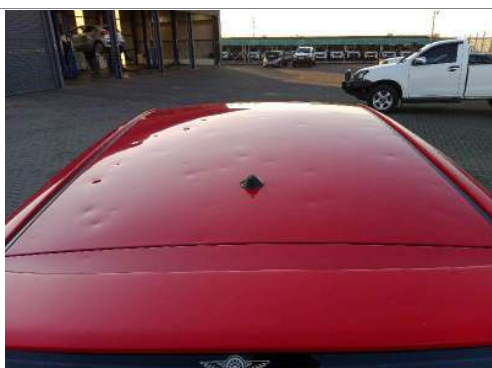
| Damage | Repair Way |
|---|---|
| Roof Damaged | Repair |

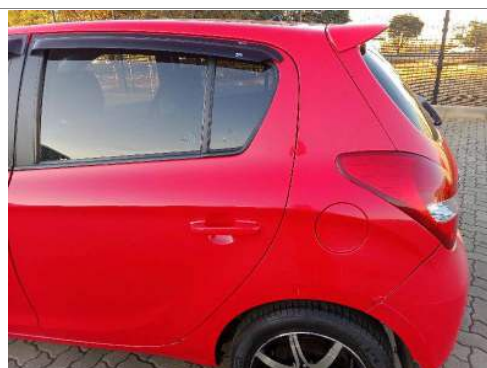
| Damage | Repair Way |
|---|---|
| Rear Fender Left Damaged | Repair |

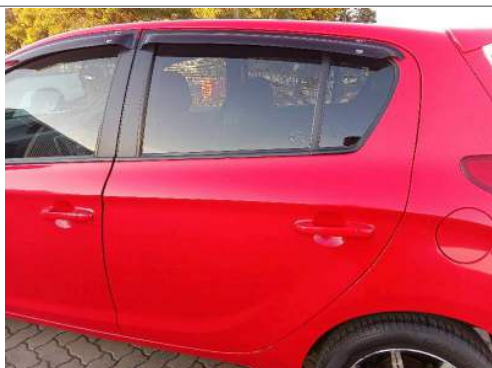
| Damage | Repair Way |
|---|---|
| Door Rear Left Paintwork • Scratched | Repair |

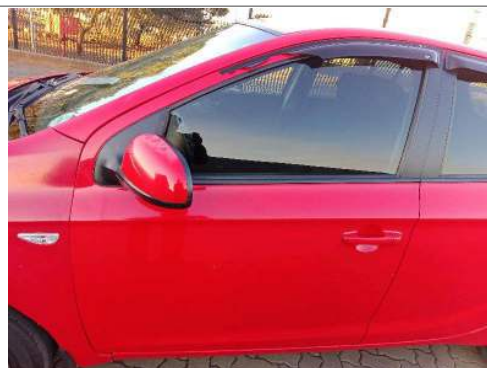
| Damage | Repair Way |
|---|---|
| Door Front Left Dented | Repair |

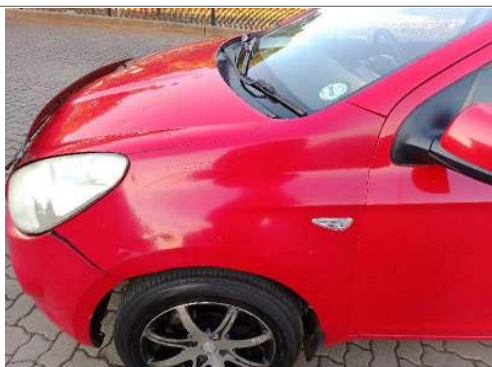
| Damage | Repair Way |
|---|---|
| Front Fender Left Damaged | Repair |

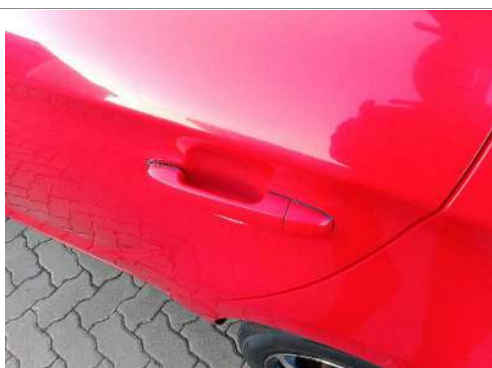
| Damage | Repair Way |
|---|---|
| Door Handle Rear Left Damaged | Replace |

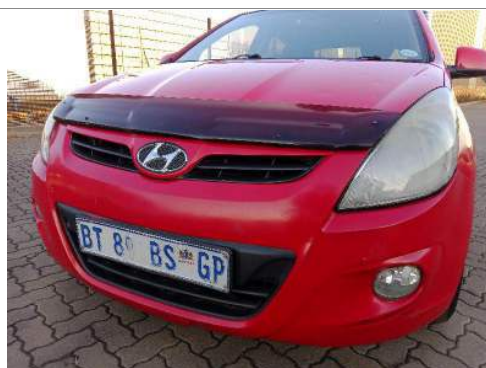
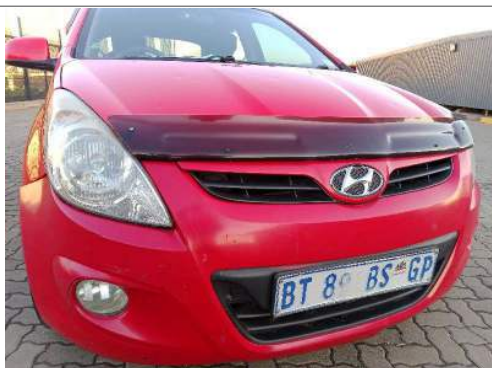
| Damage | Repair Way |
|---|---|
| Front Bumper Damaged | Repair |

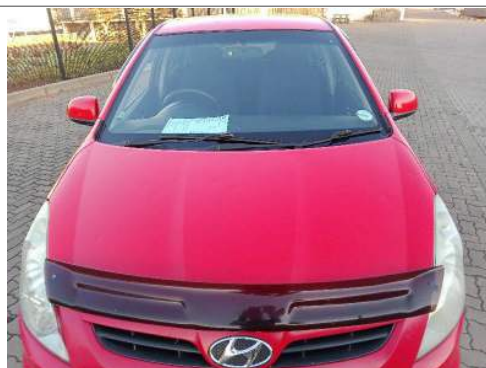
| Damage | Repair Way |
|---|---|
| Bonnet Dented | Repair |

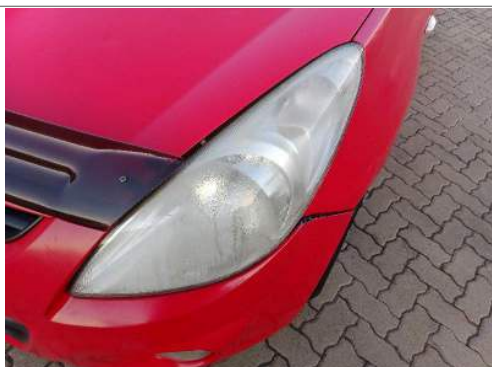
| Damage | Repair Way |
|---|---|
| Headlight Left Damaged | Replace |

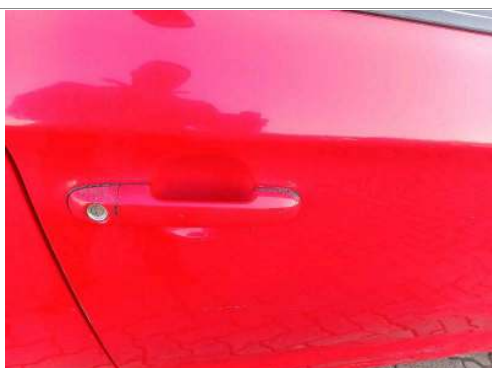
| Damage | Repair Way |
|---|---|
| Door Handle Front Right Damaged | Replace |

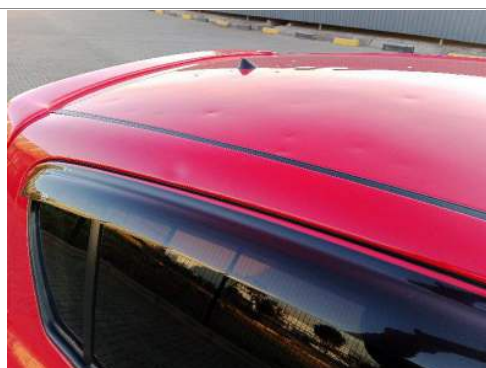
| Damage | Repair Way |
|---|---|
| C • Pillar Right Damaged | Repair |

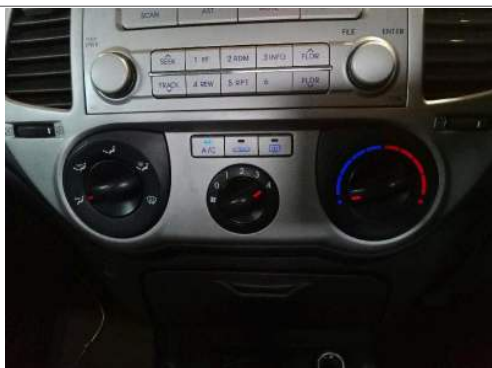
| Damage | Repair Way |
|---|---|
| Air Conditioner Insufficient | Replace |

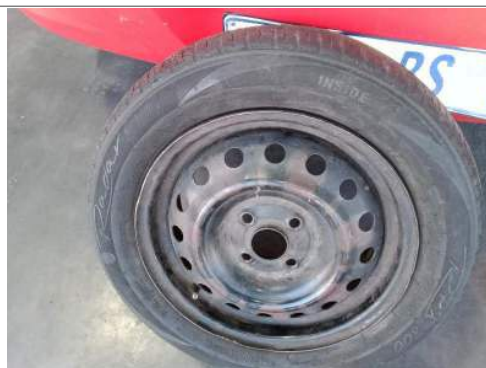
| Damage | Repair Way |
|---|---|
| Rim Spare Wheel Damaged | Repair |

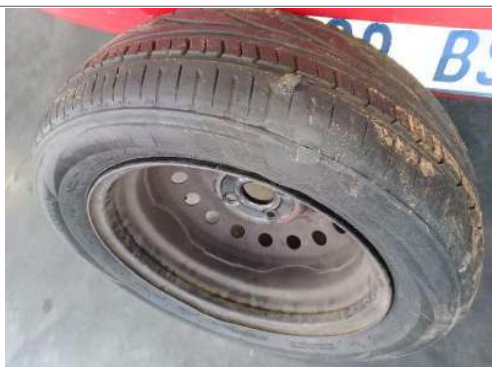
| Damage | Repair Way |
|---|---|
| Spare Tyre Damaged | Replace |

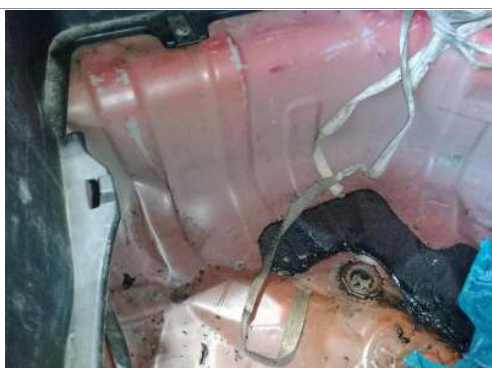
| Damage | Repair Way |
|---|---|
| Inner Boot Floor Pan and Spare Wheel Well Damaged | Repair |

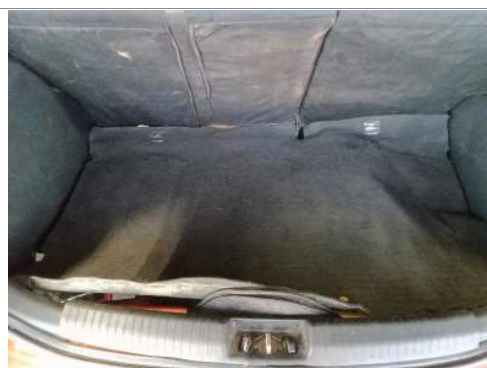
| Damage | Repair Way |
|---|---|
| Boot Carpet Damaged | Repair |

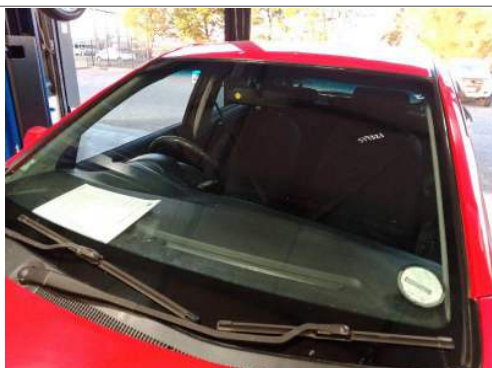
| Damage | Repair Way |
|---|---|
| Windscreen Chipped | Repair |

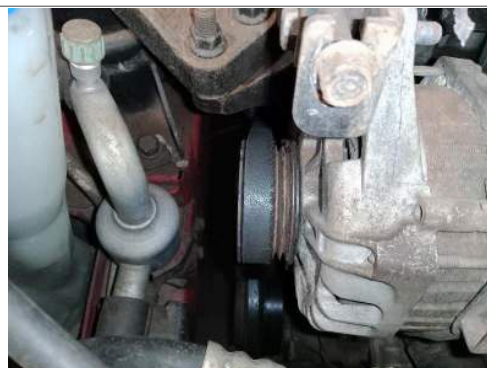
| Damage | Repair Way |
|---|---|
| Fan Belt Damaged | Replace |

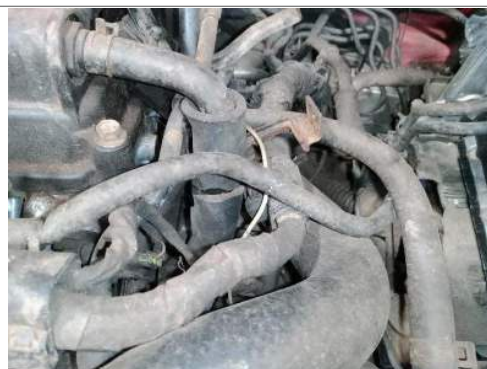
| Damage | Repair Way |
|---|---|
| Engine Wiring Defective | Repair |

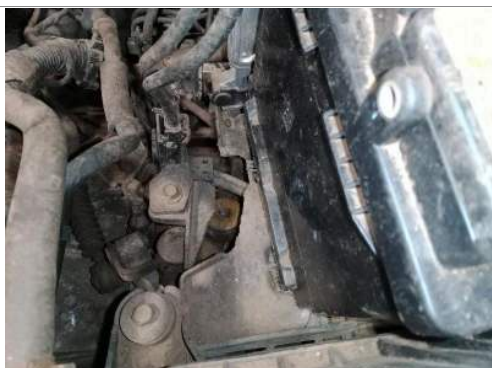
| Damage | Repair Way |
|---|---|
| Battery box Damaged | Replace |

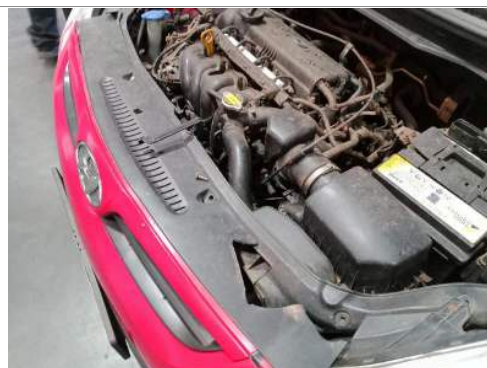
| Damage | Repair Way |
|---|---|
| Bonnet slam plate (Shock tower/ Inner tray) Damaged | Replace |

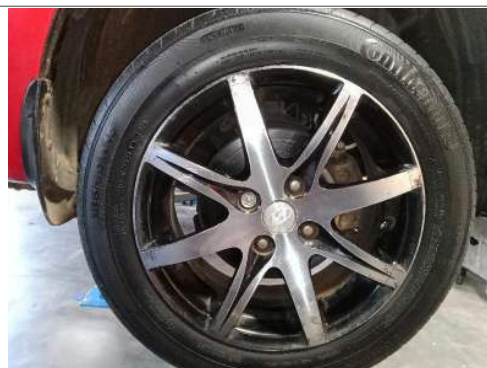
| Damage | Repair Way |
|---|---|
| Rim Front Right Damaged | Repair |

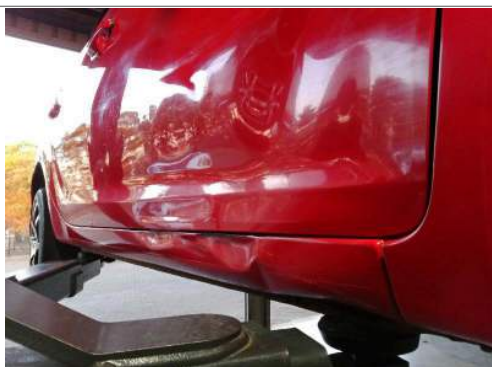
| Damage | Repair Way |
|---|---|
| Sill Panel Right Damaged | Repair |

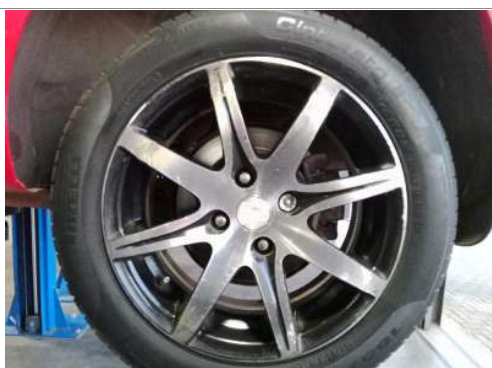
| Damage | Repair Way |
|---|---|
| Rim Rear Left Scratched | Repair |

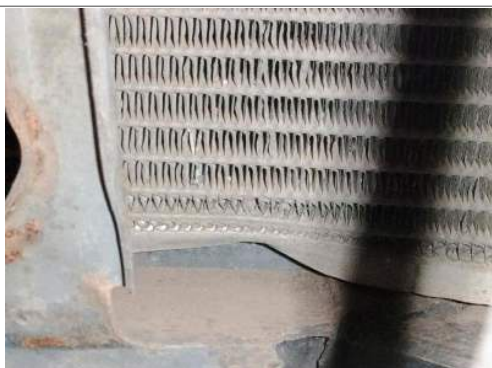
| Damage | Repair Way |
|---|---|
| Radiator Damaged | Replace |

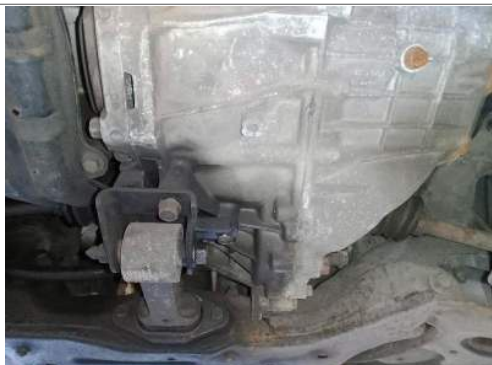
| Damage | Repair Way |
|---|---|
| Gearbox Oil Sweat | Repair |

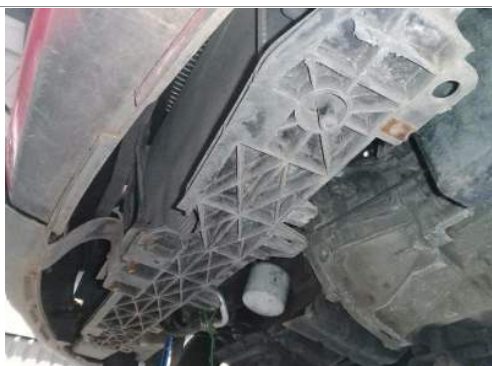
| Damage | Repair Way |
|---|---|
| Radiator Cradle Damaged | Replace |

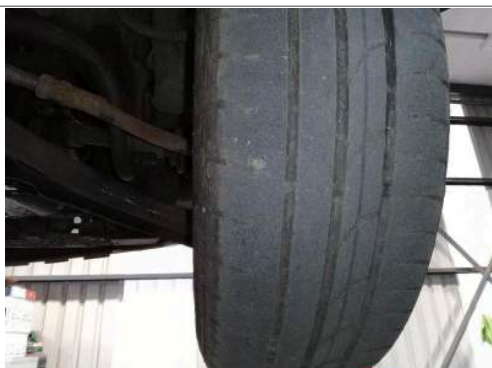
| Damage | Repair Way |
|---|---|
| Tyre Front Right Worn | Replace |

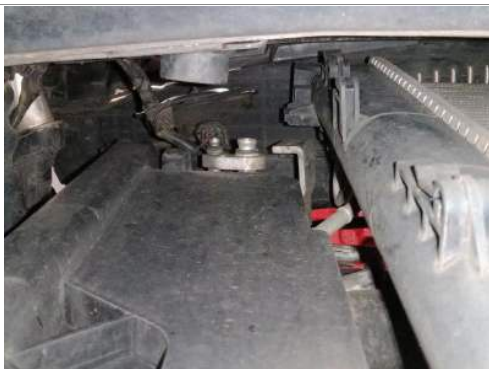
| Damage | Repair Way |
|---|---|
| Air conditioner pipes Defective | Repair |

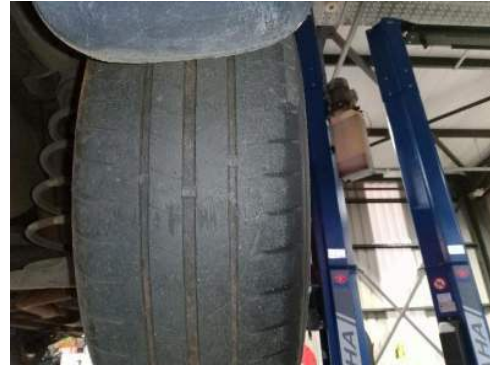
| Damage | Repair Way |
|---|---|
| Tyre Rear Right Worn | Replace |

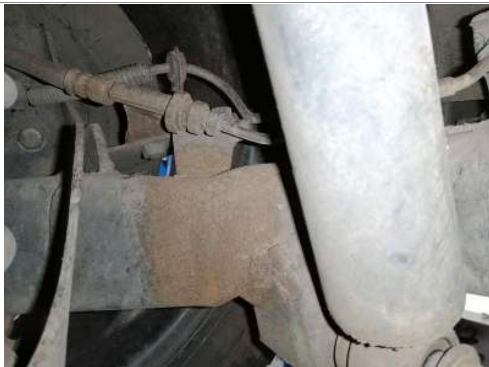
| Damage | Repair Way |
|---|---|
| Rear Axle Damaged | Replace |

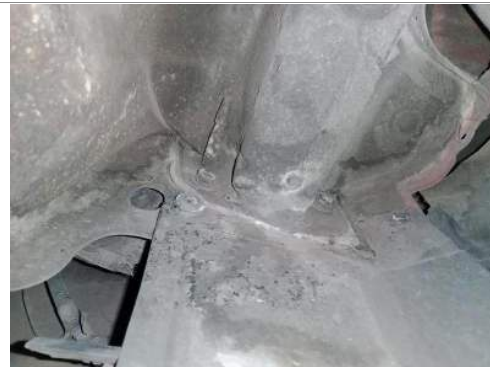
| Damage | Repair Way |
|---|---|
| Main Beam Left Damaged | Repair |

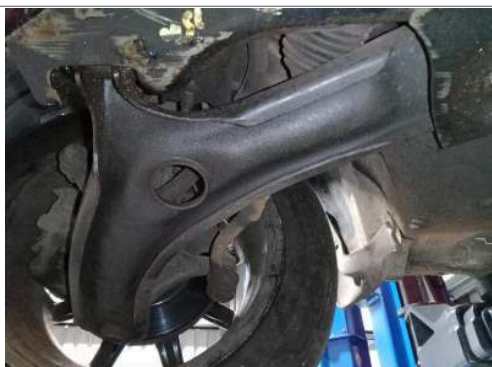
| Damage | Repair Way |
|---|---|
| Control Arm(s) Front Axle Right Defective | Replace |

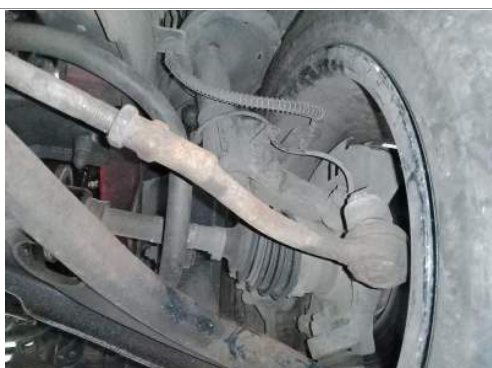
| Damage | Repair Way |
|---|---|
| Tie Rod right Defective | Replace |

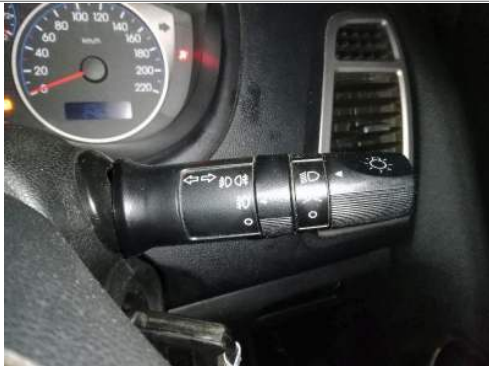
| Damage | Repair Way |
|---|---|
| Indicator Switch Damaged | Replace |

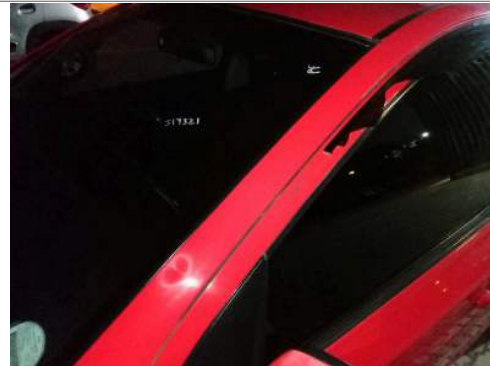
A - Pillar Left

| Damage | Repair Way |
|---|---|
| A • Pillar Left Damaged | Repair |
