Client	MFC Auction House	Inspection Location	MFC
Requested Date	31/03/2025		M57 Pretoria Road - 1619
Inspection Date	31/03/2025		Kempton Park - GT

Vehicle Type	PASSENGER VEHICLE	Registered Owner	MFC
Manufacturer	HYUNDAI	Registration Number	CZ41XJGP
Model	I20 1.4 GLIDE 5-DR [2012-2015]	Register Number	
VIN	MALBB51CLDM554451	Date Of First Licensing	
Engine Number		Last COR	
Doors	5	License Expiry Date	
Color	WHITE	Power / Displacement	
Year Model	2014	Paint Finish	TWO COAT UNI
Km Reading	97,134 KM	Fuel	PETROL
Cab / Body Type	HATCHBACK	Transmission	MANUAL

CONDITION REPORT

Report No: 2016821942

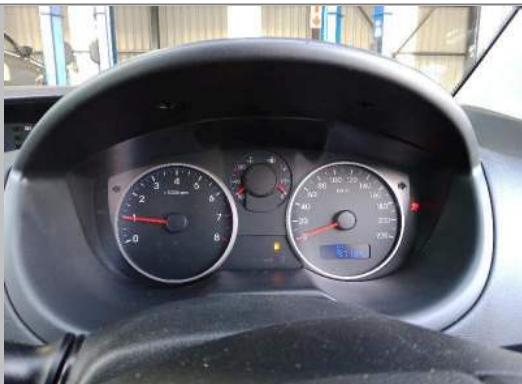
DASHBOARD (W/ ENGINE RUNNING)

Damage	Repair Way
CV Joint(s) Boot(s) Front Left (inner/outer) Damaged	Replace
CV Joint(s) Boot(s) Front Right (inner/outer) Damaged	Replace
Airbag warning light illuminated on dashboard	Repair
Front left shock absorber weak	Replace
Undercarriage	Vehicle undercarriage dirty
Body and Exterior	Minor dents and scratches on some body panels

No	System	Code	Description	Status
1	AB(AIRBAG)	B1346	DRIVER AIRBAG(DAB) RESISTANCE TOO HIGH(1ST STAGE)

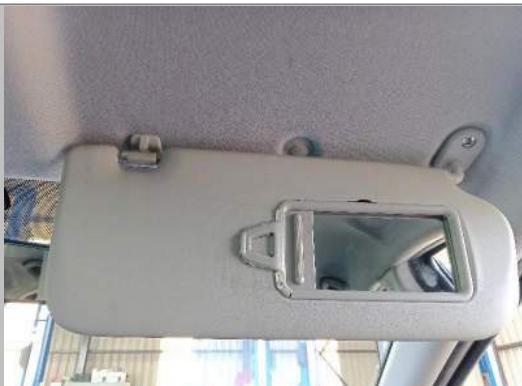
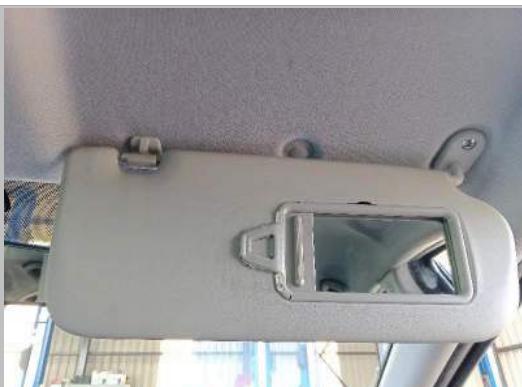
Damage	Repair Way
Sun Visor Right Damaged	Repair
Front Bumper Paintwork • Scratched	Repair
Rear Fender Left Dented	Repair
Door Front Left Paintwork • Scratched	Repair
Door Front Right Paintwork • Scratched	Repair
Door Rear Left Dented	Repair
Door Rear Right Paintwork • Chipmarks	Repair
Rear bumper Paintwork • Scratched	Repair
Shock Absorber Front Left Leak	Replace
Ball Joint(s) Front Axle Left Defective	Replace
Tyre Rear Right Defective	Replace
Rim Front Left Scratched	Repair
Rim Rear Left Scratched	Repair
Rim Spare Wheel Dented	Repair
Chassis Dented	Repair
Sub Frame Damaged	Repair
Silencer Defective	Repair
Belly plates Damaged	Repair
Fuel Tank Sweat	Repair
Fuel Lines Sweat	Repair
