CONDITION REPORT

Report No:  
2017305240  
DATE  
30/09/2026

MFC Auction House  
M57 Pretoria Rd, Glenmarais, KEMPTON PARK  
Gauteng

| Manufacturer | HYUNDAI | Registration Number | BC99KHGP |

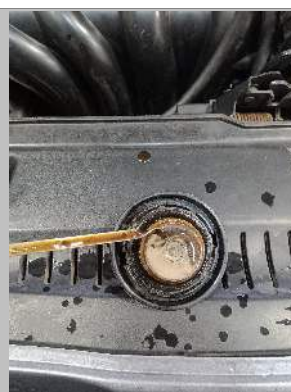
General Comments: ACCORDING TO THE AGE AND MILEAGE OF THE VEHICLE, NORMAL WEAR AND TEAR MARKS ARE VISIBLE ON THE INTERIOR, EXTERIOR, ELECTRICAL AND MECHANICAL PARTS. SIGNS OF REPAIR WORK DONE TO BODY PANELS. POOR ALIGNMENT TO SOMEBODY PANELS. REPAIR WORK DONE TO VEHICLE BELOW STANDARD / FOREIGN SUBSTANCE ON OIL FILLER CAP.

Oil cap and dipstick.

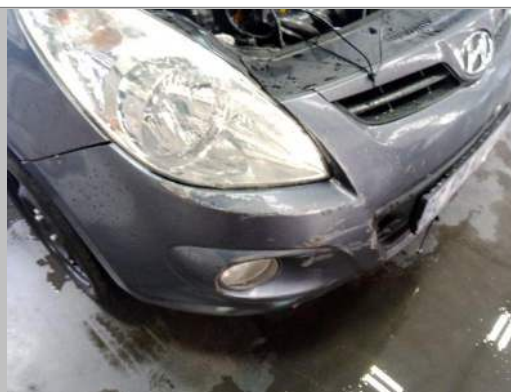
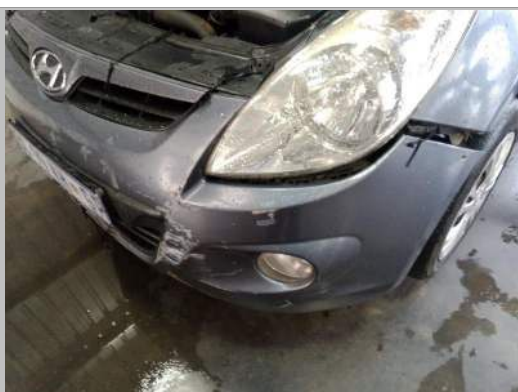
| Front Bumper Damaged | Repair |

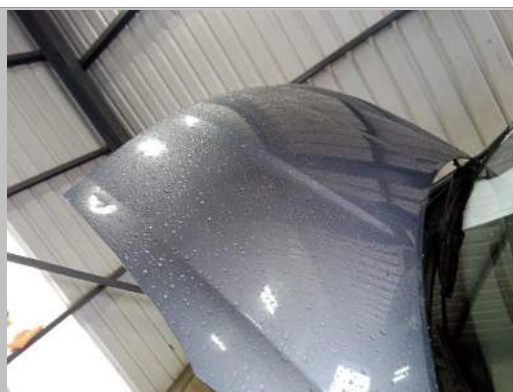
| Bonnet Damaged | Repair |

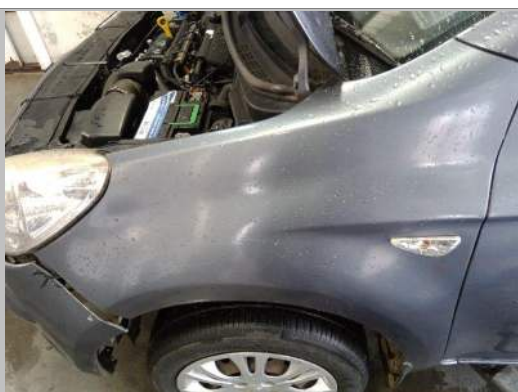
| Front Fender Left Damaged | Repair |

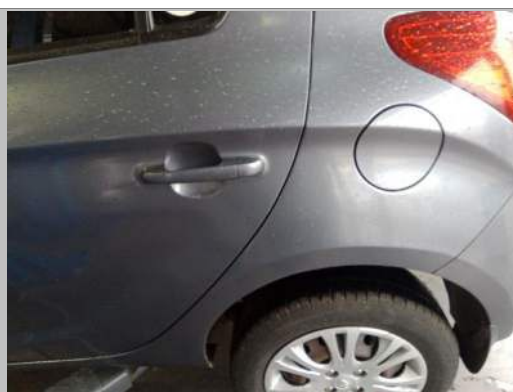
| Rear Fender Left Damaged | Repair |

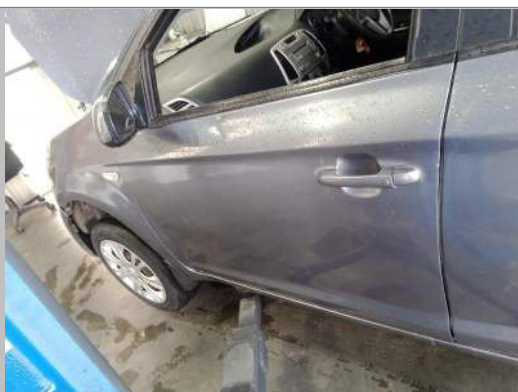
| Door Front Left Damaged | Repair |
| Left front door does not open | Repair |

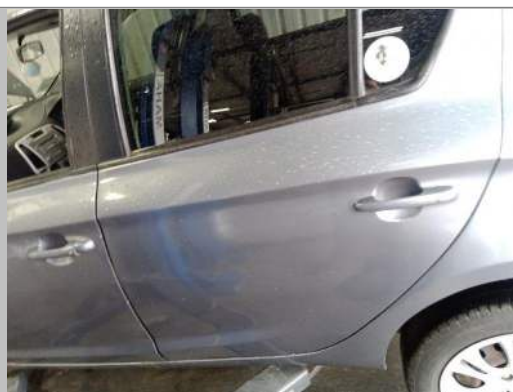
| Door Rear Left Damaged | Repair |

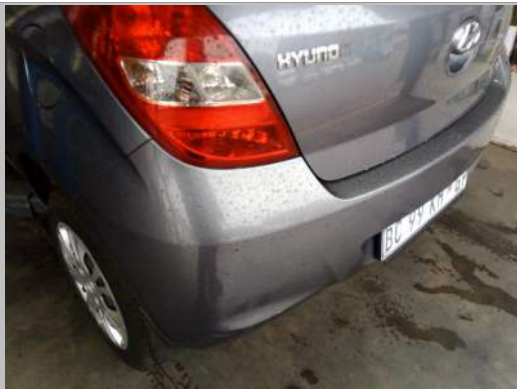
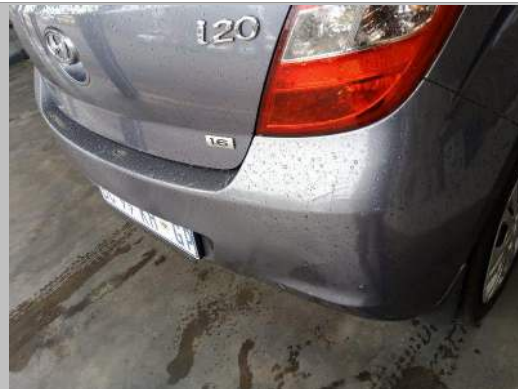
| Rear bumper Damaged | Replace |

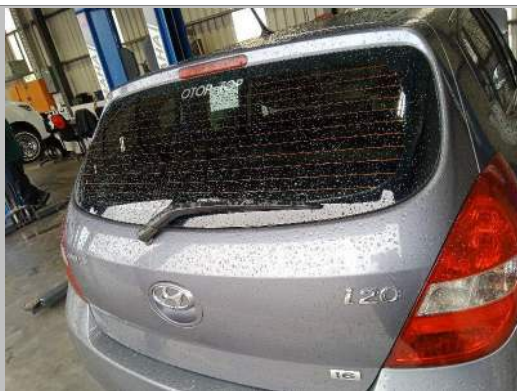
| Boot Lid / Hatch door Damaged | Repair |

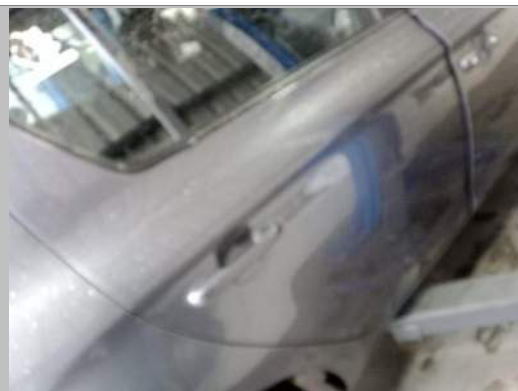
| Door Rear Right Damaged | Repair |

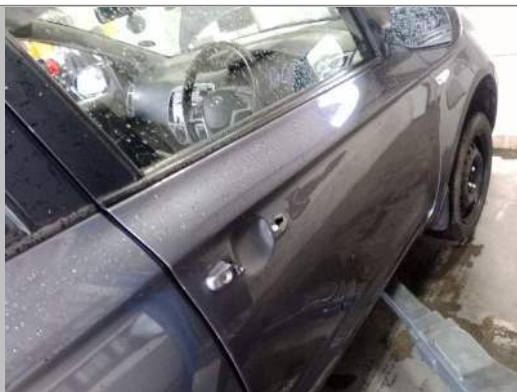
| Door Front Right Damaged | Repair |

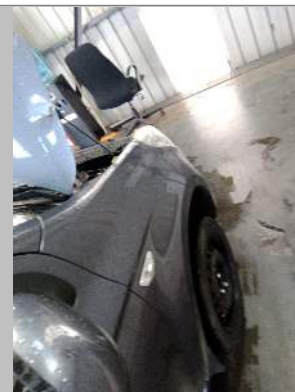
| Front Fender Right Damaged | Repair |

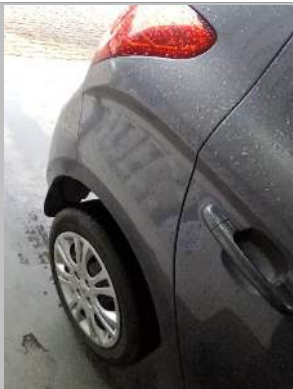
| Rear Fender Right Damaged | Repair |

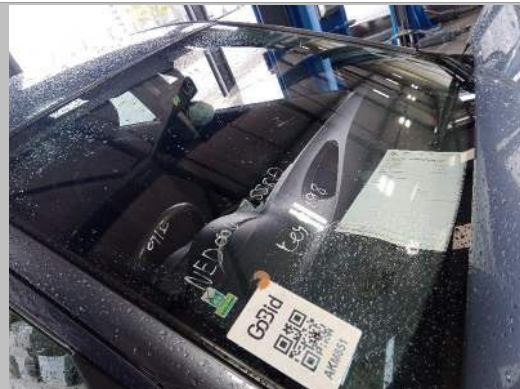
| Windscreen Damaged | Replace |

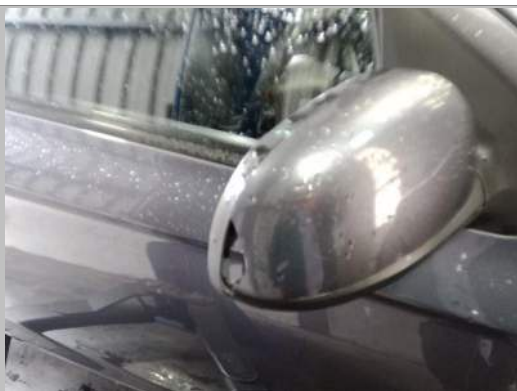
| Side Mirror Right Damaged | Replace |

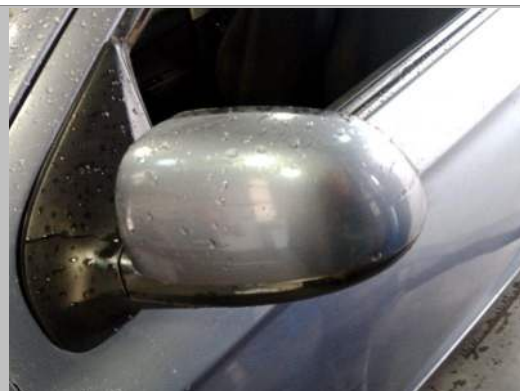
| Side Mirror Left Damaged | Replace |

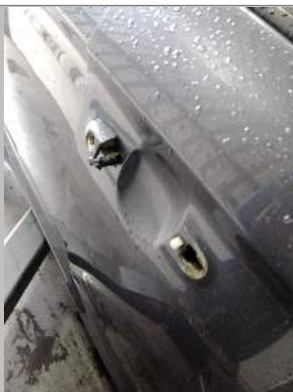
| Door Handle Front Right Damaged | Replace |
| Driver side door does not open from outside | Repair |

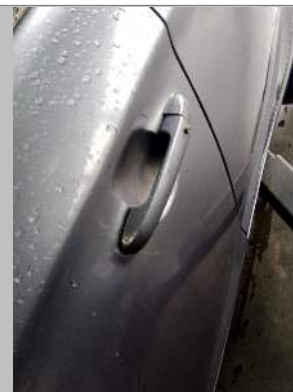
| Door Handle Front Left Damaged | Replace |

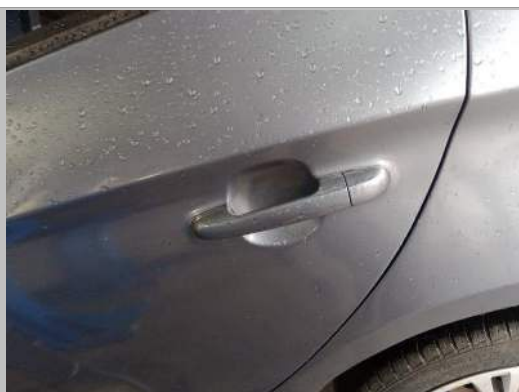
| Door Handle Rear Left Damaged | Repair |

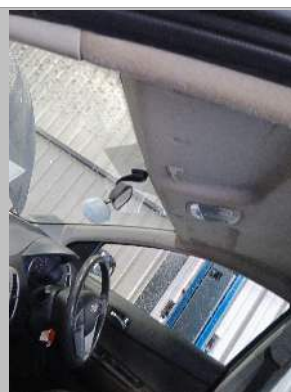
| Sun Visor Left Damaged | Replace |

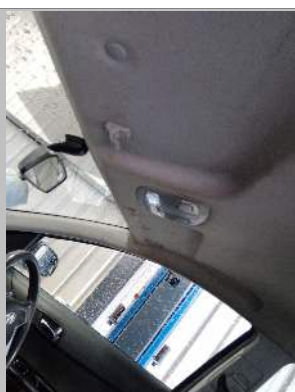
| Sun Visor Right Damaged | Replace |

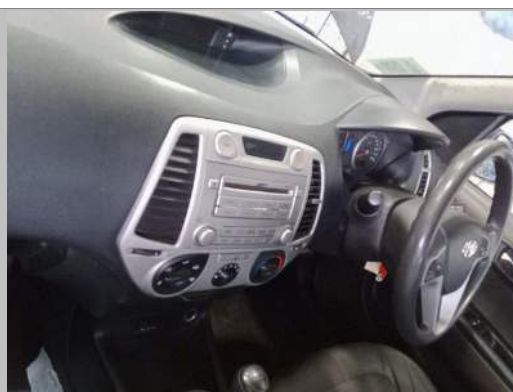
| Central Air Vent Damaged | Replace |

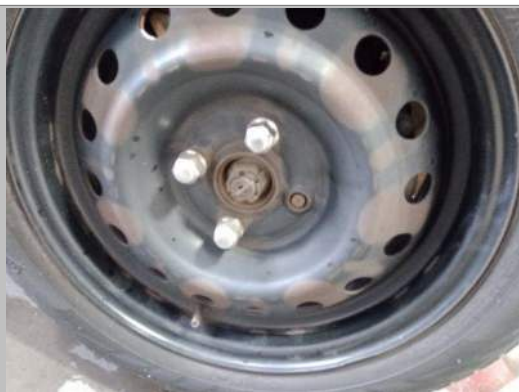
| Bolt(s) / Nut(s) Front Wheel Right Damaged | Replace |

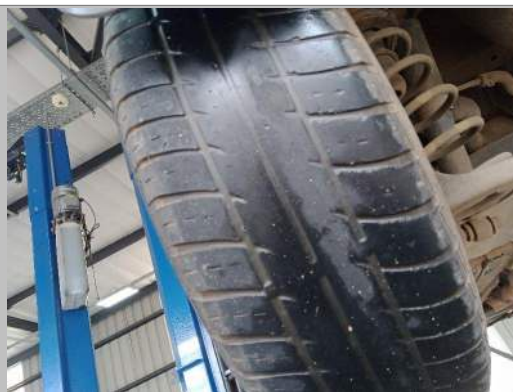
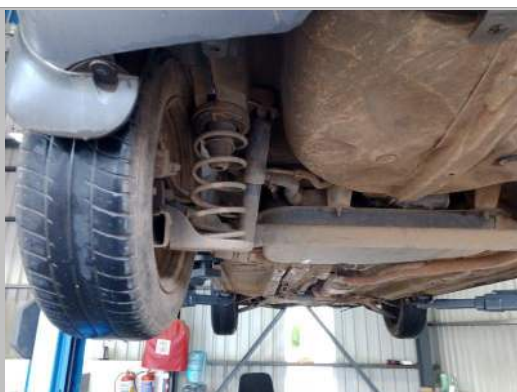
| Tyre Rear Left Worn | Replace |
| Rear tyres size differs | Replace |

| | Size | Load/Speed Index | Manufacture | Model | Type* | Production Date | Tread Depth (mm) |
|---|---|---|---|---|---|---|---|
| Rear Left | 185/65R15 | 92T | Barum | Radial | V | 0121 | 0 mm |

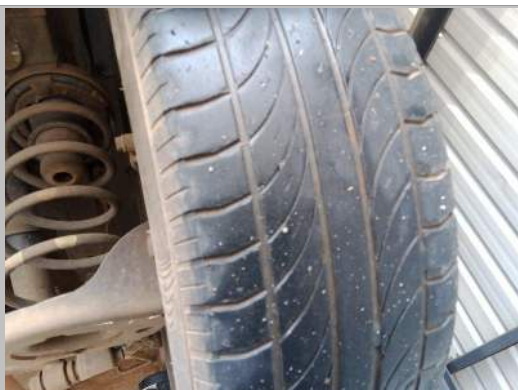
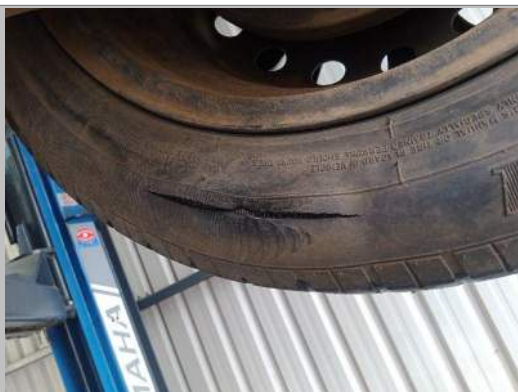
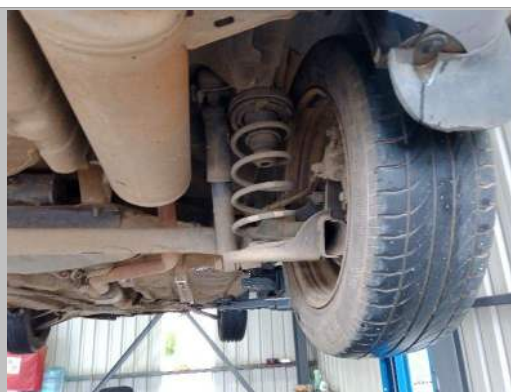
| Tyre Rear Right Worn | Replace |

| | Size | Load/Speed Index | Manufacture | Model | Type* | Production Date | Tread Depth (mm) |
|---|---|---|---|---|---|---|---|
| Rear Right | 185/60R15 | 84H | Onyx | Radial | V | 3219 | 0 mm |

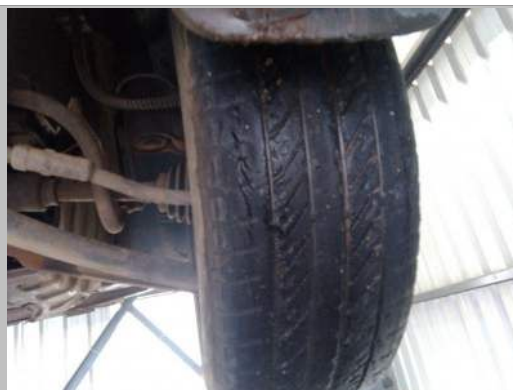
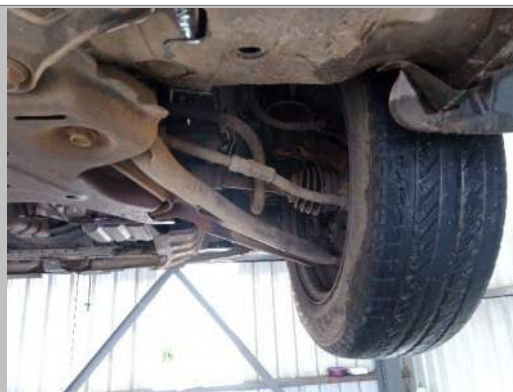
| Tyre Front Right Worn | Replace |

| | Size | Load/Speed Index | Manufacture | Model | Type* | Production Date | Tread Depth (mm) |
|---|---|---|---|---|---|---|---|
| Front Right | 185/60R15 | 88H | Dunlop | Radial | V | 1820 | 0 mm |

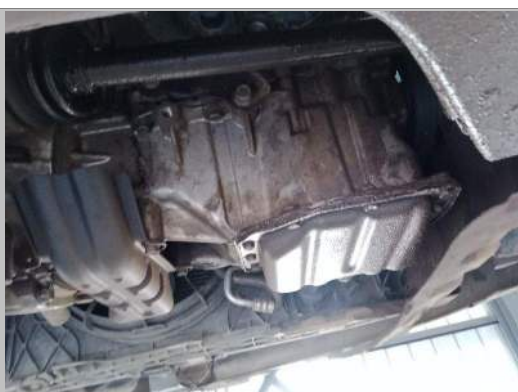
| Engine Oil Leak | Repair |

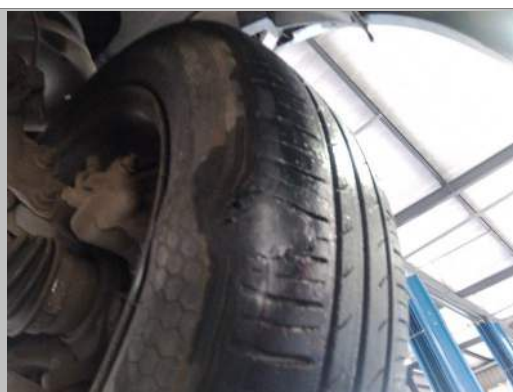
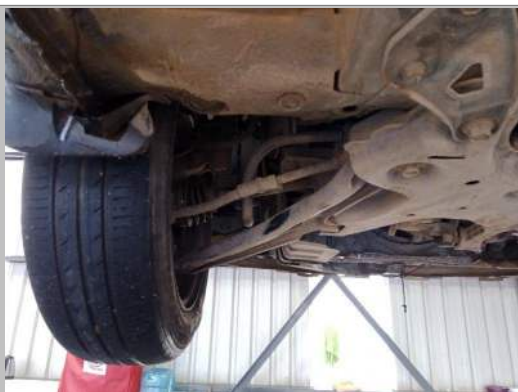
| Tyre Front Left Worn | Replace |

| | Size | Load/Speed Index | Manufacture | Model | Type* | Production Date | Tread Depth (mm) |
|---|---|---|---|---|---|---|---|
| Front Left | 185/60R15 | 84H | Kumho | Radial | V | 2521 | 0 mm |

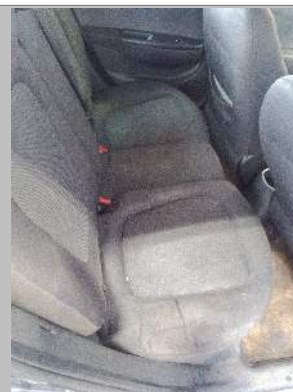
| Seat Rear Worn | Repair |

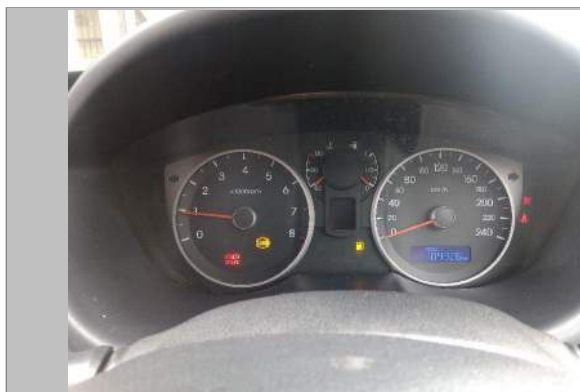
| Engine Management Lights Set | Repair |

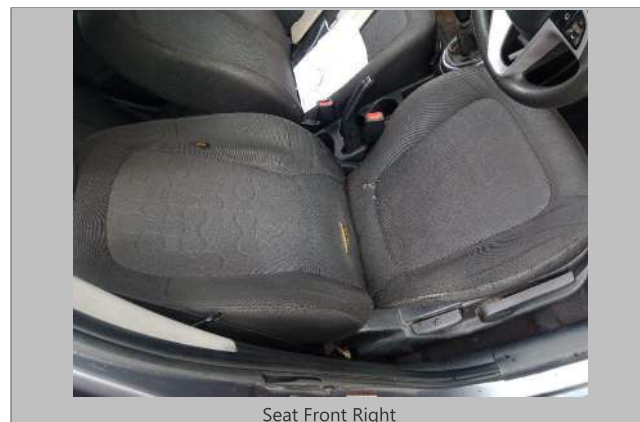
| Seat Front Right Damaged | Repair |
