CONDITION REPORT

Report No:  
2017302333  
DATE  
22/09/2026

MFC Auction House  
M57 Pretoria Rd, Glenmarais, KEMPTON PARK  
Gauteng

| Manufacturer | HYUNDAI | Registration Number | KS31DFGP |

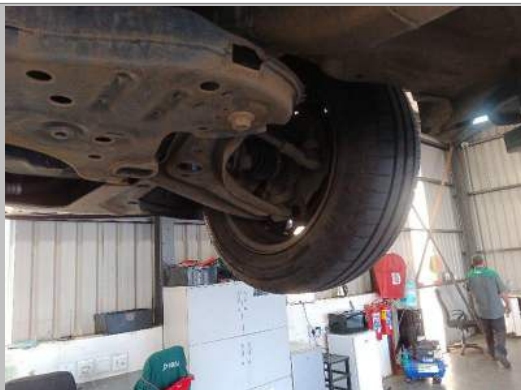
RF TYRE TREAD

| R/F tire deferred name brand | Repair |

| | Size | Load/Speed Index | Manufacture | Model | Type* | Production Date | Tread Depth (mm) |
|---|---|---|---|---|---|---|---|
| Front Right | 185/60R15 | 88H | Goodyear | Efficient gr | V | 2323 | 3 mm |

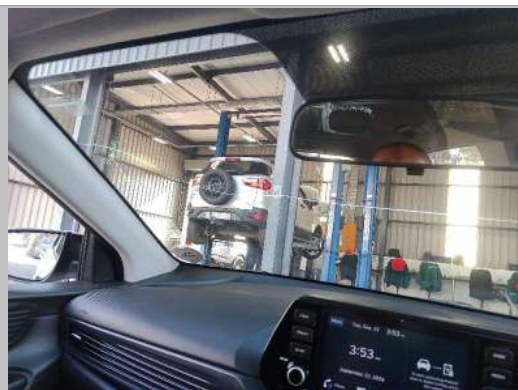
| Windscreen Cracked | Replace |

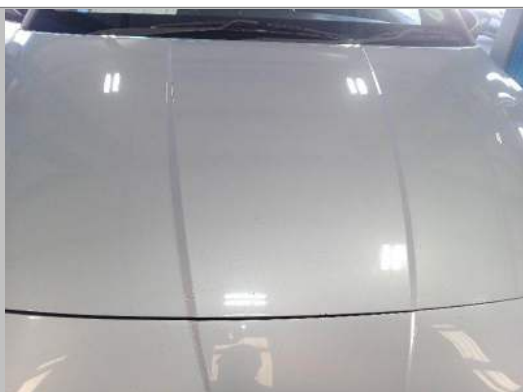
| Bonnet Paintwork • Chipmarks | Repair |

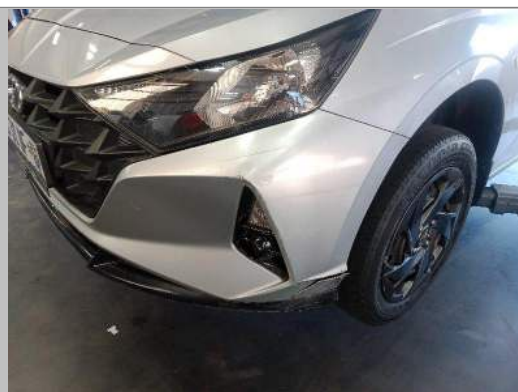
| Front Bumper Damaged | Repair |

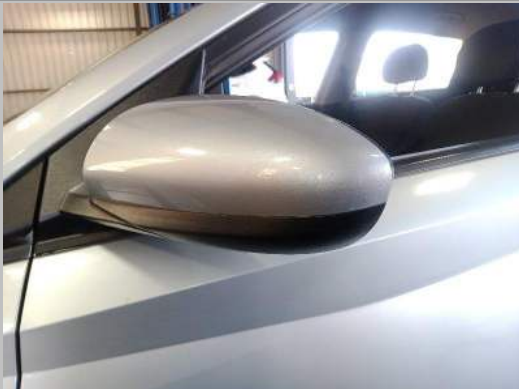
| Side Mirror Left Paintwork • Scratched | Repair |

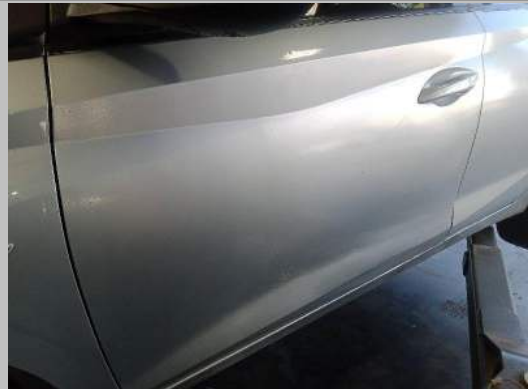
| Door Front Left Residual Traces of Repair | Repair |

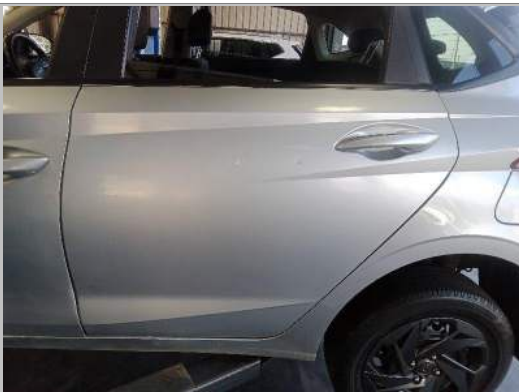
| Door Rear Left Residual Traces of Repair | Repair |

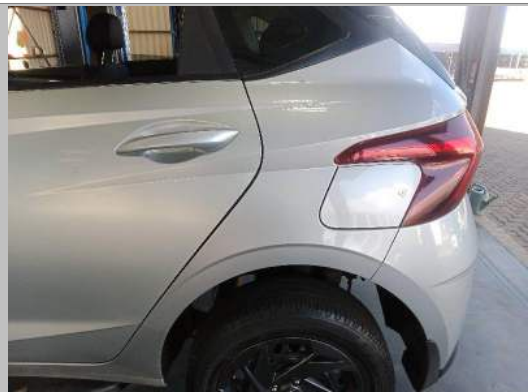
| Rear Fender Left Dented | Repair |

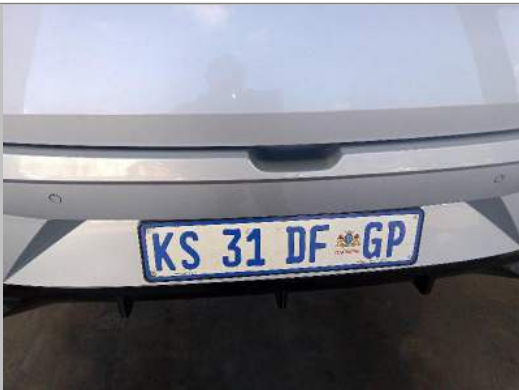
| Rear bumper Paintwork • Scratched | Repair |

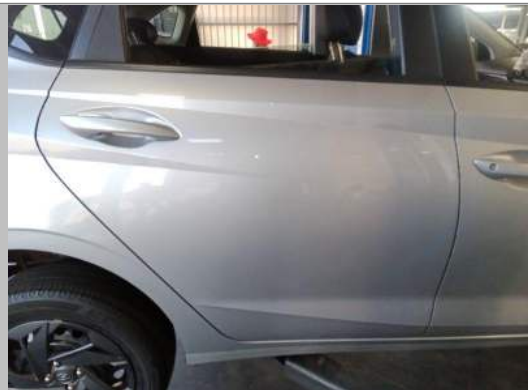
| Door Rear Right Dented | Repair |

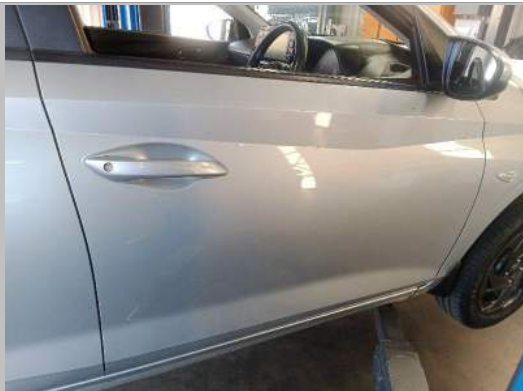
| Door Front Right Paintwork • Scratched | Repair |

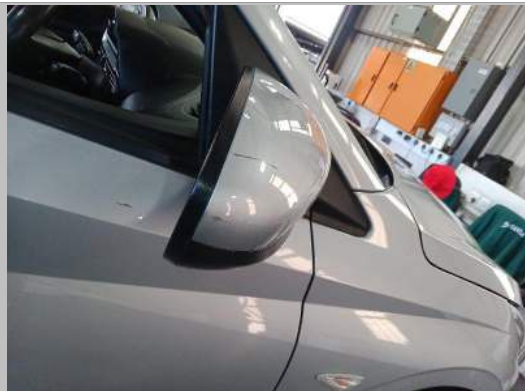
| Side Mirror Right Paintwork • Scratched | Repair |

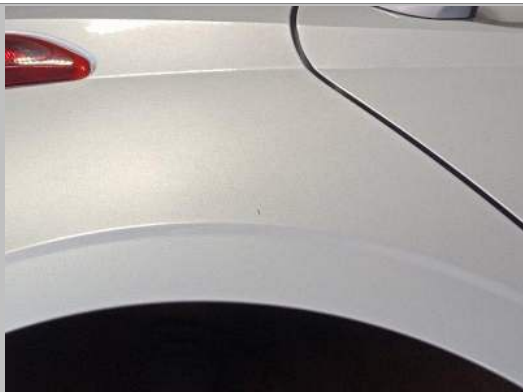
| Rear Fender Right Paintwork • Scratched | Repair |
