CONDITION REPORT

Report No:  
2017302500  
DATE  
23/09/2026

MFC Auction House  
M57 Pretoria Rd, Glenmarais, KEMPTON PARK  
Gauteng

| Manufacturer | HYUNDAI | Registration Number | MH60SSGP |

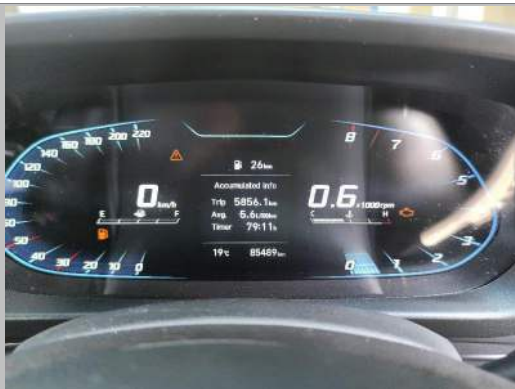
| Warning lights illuminated | Repair |

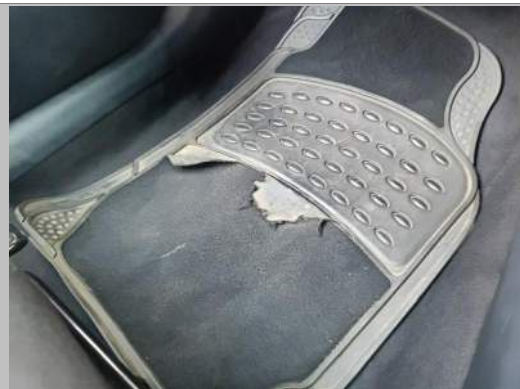
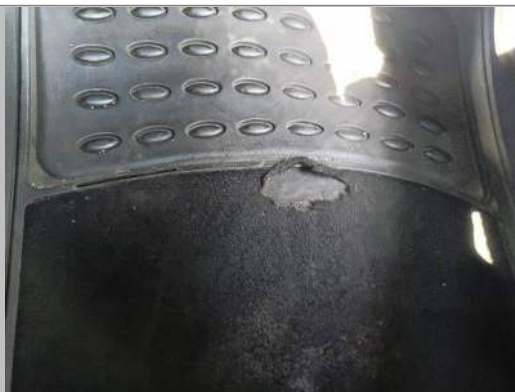
| Carpet Front Torn / Cut | Replace |

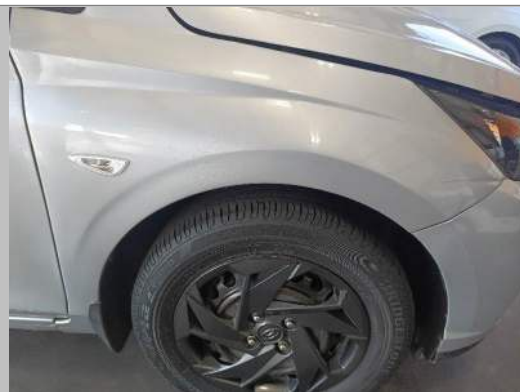
| Front Fender Right Residual Traces of Repair | Repair |

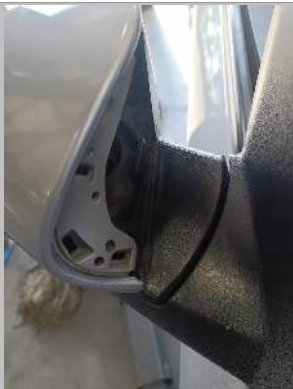
| Side Mirror Right Damaged | Replace |

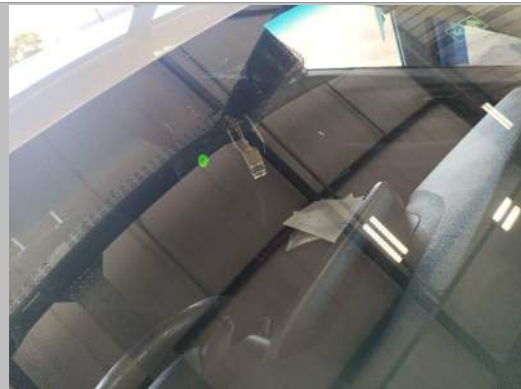
| Windscreen Cracked | Replace |

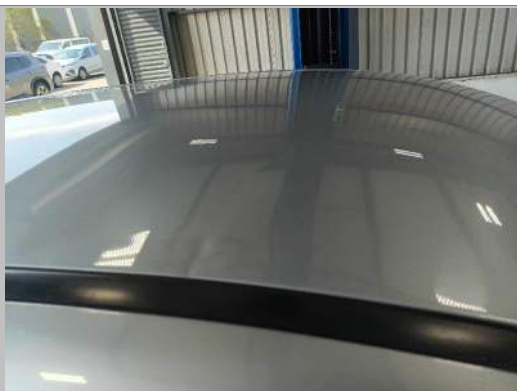
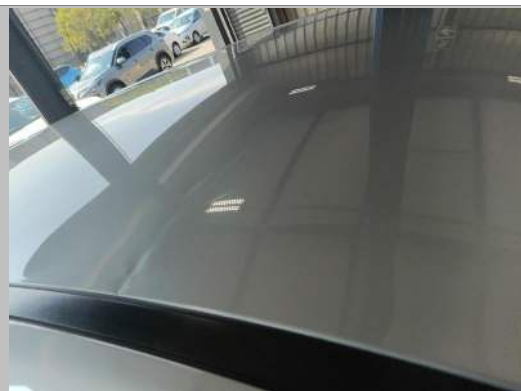
| Roof Dented | Repair |

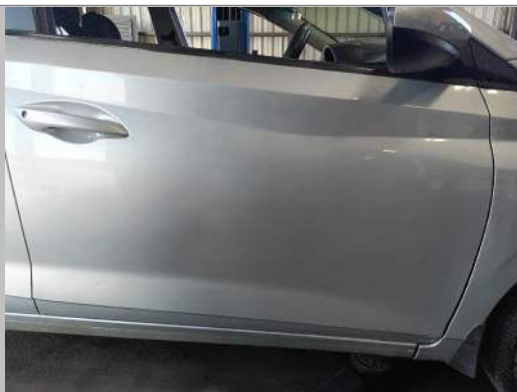
| Door Front Right Residual Traces of Repair | Repair |

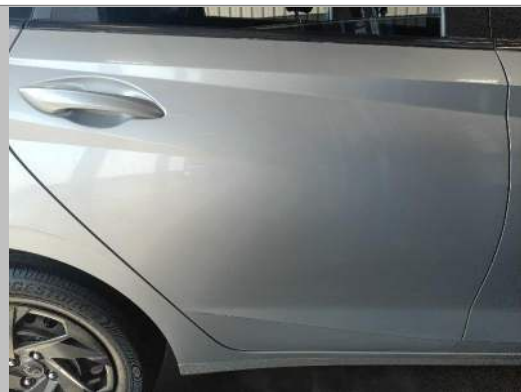
| Door Rear Right Residual Traces of Repair | Repair |

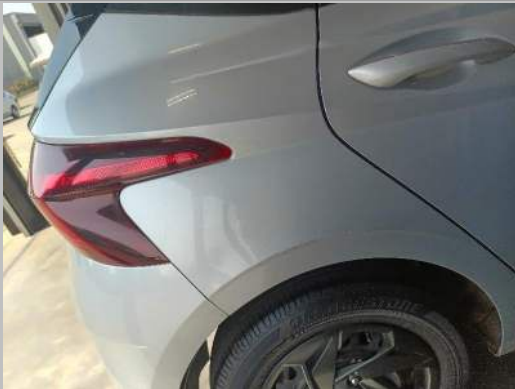
| Rear Fender Right Paintwork • Scratched | Repair |

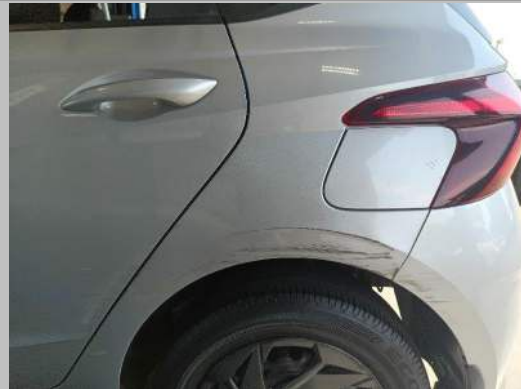
| Rear Fender Left Paintwork • Scratched | Repair |

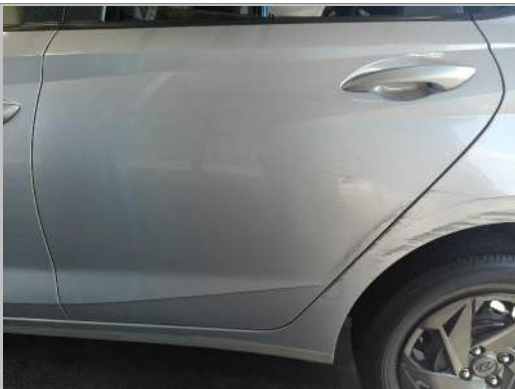
| Door Rear Left Paintwork • Scratched | Repair |

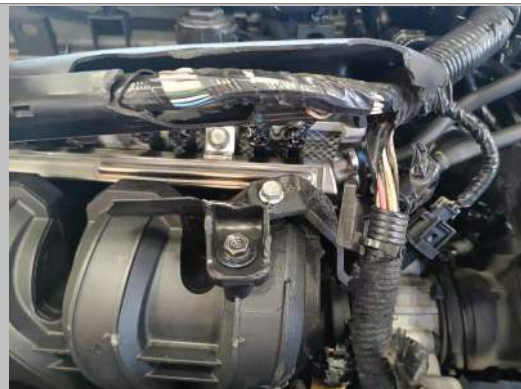
| Engine Wiring Defective | Repair |

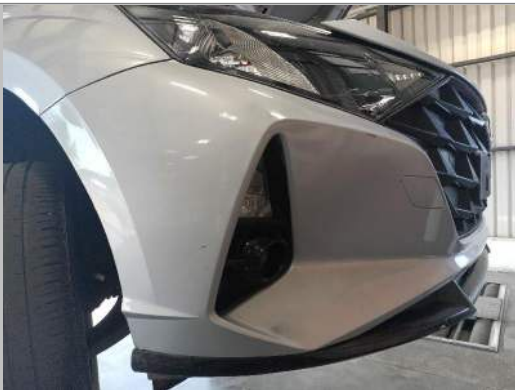
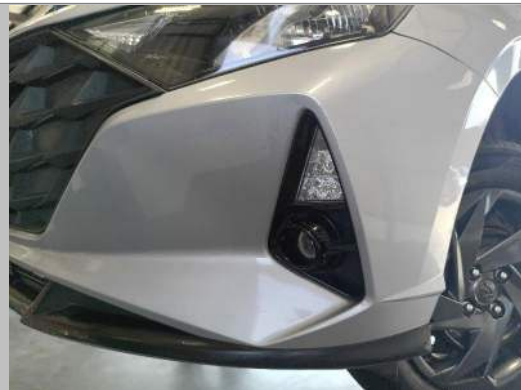
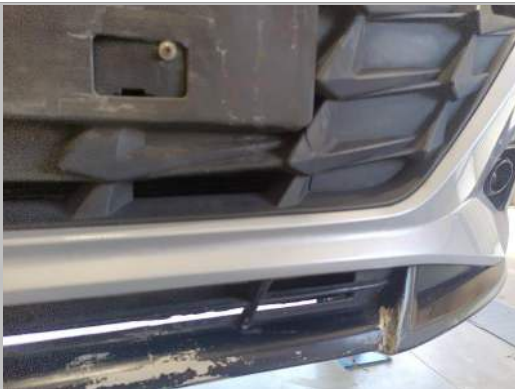
| Front Bumper Residual Traces of Repair | Repair |

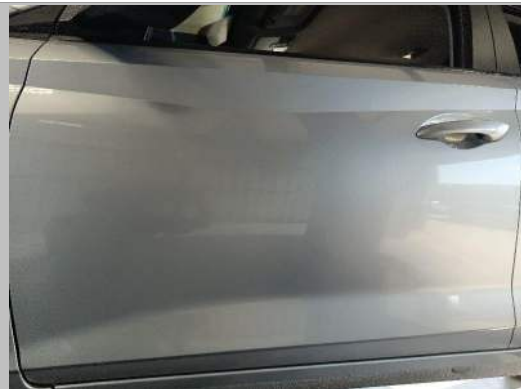
| Door Front Left Residual Traces of Repair | Repair |

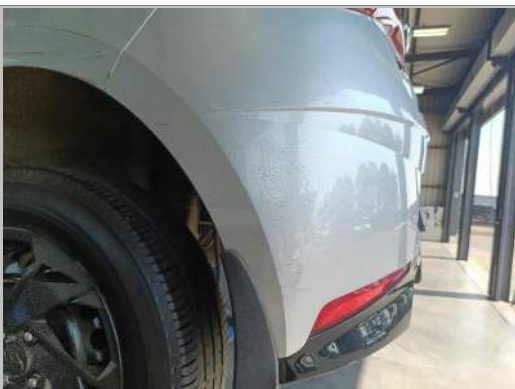
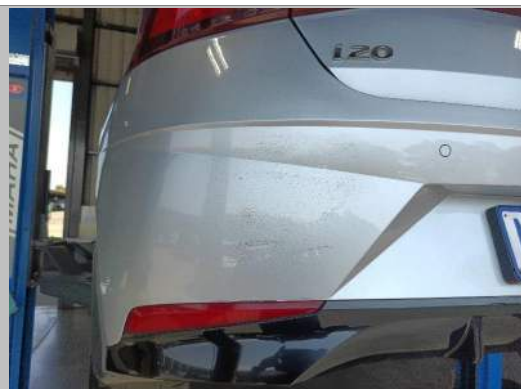
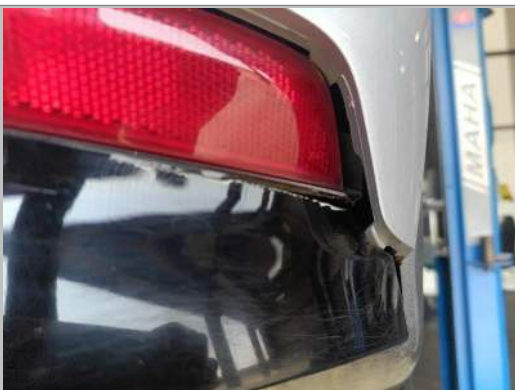
| Rear bumper Paintwork • Scratched | Repair |

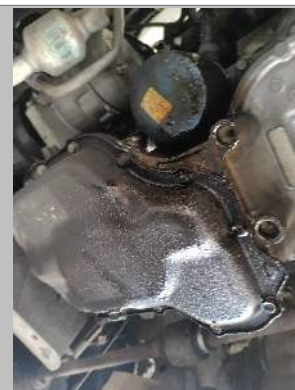
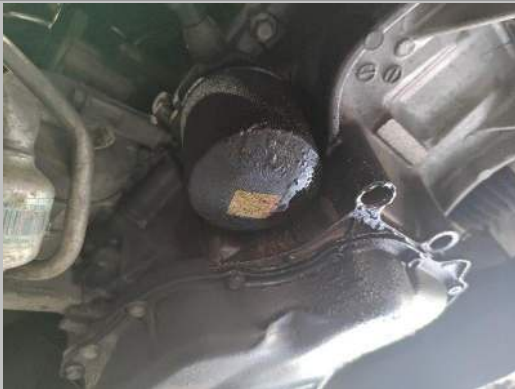
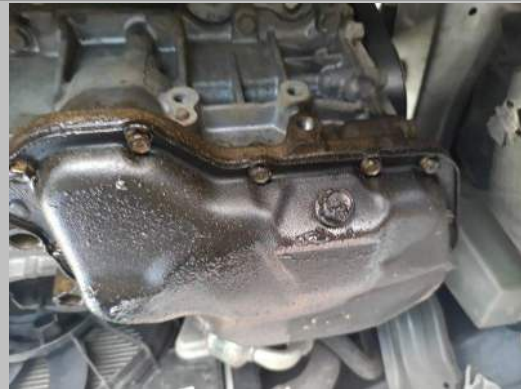
| Engine Oil Leak | Repair |
