CONDITION REPORT

Report No:  
2017296486  
DATE  
09/09/2026

| Manufacturer | HYUNDAI | Registration Number | LF80PPGP |
| Model | I20 1.2 MOTION 5-DR [2021-2024] | Register Number | |

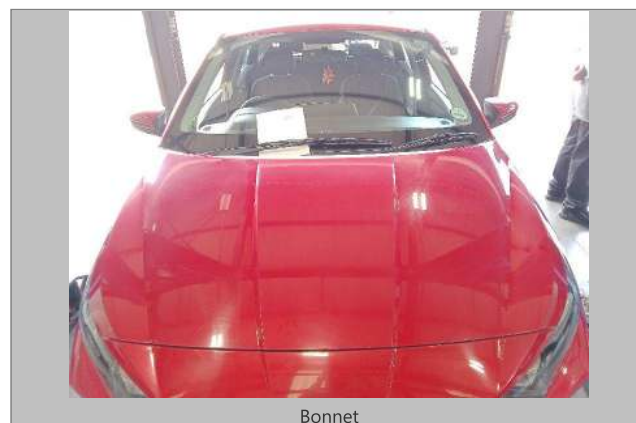
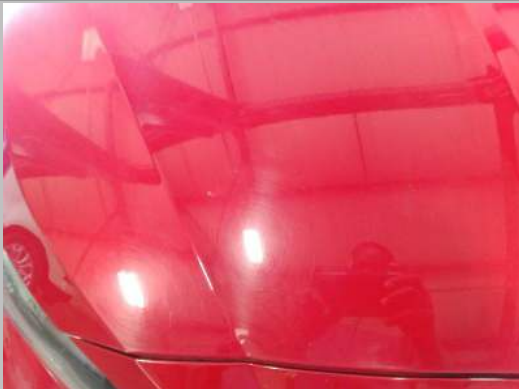
| Bonnet Paintwork • Scratched | Repair |

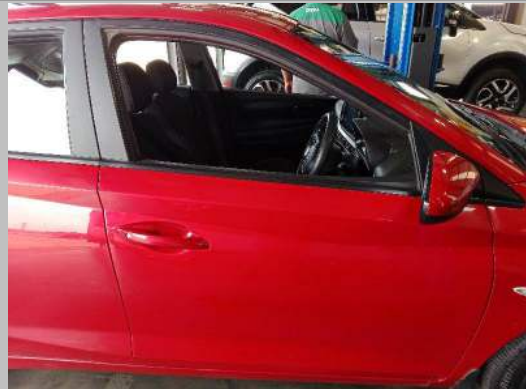
| Door Front Right Residual Traces of Repair | Repair |

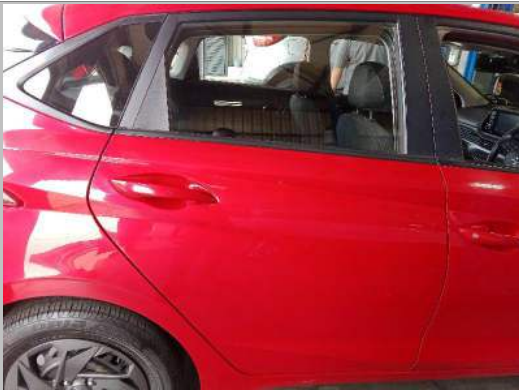
| Door Rear Right Residual Traces of Repair | Repair |

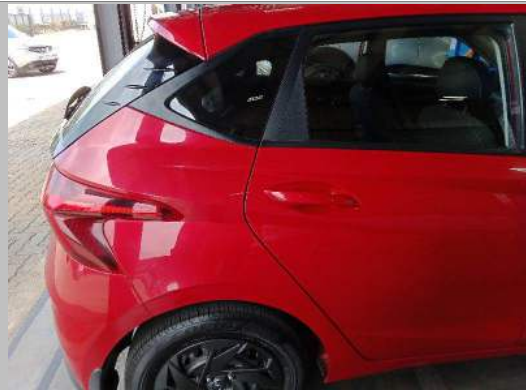
| Rear Fender Right Residual Traces of Repair | Repair |

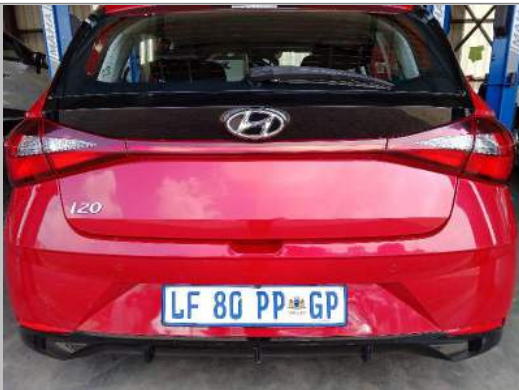
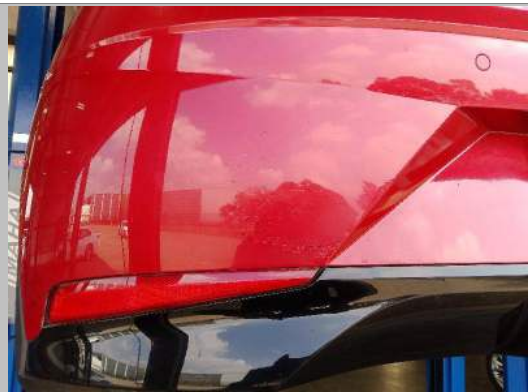
| Rear bumper Paintwork • Scratched | Repair |

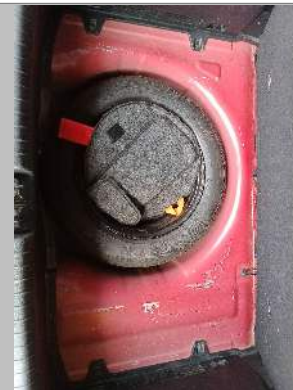
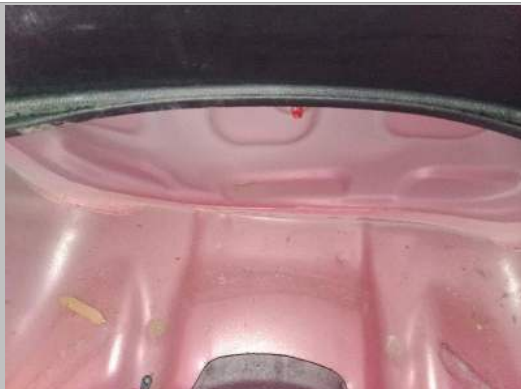
| Inner Boot Floor Pan and Spare Wheel Well Damaged | Repair |

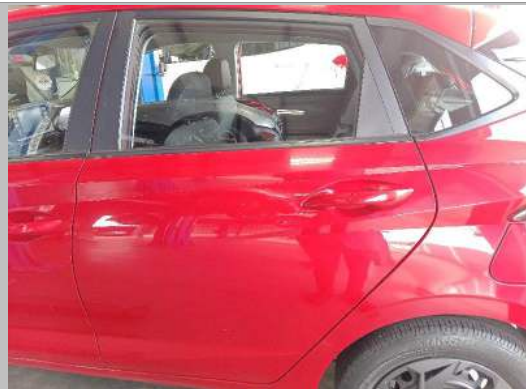
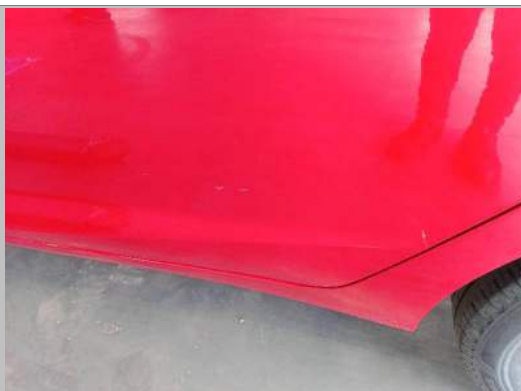
| Door Rear Left Paintwork • Scratched | Repair |

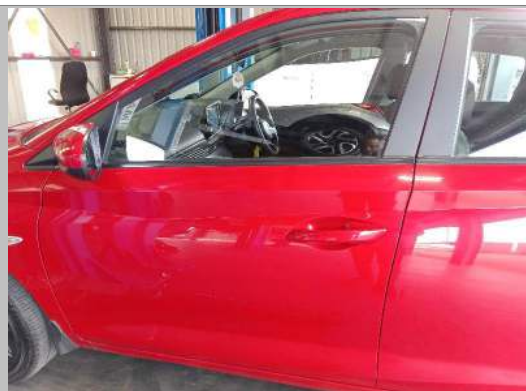
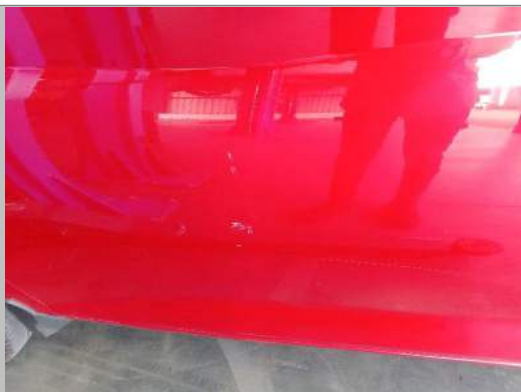
| Door Front Left Paintwork • Scratched | Repair |

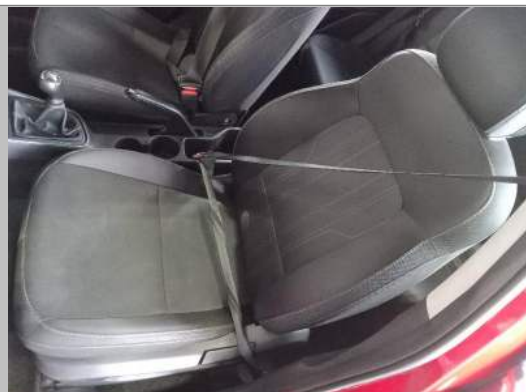
| Seat Front Left Dirty | Repair |

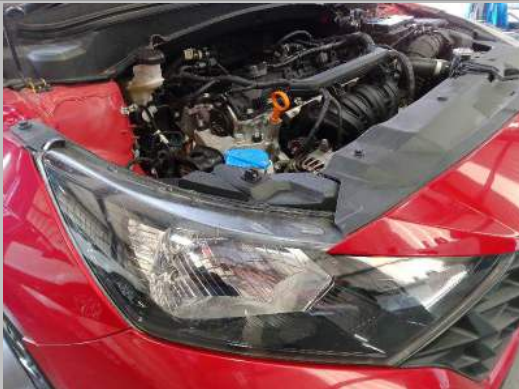
| Headlight Right Cracked | Replace |

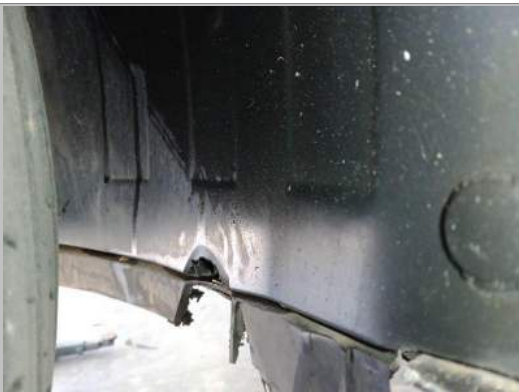
| Rear Fender Right / Inner Tray Damaged | Repair |

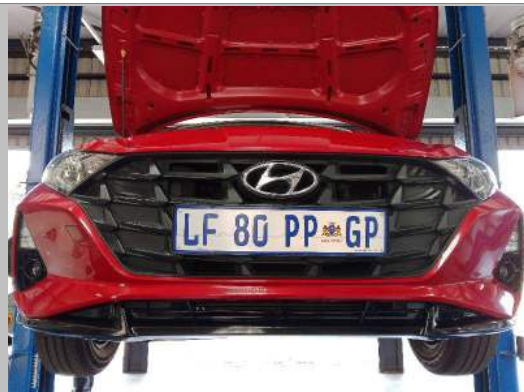
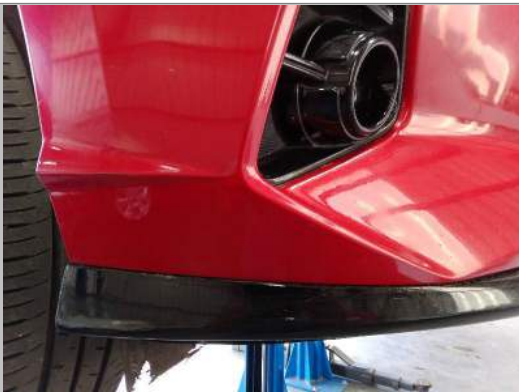
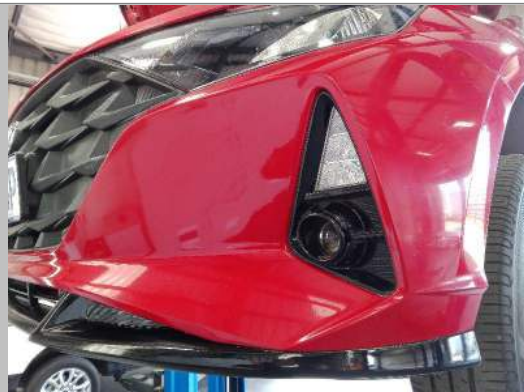
| Front Bumper Paintwork • Scratched | Repair |

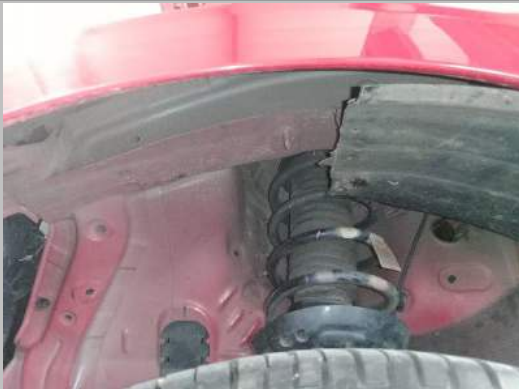
| Front Fender Left / Inner Tray Damaged | Replace |

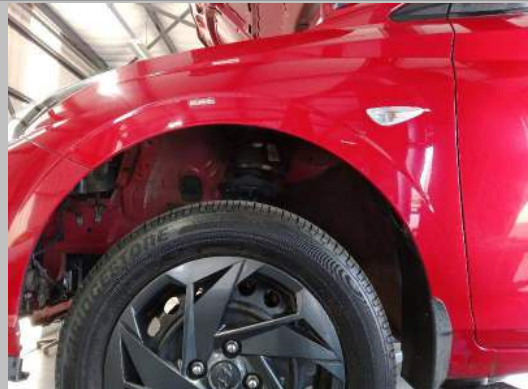
| Front Fender Left Damaged | Repair |

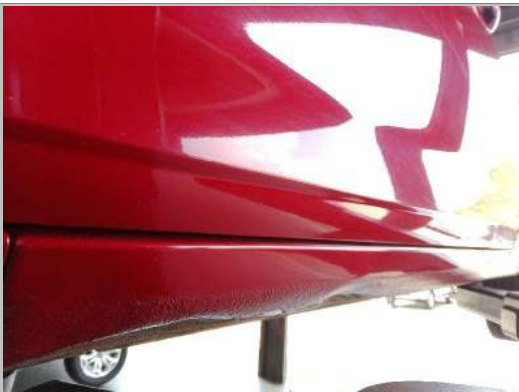
| Sill Panel Left Damaged | Repair |

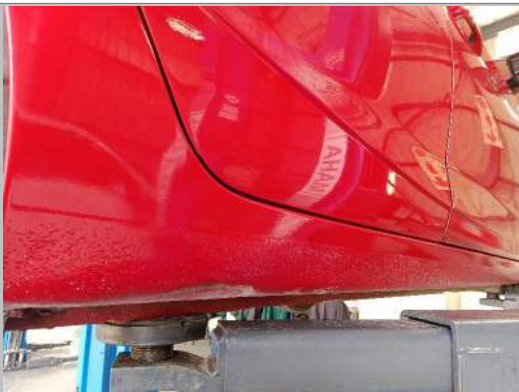
| Sill Panel Right Damaged | Repair |

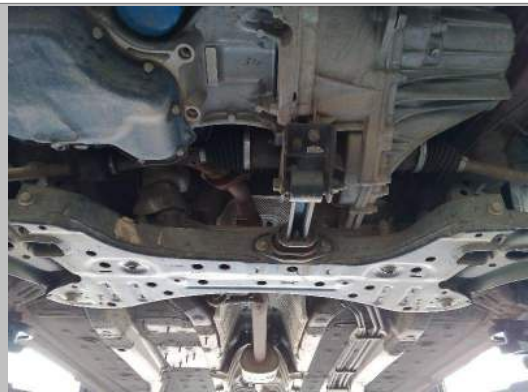
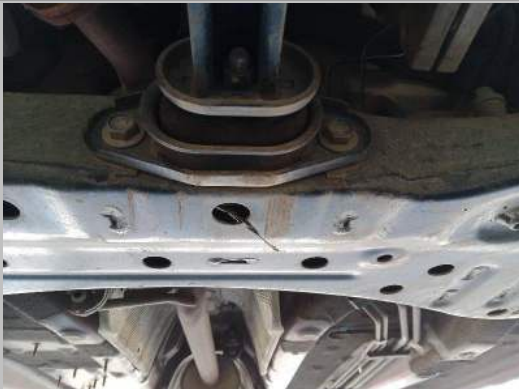
| Sub Frame Scratched | Repair |

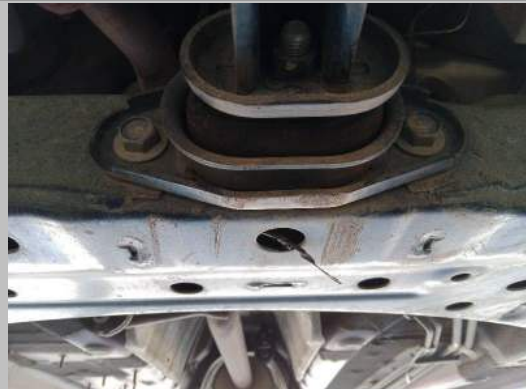
| Gearbox Mountings Defective | Repair |

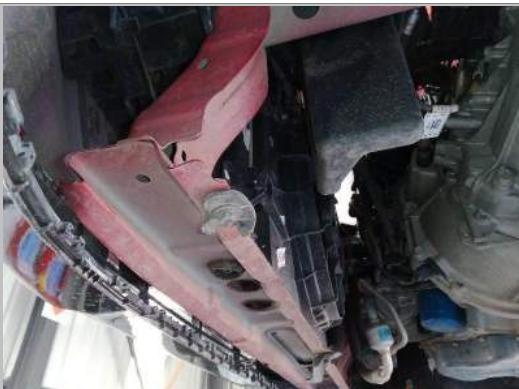
| Radiator Cradle Damaged | Repair |

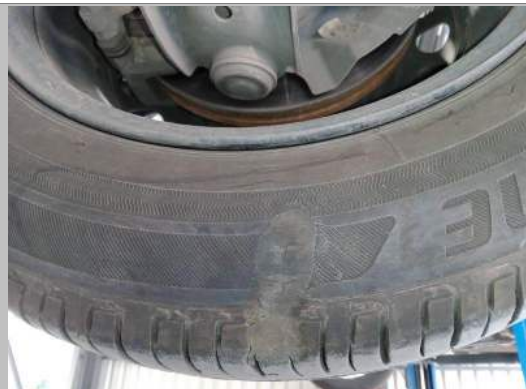
| Tyre Front Right Damaged | Replace |

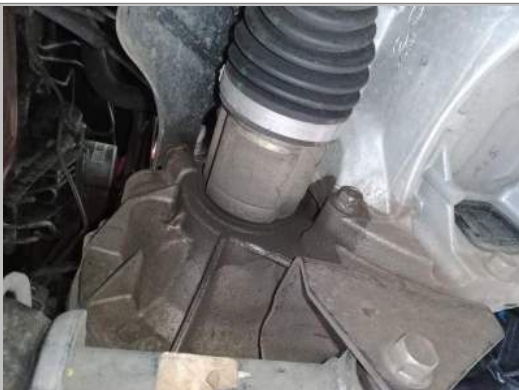
| Gearbox Oil Sweat | Repair |
