CONDITION REPORT

Report No: 2016207178

Vehicle Type	PASSENGER VEHICLE	Registered Owner	MFC
Manufacturer	HYUNDAI	Registration Number	NU138-273
Model	i20	Register Number	
VIN	MALBM51BLKM527718	Date Of First Licensing	
Engine Number		Last COR	
Doors	5	License Expiry Date	30/09/2023
Color	BLUE	Power / Displacement	
Year Model		Paint Finish	M - METALLIC
Km Reading	110,298 KM	Fuel	PETROL
Cab / Body Type	HATCHBACK	Transmission	MANUAL

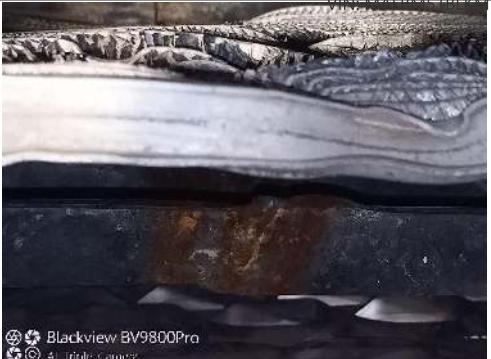
Front bumper stiffener weld	Replace
Bonnet release latch damage	Repair
L/F door not opening	Repair
Airbag and oil light on	Repair
Button on steering wheel multifunction	Repair
Windscreen washers not working	Repair
Both front fog lights multifunction	Repair

Front bumper stiffener weld

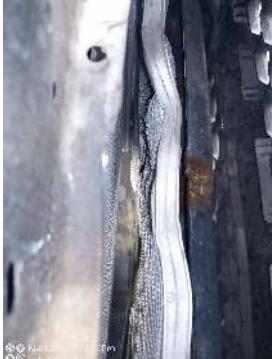
Damage	Repair Way
Engine Oil Leak	Repair
Hooter Defective	Repair
Door Handle Front Left Missing	Replace
Window Winder rear right Missing	Replace
Side Mirror Right Paintwork • Scratched	Repair
Front Bumper Paintwork • Scratched	Repair
Bonnet Paintwork • Pitmarks	Repair
Front Fender Left Paintwork • Pitmarks	Repair
Front Fender Right Paintwork • Scratched	Repair
Rear Fender Left Paintwork • Scratched	Repair
Rear Fender Right Dented	Repair
Door Front Left Paintwork • Scratched	Repair
Door Front Right Paintwork • Scratched	Repair
Door Rear Left Defective	Repair
Door Rear Right Paintwork • Scratched	Repair
Rear bumper Paintwork • Scratched	Repair
Sill Panel Left Paintwork • Scratched	Repair
Main Beam Left Residual Traces of Repair	Repair
CV Joint(s) Boot(s) Front Left (inner/outer) Defective	Repair
CV Joint(s) Boot(s) Front Right (inner/outer) Defective	Repair
Boot not opening cannot see spare wheel	Repair
Aircorn condenser damage	Replace

Aircon condenser damage

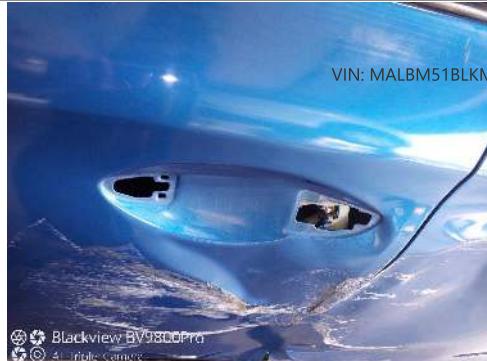
Door Handle Front Left

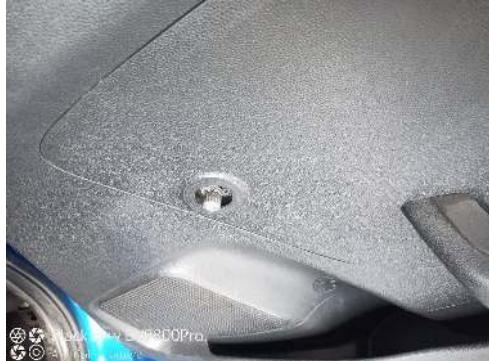
Window Winder rear right

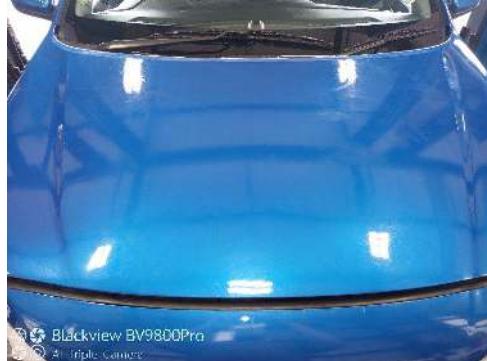
Bonnet

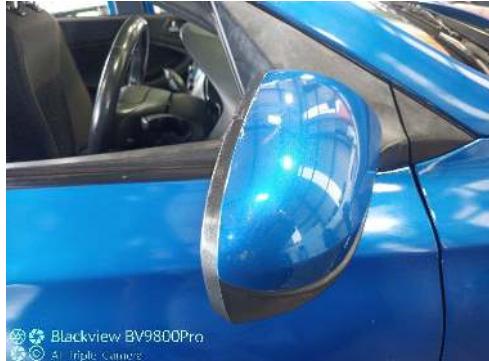
Side Mirror Right

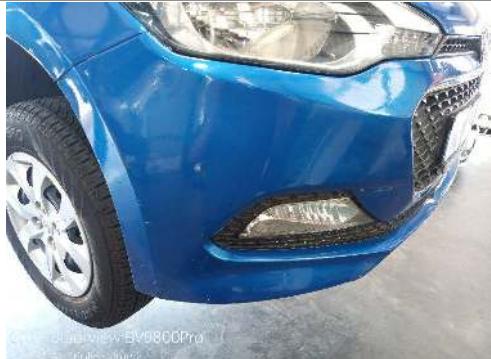
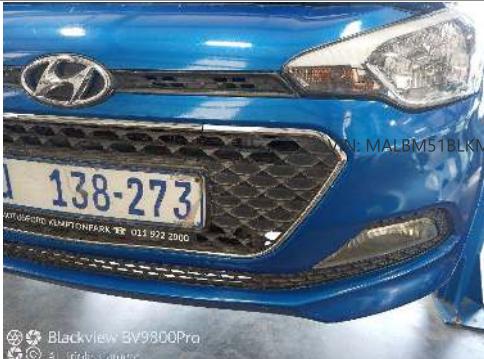
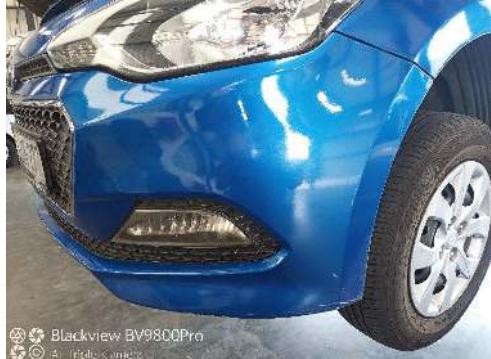
Front Bumper

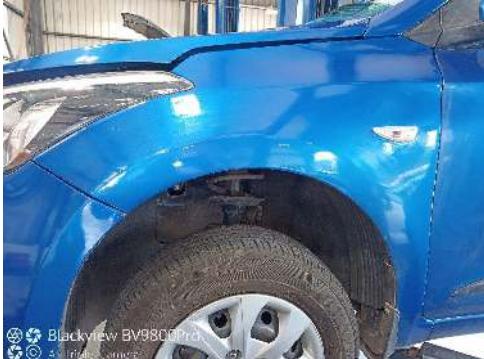
Front Fender Left

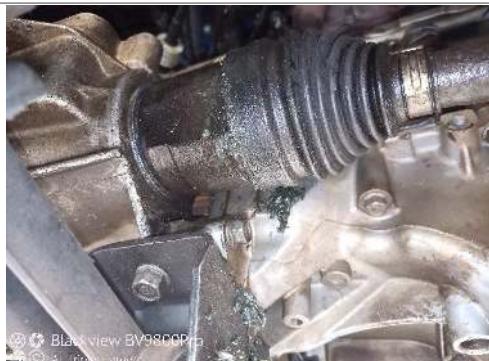
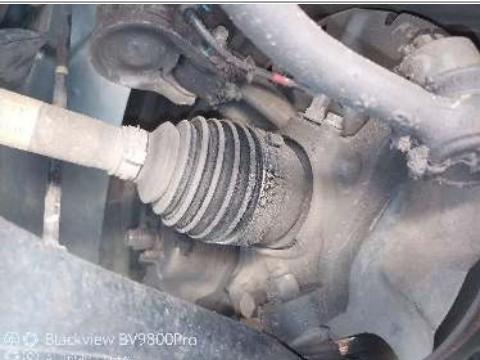
CV Joint(s) Boot(s) Front Right (inner/outer)

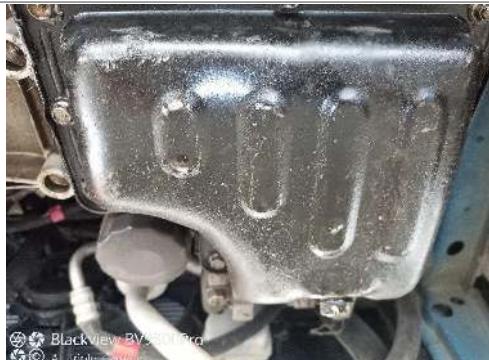
Engine

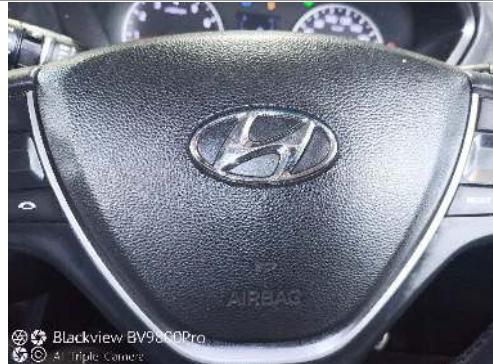
Hooter
