CONDITION REPORT

Report No: 2016212397

MFC Auction House  
M57 Pretoria Rd, Glenmarais, KEMPTON PARK  
Gauteng

| Manufacturer | HYUNDAI | Registration Number | JP12VGGP |

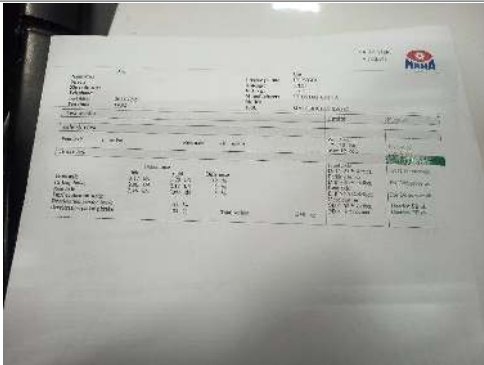
Brake test

| | Left | Right | | |
|---|---|---|---|---|
| Front | 3.17 | 2.78 | - | |
| Rear | 2.46 | 2.6 | - | |
| Emergency / Parking | 2 | 2.17 | - | |

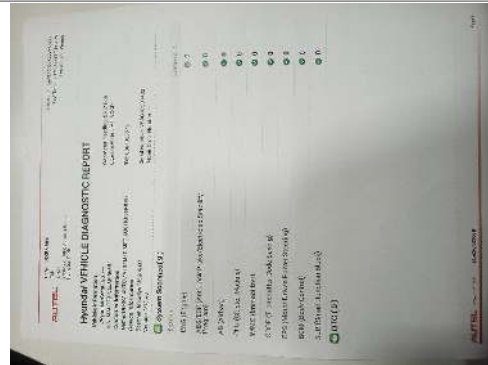
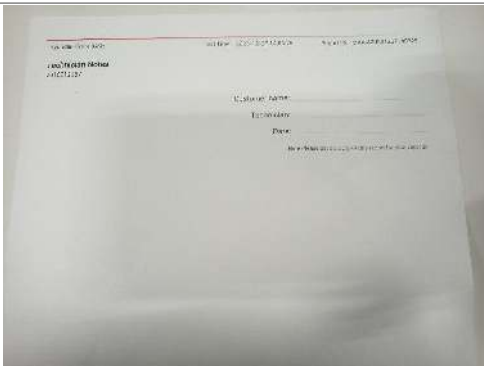
Diagnostic report

During the diagnostic no active error messages were detected. (See also attached Diagnostic Report. For more information regarding the Fault Codes (DTC) and the recommended rectifications please contact the workshops of the vehicle manufacture).

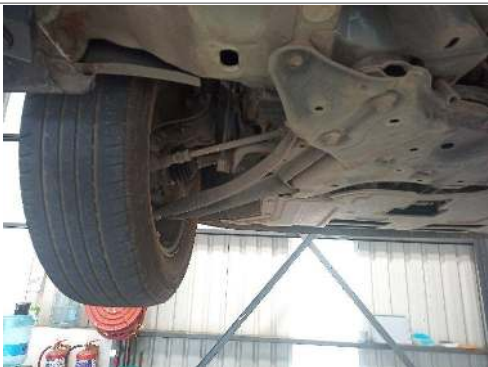
LF TYRE TREAD

| | Size | Load/Speed Index | Manufacture | Model | Type* | Production Date | Tread Depth (mm) |
|---|---|---|---|---|---|---|---|
| Front Left | 205/65R16 | 95H | Goodyear | Assurance | V | 4819 | 2 mm |

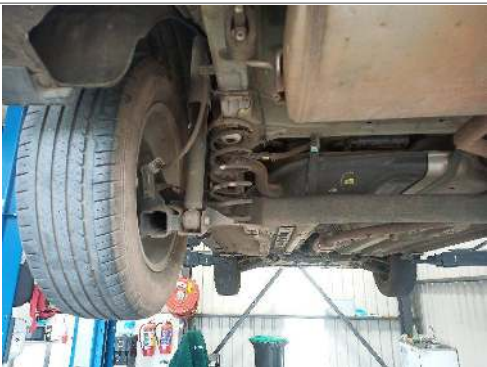
LR TYRE TREAD

| | Size | Load/Speed Index | Manufacture | Model | Type* | Production Date | Tread Depth (mm) |
|---|---|---|---|---|---|---|---|
| Rear Left | 205/65R16 | 95H | Goodyear | Assurance | V | 4819 | 2 mm |

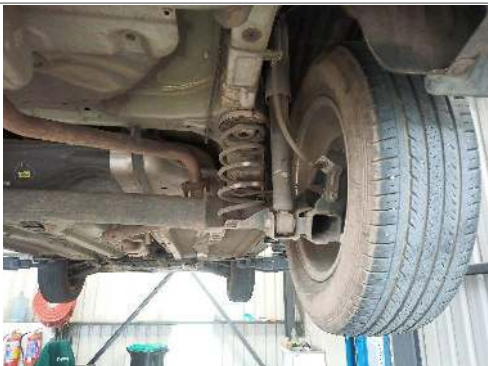
RR TYRE TREAD

| | Size | Load/Speed Index | Manufacture | Model | Type* | Production Date | Tread Depth (mm) |
|---|---|---|---|---|---|---|---|
| Rear Right | 205/65R16 | 95H | Goodyear | Assurance | V | 4819 | 2 mm |

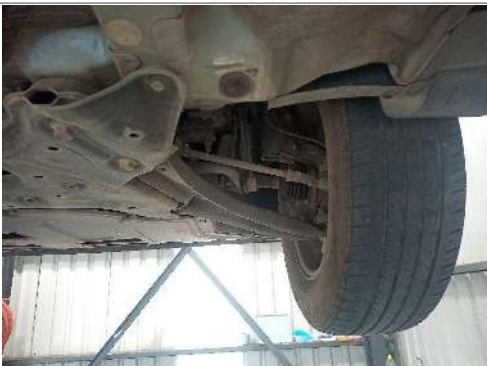
RF TYRE TREAD

| | Size | Load/Speed Index | Manufacture | Model | Type* | Production Date | Tread Depth (mm) |
|---|---|---|---|---|---|---|---|
| Front Right | 205/65R16 | 95H | Goodyear | Assurance | V | 4819 | 2 mm |

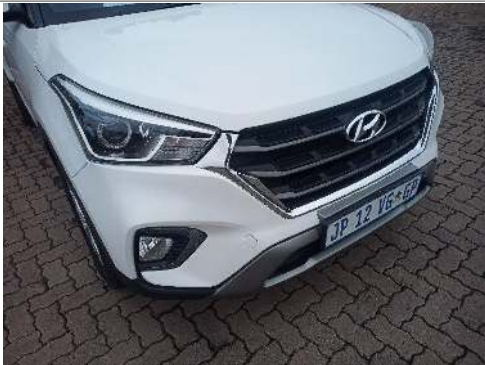
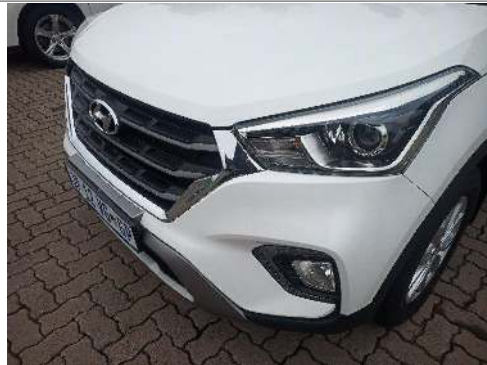
| Damage | Repair Way |
|---|---|
| Front Bumper Damaged | Repair |

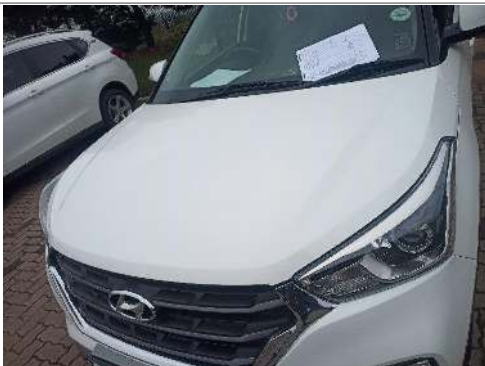
| Damage | Repair Way |
|---|---|
| Bonnet Damaged | Repair |

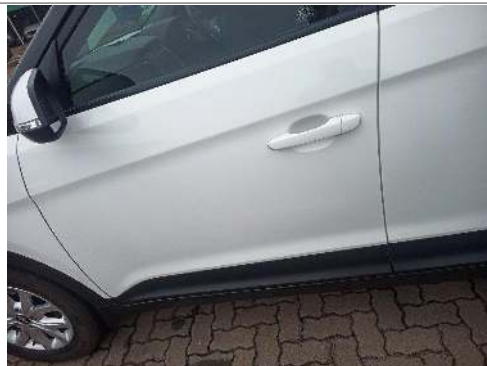
| Damage | Repair Way |
|---|---|
| Door Front Left Damaged | Repair |

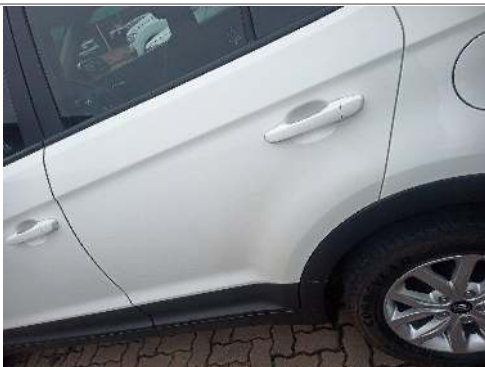
| Damage | Repair Way |
|---|---|
| Door Rear Left Damaged | Repair |

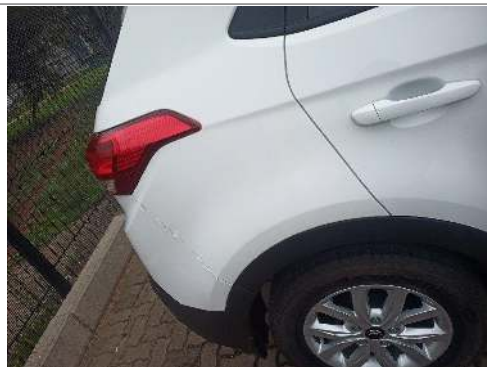
| Damage | Repair Way |
|---|---|
| Rear Fender Right Damaged | Repair |
