## CONDITION REPORT

Report No: 2016867682

| Manufacturer | HYUNDAI | Registration Number | NO REG |
| Model | CRETA | Register Number | |

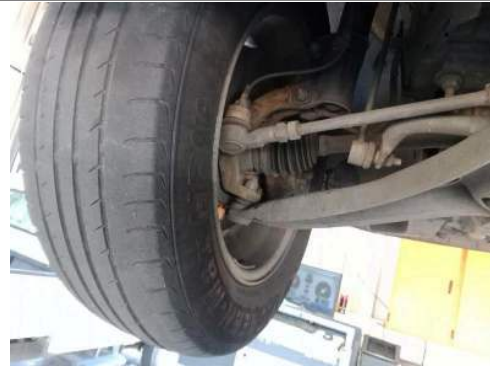
LF TYRE TREAD

| | Size | Load/Speed Index | Manufacture | Model | Type* | Production Date | Tread Depth (mm) |
|---|---|---|---|---|---|---|---|
| Front Left | 205/65R16 | 95H | Ling long | Green max | V | 3620 | 1 mm |

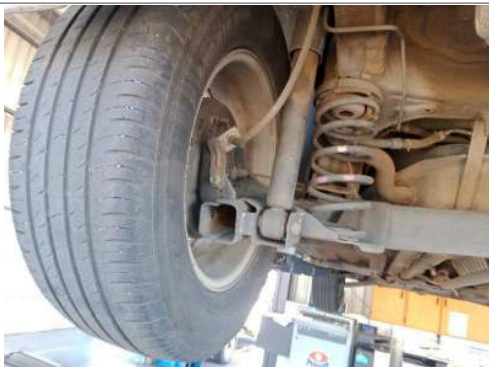
LR TYRE TREAD

| | Size | Load/Speed Index | Manufacture | Model | Type* | Production Date | Tread Depth (mm) |
|---|---|---|---|---|---|---|---|
| Rear Left | 235/60R16 | 100H | Kumho | Ecowing | V | 011 | 3 mm |

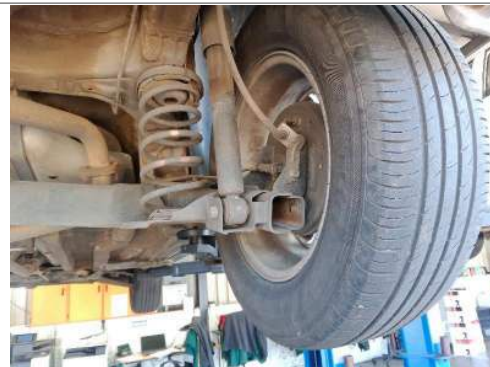
RR TYRE TREAD

| | Size | Load/Speed Index | Manufacture | Model | Type* | Production Date | Tread Depth (mm) |
|---|---|---|---|---|---|---|---|
| Rear Right | 235/60R16 | 100H | Kumho | Ecowing | V | 0117 | 3 mm |

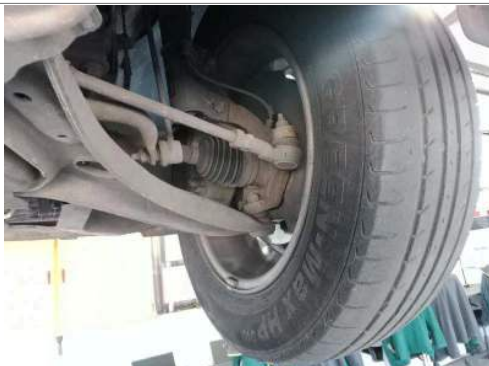
RF TYRE TREAD

| | Size | Load/Speed Index | Manufacture | Model | Type* | Production Date | Tread Depth (mm) |
|---|---|---|---|---|---|---|---|
| Front Right | 205/65R16 | 96H | Ling long | Green max | V | 3620 | 1 mm |

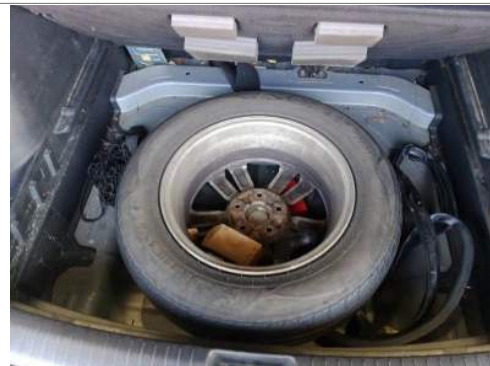
Sparewheel

| | Size | Load/Speed Index | Manufacture | Model | Type* | Production Date | Tread Depth (mm) |
|---|---|---|---|---|---|---|---|
| Spare | 205/65R16 | 95H | Kumho | Solus | V | 0000 | 1 mm |

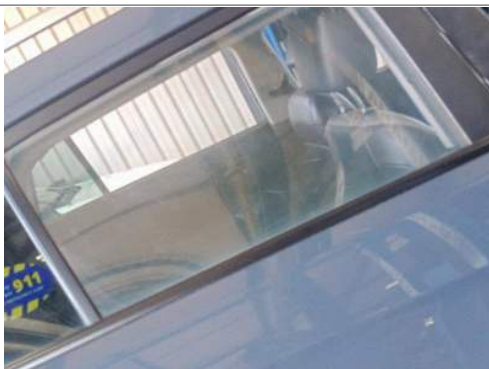
Perspex window

| Damage | Repair Way |
|---|---|
| left rear window perspex | Replace |

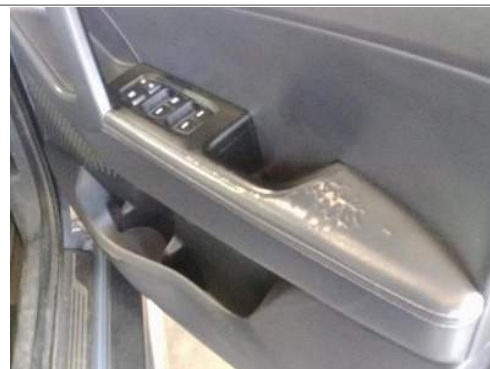
| Damage | Repair Way |
|---|---|
| Door Panel Front Right Torn / Cut | Repair |

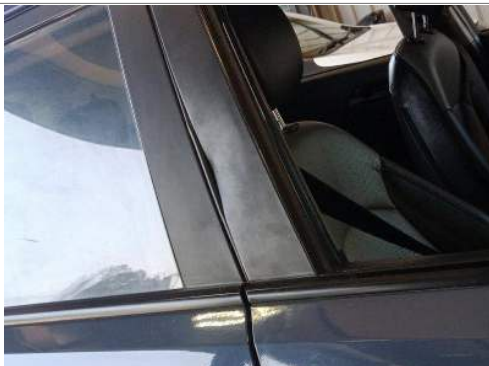
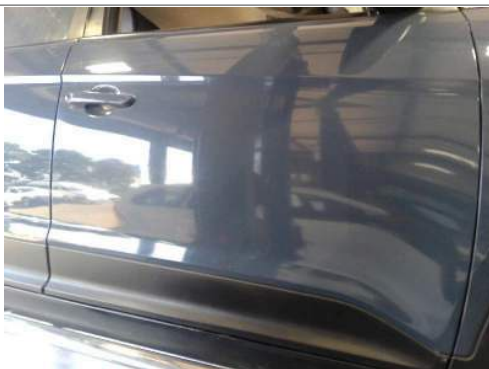
| Damage | Repair Way |
|---|---|
| Door Front Right Dented | Repair |

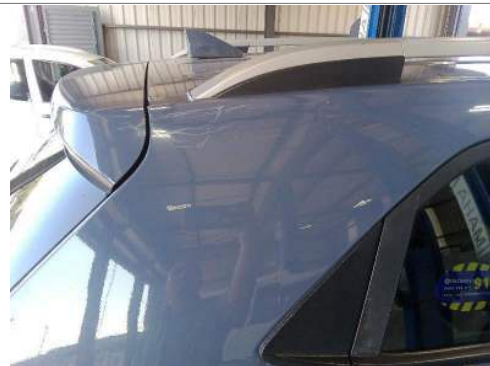
| Damage | Repair Way |
|---|---|
| A • Pillar Right Paintwork • Scratched | Repair |

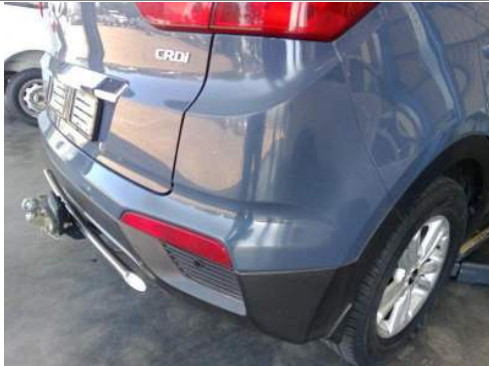
| Damage | Repair Way |
|---|---|
| Rear bumper Residual Traces of Repair | Repair |

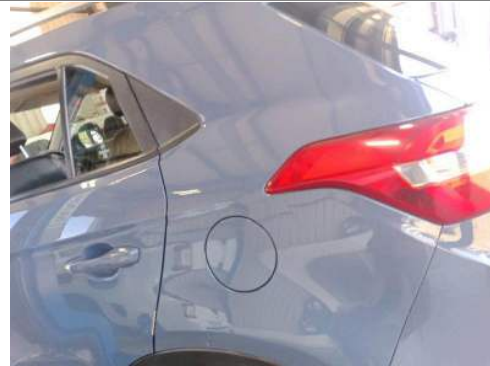
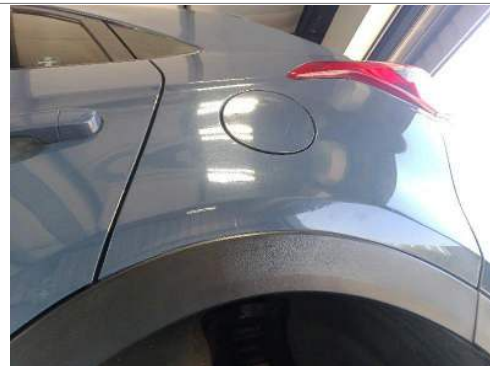
| Damage | Repair Way |
|---|---|
| Rear Fender Left Dented | Repair |

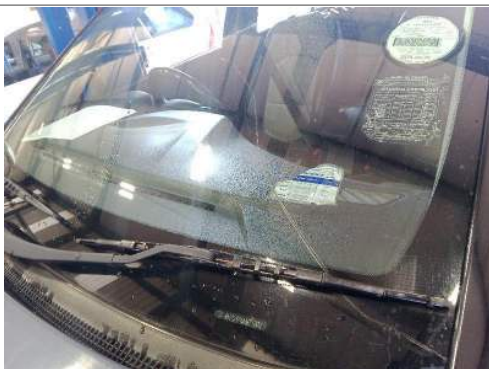
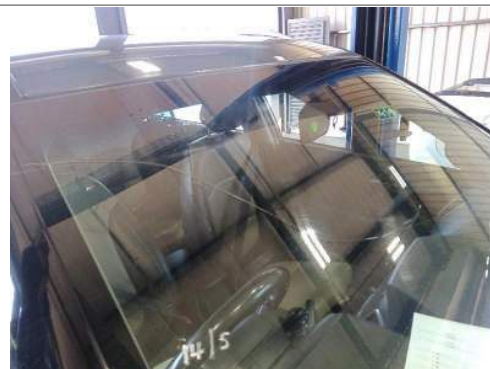
| Damage | Repair Way |
|---|---|
| Windscreen Cracked | Replace |

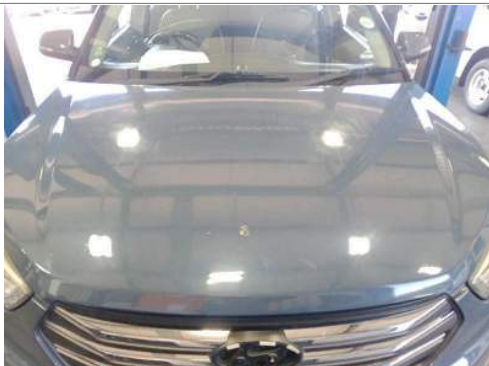
| Damage | Repair Way |
|---|---|
| Bonnet Residual Traces of Repair | Replace |

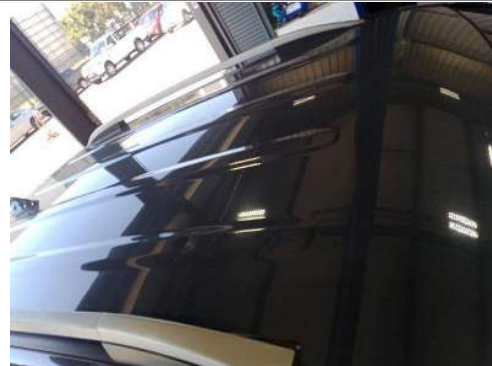
| Damage | Repair Way |
|---|---|
| Roof Dented | Repair |

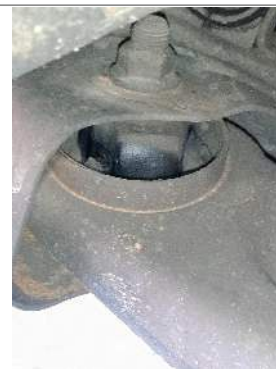
| Damage | Repair Way |
|---|---|
| Control Arm Bush(es) Front Axle Right Loose / Excessive Play | Replace |

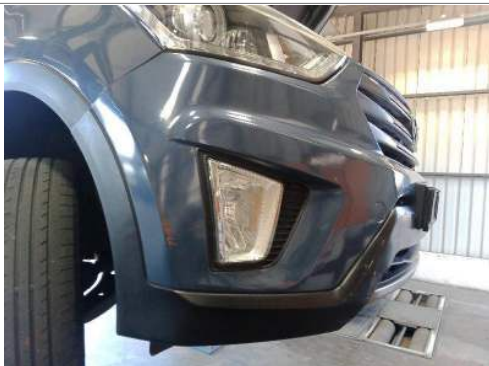
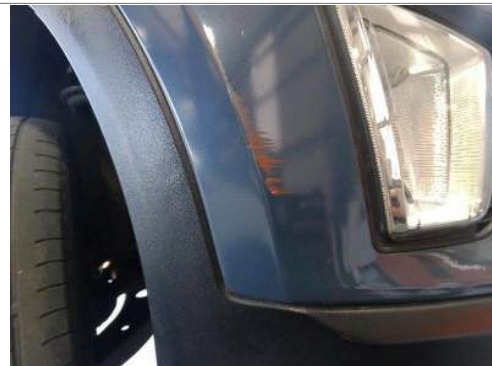
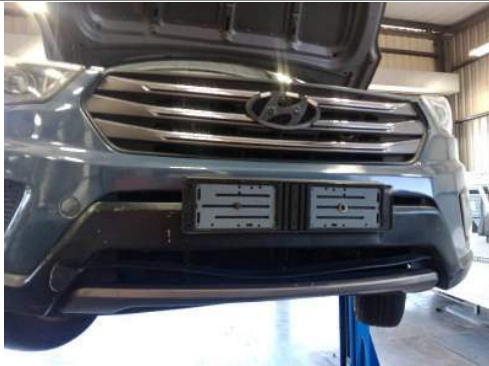
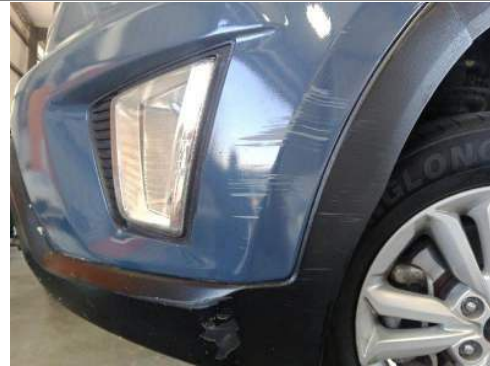
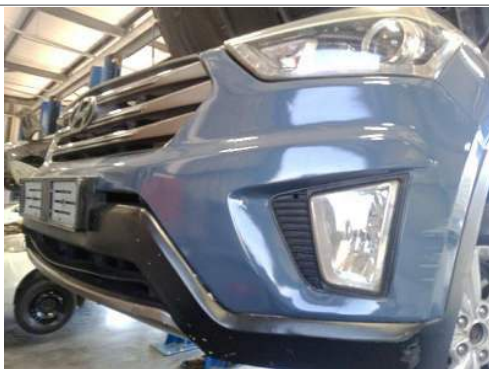
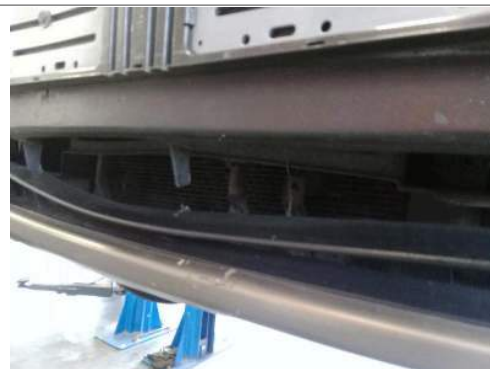
| Damage | Repair Way |
|---|---|
| Front Bumper Residual Traces of Repair | Repair |

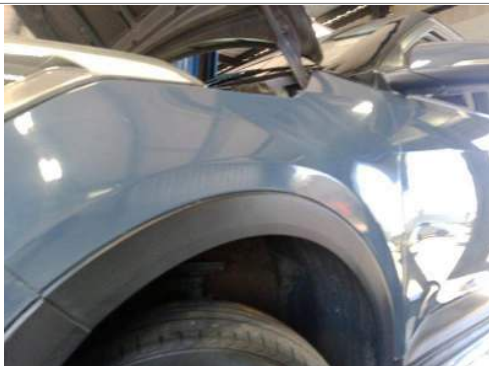
| Damage | Repair Way |
|---|---|
| Front Fender Left Residual Traces of Repair | Repair |

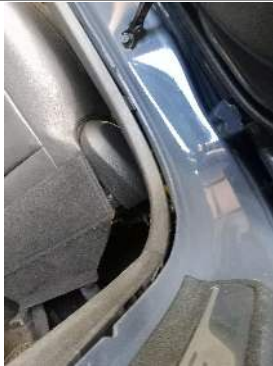
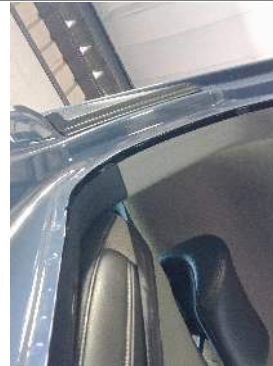
| Damage | Repair Way |
|---|---|
| Door Sealing Rubber Rear Right Missing | Replace |

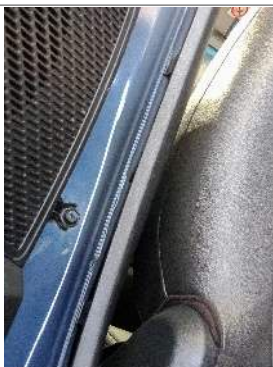
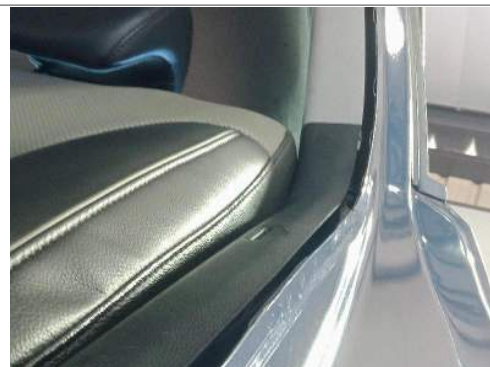
| Damage | Repair Way |
|---|---|
| Door Sealing Rubber Rear Left Missing | Replace |

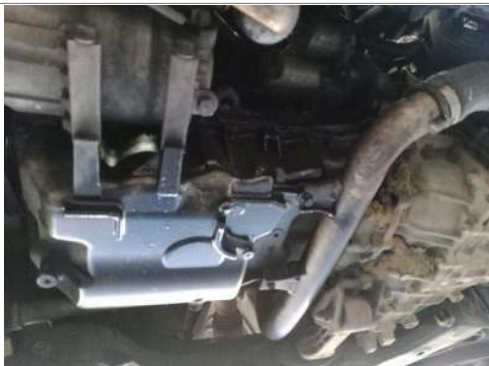
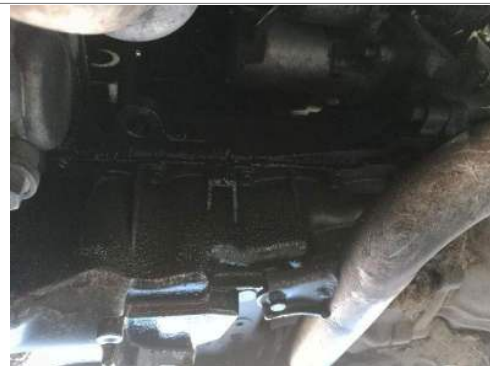
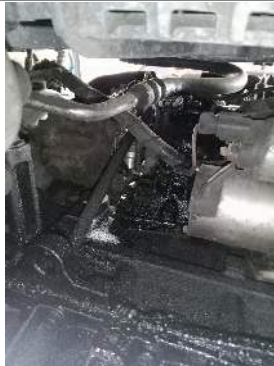
| Damage | Repair Way |
|---|---|
| Engine Oil Leak | Repair |

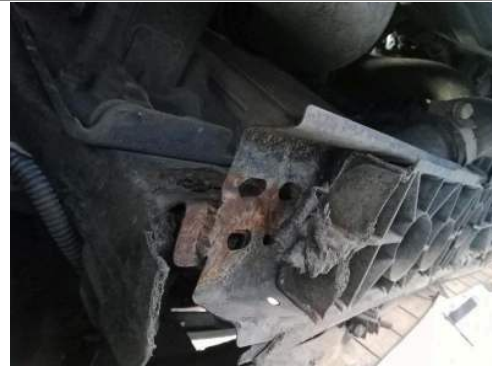
| Damage | Repair Way |
|---|---|
| Radiator Cradle Welded | Repair |

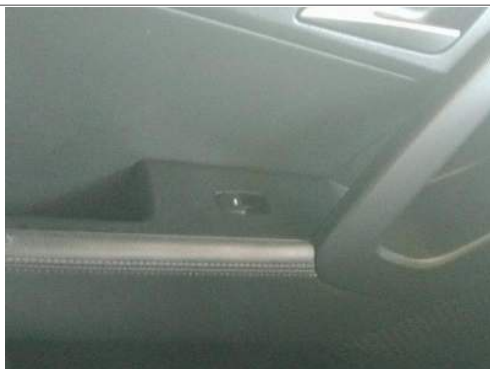
| Damage | Repair Way |
|---|---|
| Switch Electrical Window Winder front left Defective | Repair |

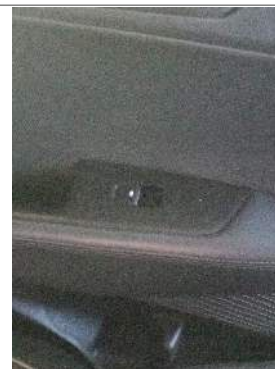
| Damage | Repair Way |
|---|---|
| Switch Electrical Window Winder rear left Defective | Repair |

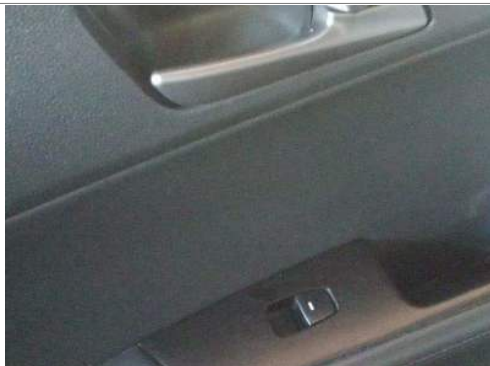
| Damage | Repair Way |
|---|---|
| Switch Electrical Window Winder rear right Defective | Repair |
