## CONDITION REPORT

Report No:  
2016959081  
DATE  
26/07/2025

Vehicle Type	PASSENGER VEHICLE	Registered Owner	MFC
Manufacturer	HYUNDAI	Registration Number	KJB281NW
Model	VENUE 1.0 88KW TGDI MOTION INFOTAINMENT [2020-2023]	Register Number	
VIN	MALFB81ALLM071768	Date Of First Licensing	
Engine Number		Last COR	
Doors	5	License Expiry Date	
Color	RED	Power / Displacement	
Year Model	2020	Paint Finish	TWO COAT METALLIC
Km Reading	181,956 KM	Fuel	PETROL
Cab / Body Type	HATCHBACK	Transmission	MANUAL

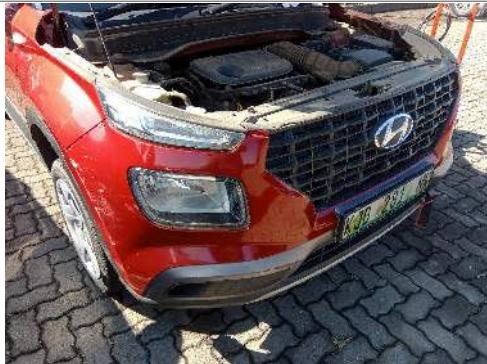
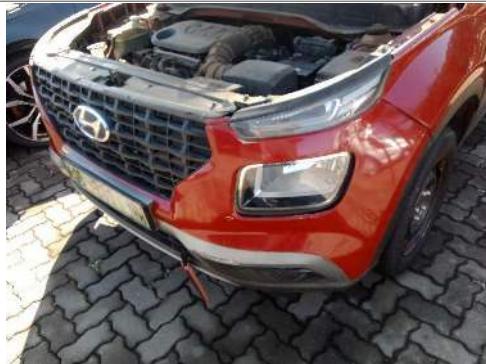
Damage	Repair Way
Engine Oil Leak	Repair
Engine Management Lights Set	Repair
Tail Light Right Damaged	Replace
Mirror Adjusters Damaged	Repair
Front Bumper Damaged	Repair
Bonnet Damaged	Repair
Front Fender Left Damaged	Repair
Front Fender Right Damaged	Repair
Rear Fender Left Damaged	Repair
Rear Fender Right Damaged	Repair
Door Front Left Damaged	Repair
Door Front Right Damaged	Repair
Door Rear Left Damaged	Repair
Door Rear Right Damaged	Repair
Boot Lid / Hatch door Damaged	Repair
Rear bumper Damaged	Repair
Roof Damaged	Replace
Windscreen Damaged	Replace
Tyre Front Left Worn	Replace
Tyre Front Right Damaged	Replace
Tyre Rear Left Worn	Replace
Tyre Rear Right Worn	Replace
Radiator Cradle Damaged	Replace
Engine Performance Insufficient	Repair
Engine Noise Idling / Hunting	Repair

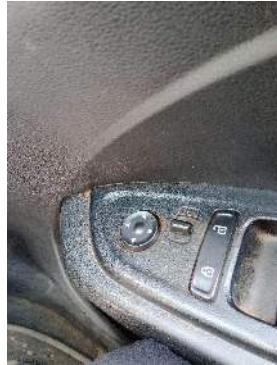
Mirror Adjusters

General Comments: Engine Compartment: Battery loose.  
Interior: electronic mirrors adjusters do not work.  
Body • Exterior: Minor dents and scratches and stone chips to some body panels. Signs of repair work done to somebody panels. Poor alignment to somebody panels. Repair work done to vehicle below standard. Vehicle body in poor condition.

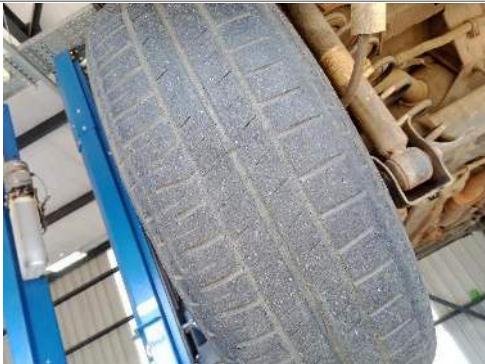
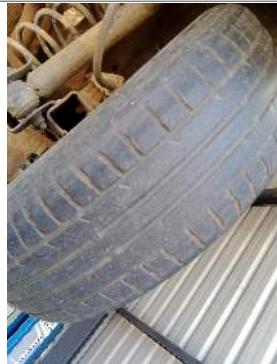
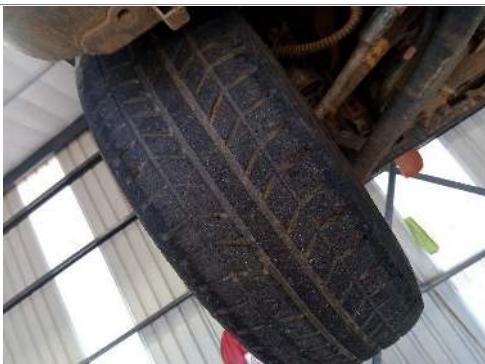
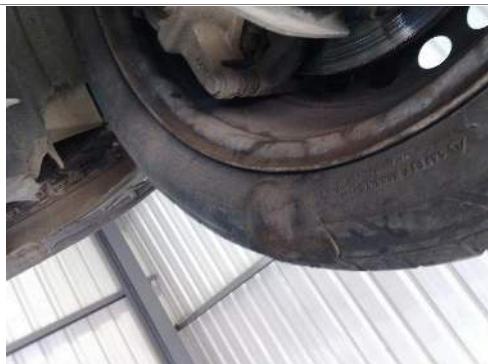
Size	Load/Speed Index	Manufacture	Model	Type*	Production Date	Tread Depth (mm)
Front Left	195/65R15	91V	Dunlop	Sp	V	2222	0 mm
Front Right	195/50R15	82V	Joyride	Radial	V	0122	2 mm
Rear Left	185/65R15	88H	Winrun	Radial	V	2922	0 mm
Rear Right	185/65R15	88H	Dunlop	Sp	V	4321	0 mm
