MFC Auction House
M57 Pretoria Rd, Glenmarais, KEMPTON PARK
Gauteng

DEKRA MFC
M57 Pretoria Rd - 1619
KEMPTON PARK - GT
08610 33572

VEHICLE INSPECTION

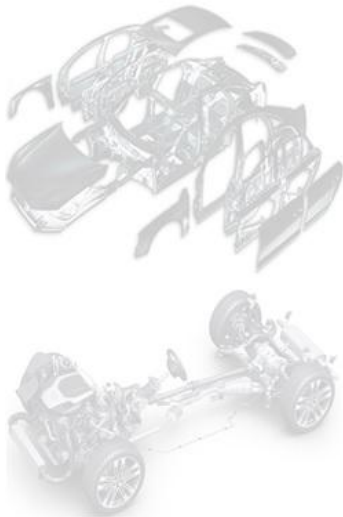
| Damage | Repair Way |
|---|---|
| Door Rear Left Dented | Repair |

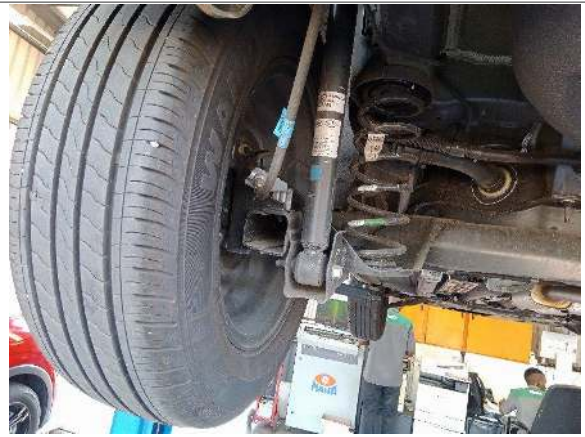
LR TYRE TREAD

| | Size | Load/Speed Index | Manufacture | Model | Type* | Production Date | Tread Depth (mm) |
|---|---|---|---|---|---|---|---|
| Rear Left | 215/60R16 | 95H | MRF | Wanderer | V | 4222 | 6 mm |

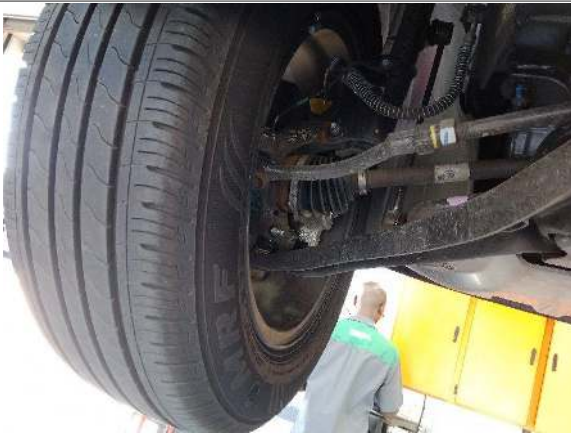
LF TYRE TREAD

| | Size | Load/Speed Index | Manufacture | Model | Type* | Production Date | Tread Depth (mm) |
|---|---|---|---|---|---|---|---|
| Front Left | 215/60R16 | 95H | MRF | Wanderer | V | 4222 | 5 mm |

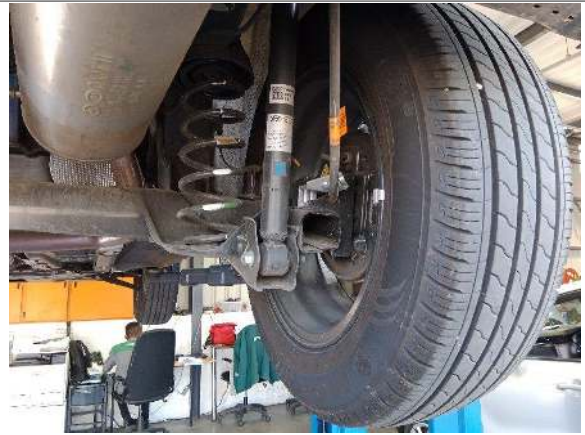
RR TYRE TREAD

| | Size | Load/Speed Index | Manufacture | Model | Type* | Production Date | Tread Depth (mm) |
|---|---|---|---|---|---|---|---|
| Rear Right | 215/60R16 | 95H | MRF | Wanderer | V | 4222 | 6 mm |

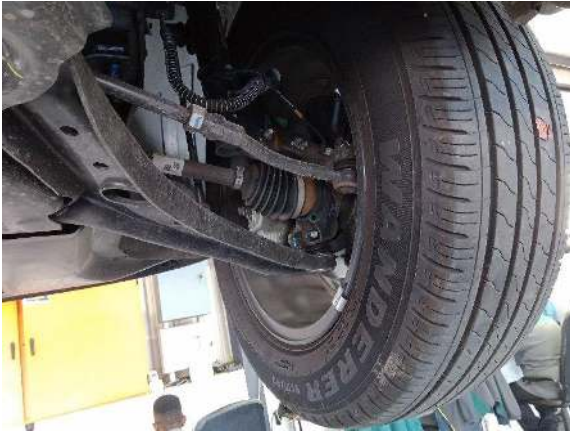
RF TYRE TREAD

| | Size | Load/Speed Index | Manufacture | Model | Type* | Production Date | Tread Depth (mm) |
|---|---|---|---|---|---|---|---|
| Front Right | 215/60R16 | 95H | MRF | Wanderer | V | --- | 6 mm |

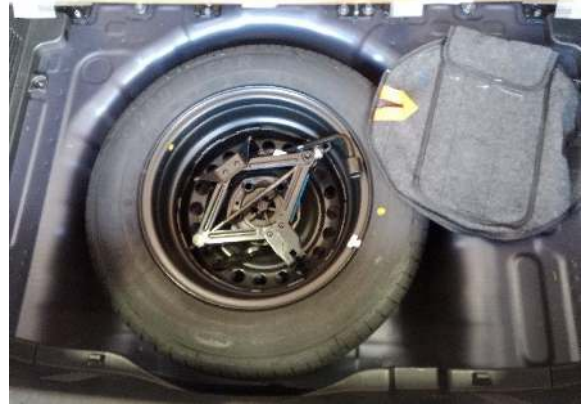
SPARE WHEEL

| | Size | Load/Speed Index | Manufacture | Model | Type* | Production Date | Tread Depth (mm) |
|---|---|---|---|---|---|---|---|
| Spare | 195/65R15 | 91H | Goodyear Asu | Assurance | V | --- | 5 mm |
