CONDITION REPORT

Report No: 201644863

DATE
10/07/2024

Vehicle Type	PASSENGER VEHICLE	Registered Owner	MFC AUCTION HOUSE
Manufacturer	HYUNDAI	Registration Number	LC71YZGP
Model	VENUE	Register Number	
VIN	MALFB81BLPM405603	Date Of First Licensing	
Engine Number		Last COR	
Doors	5	License Expiry Date	30/04/2024
Color	SILVER	Power / Displacement	
Year Model		Paint Finish	TWO COAT UNI
Km Reading	19,757 KM	Fuel	PETROL
Cab / Body Type	HATCHBACK	Transmission	MANUAL

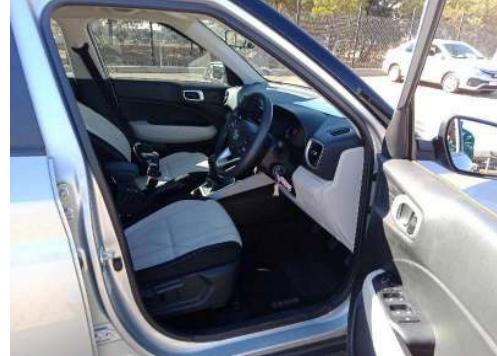
INTERIOR (FRONT DRIVER DOOR)

Interior: Vehicle interior dirty and some panels scratched.

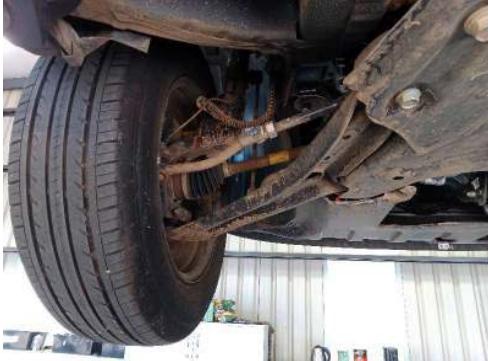
LF TYRE TREAD

Size	Load/Speed Index	Manufacture	Model	Type*	Production Date	Tread Depth (mm)
Front Left	195/65 R15	91H	Goodyear	Assurance	V	2322	5 mm
Front Right	195/65 R15	91H	Goodyear	Assurance	V	3522	4 mm
Rear Left	195/65 R15	91H	Goodyear	Assurance	V	3222	5 mm
Rear Right	195/65 R15	91H	Goodyear	Assurance	V	3422	5 mm
Spare	195/65 R15	91H	Goodyear	Assurance	V	3522	6 mm

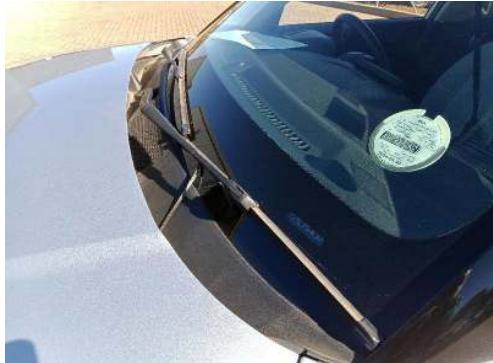
Damage	Repair Way
Windscreen Wiper Damaged	Replace
Front Bumper Paintwork • Scratched	Repair
Door Front Right Paintwork • Scratched	Repair
Door Rear Right Dented	Repair
