## CONDITION REPORT

Report No: 2016844468

| Manufacturer | HYUNDAI | Registration Number | JS42DSGP |
| Model | VENUE 1.0 88KW TGD1 FLUID 2 TONE [2020-2023] | Register Number | |

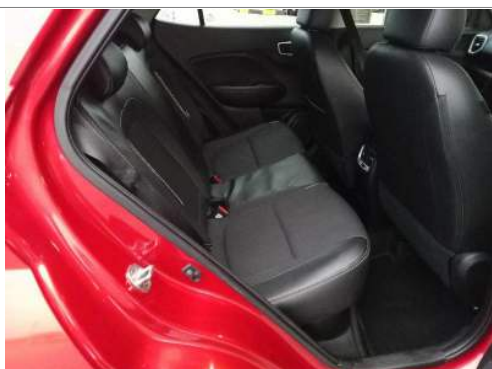
| Damage | Repair Way |
|---|---|
| Seat Rear Defective | Repair |

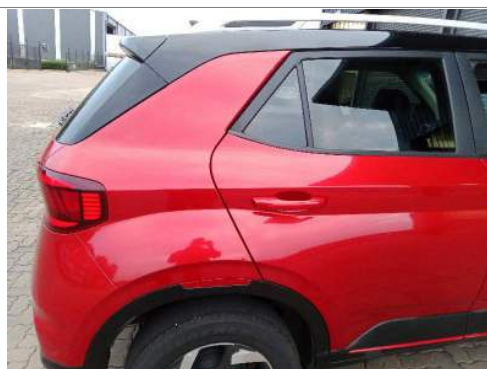
| Damage | Repair Way |
|---|---|
| Rear Fender Right Dented | Repair |

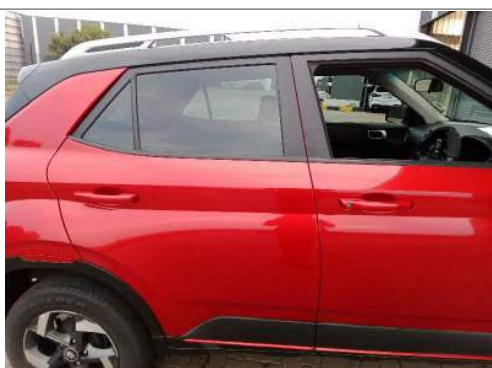
| Damage | Repair Way |
|---|---|
| Door Rear Right Paintwork • Scratched | Repair |

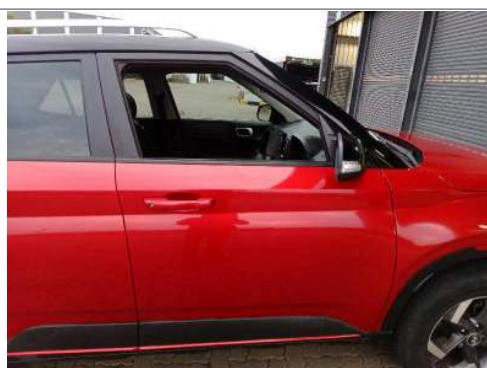
| Damage | Repair Way |
|---|---|
| Door Front Right Dented | Repair |

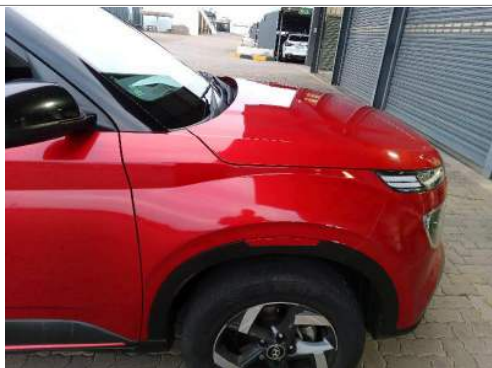
| Damage | Repair Way |
|---|---|
| Front Fender Right Residual Traces of Repair | Repair |

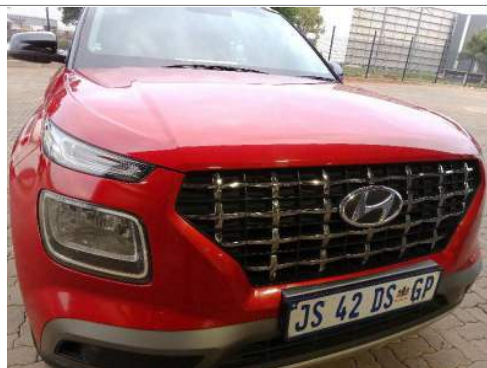
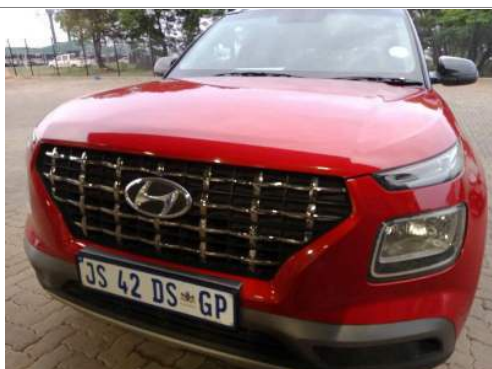
| Damage | Repair Way |
|---|---|
| Front Bumper Damaged | Repair |

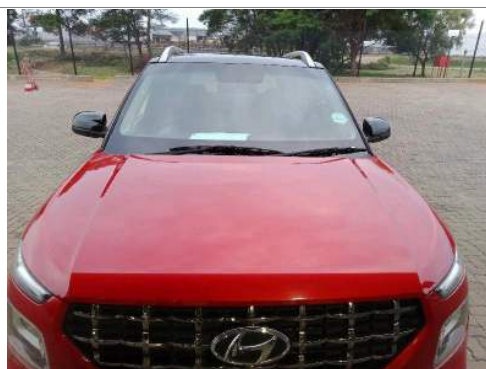
| Damage | Repair Way |
|---|---|
| Bonnet Paintwork • Chipmarks | Repair |

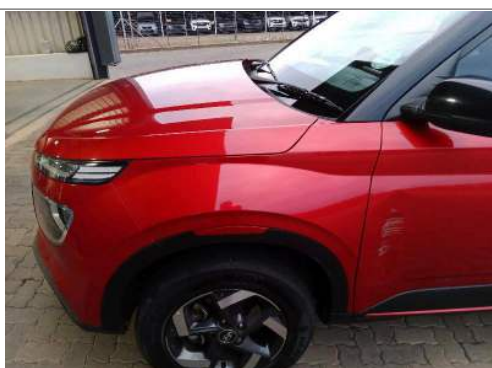
| Damage | Repair Way |
|---|---|
| Front Fender Left Dented | Repair |

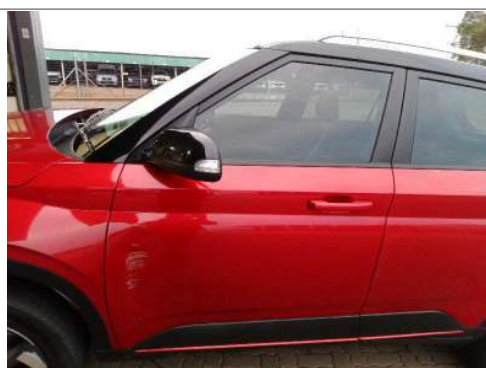
| Damage | Repair Way |
|---|---|
| Door Front Left Damaged | Repair |

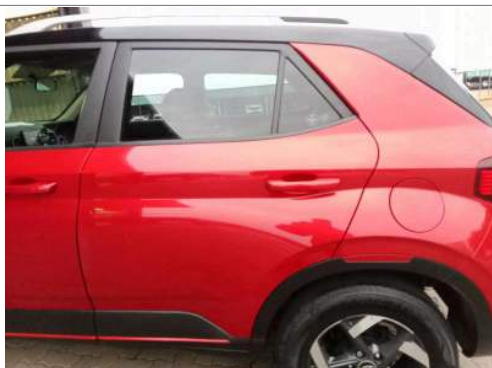
| Damage | Repair Way |
|---|---|
| Door Rear Left Paintwork • Scratched | Repair |

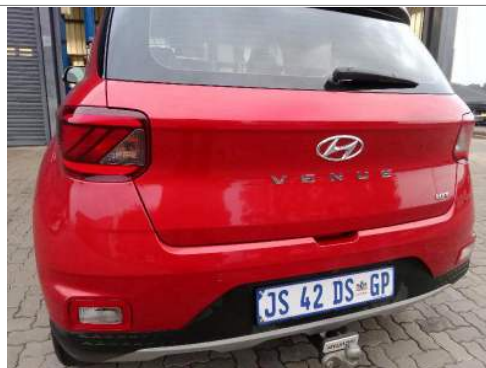
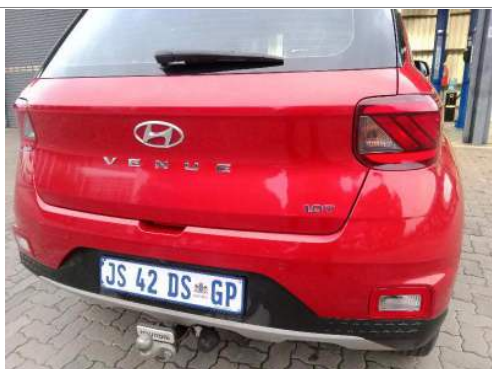
| Damage | Repair Way |
|---|---|
| Rear bumper Paintwork • Scratched | Repair |

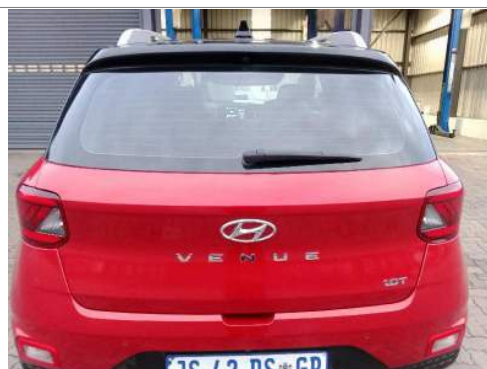
| Damage | Repair Way |
|---|---|
| Boot Lid / Hatch door Paintwork • Scratched | Repair |

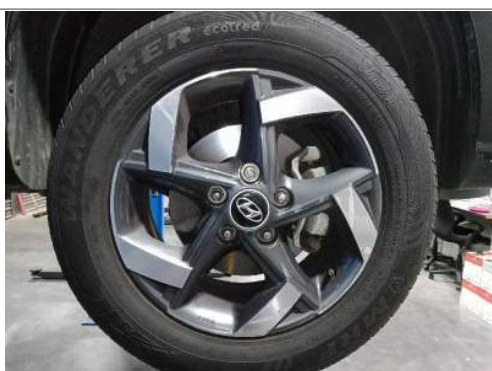
| Damage | Repair Way |
|---|---|
| Rim Front Right Scratched | Repair |

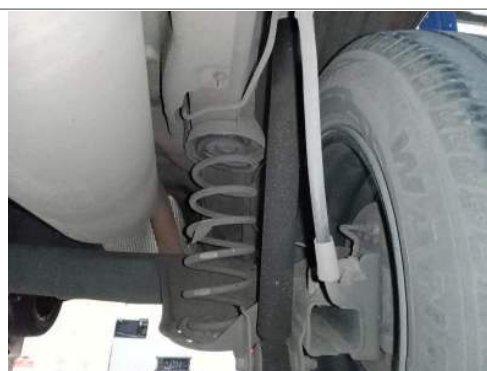
| Damage | Repair Way |
|---|---|
| Shock Absorber Rear Right Sweat | Replace |

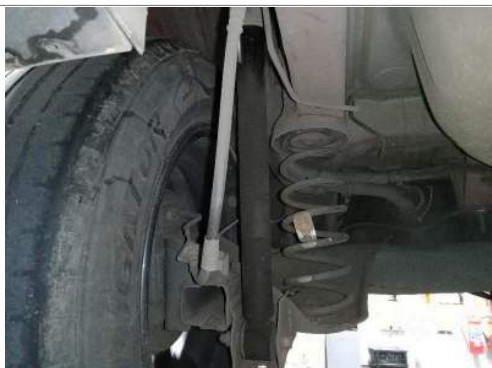
| Damage | Repair Way |
|---|---|
| Shock Absorber Rear Left Sweat | Replace |

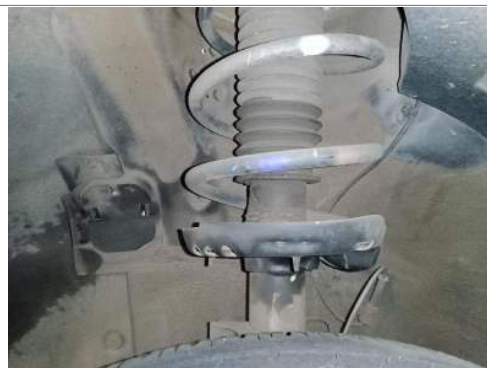
| Damage | Repair Way |
|---|---|
| Shock Absorber Front Left Sweat | Replace |

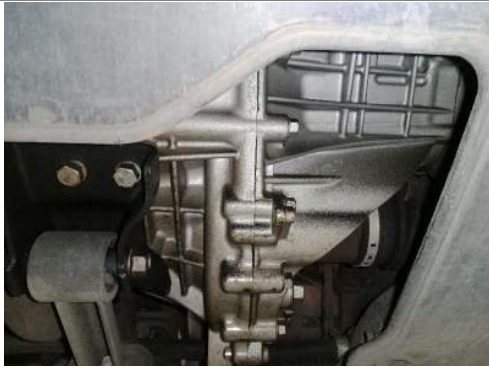
| Damage | Repair Way |
|---|---|
| Gearbox Oil Leak | Repair |

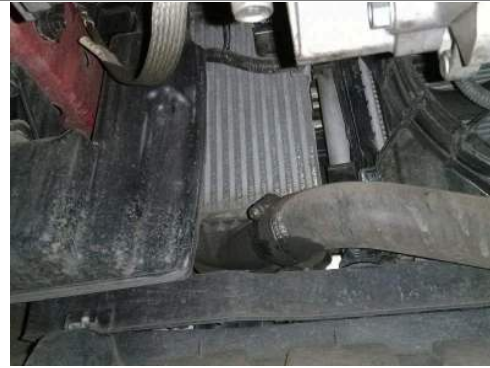
| Damage | Repair Way |
|---|---|
| Hoses Oil Leak | Repair |

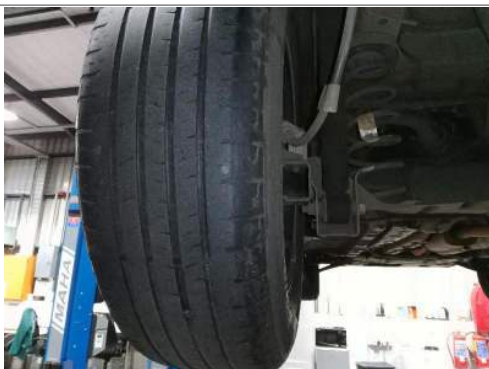
| Damage | Repair Way |
|---|---|
| Tyre Rear Left Worn | Replace |

| | Size | Load/Speed Index | Manufacture | Model | Type* | Production Date | Tread Depth (mm) |
|---|---|---|---|---|---|---|---|
| Rear Left | 215/65 R16 | 98H | Lanvigator | Comfort | V | 3121 | 0 mm |

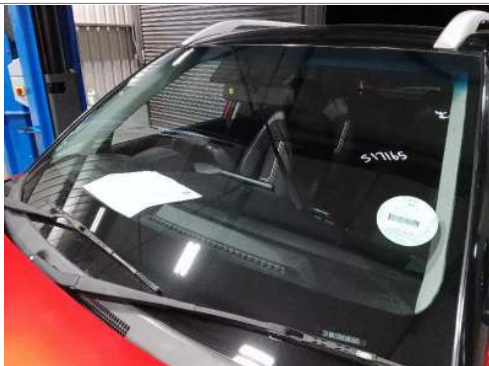
| Damage | Repair Way |
|---|---|
| Windscreen Chipped | Repair |

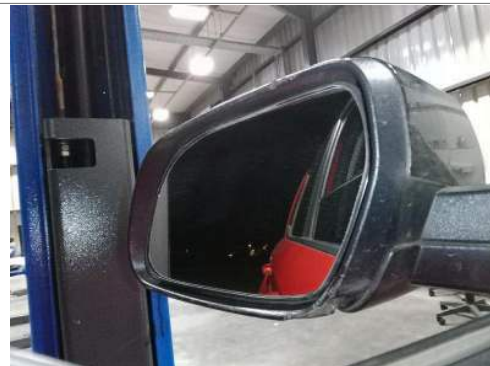
| Damage | Repair Way |
|---|---|
| Side Mirror Left Residual Traces of Repair | Replace |
